MONTICELLO NUCLEAR GENERATING PLANT  
Docket No. 50-263 License No. DPR-22

Supplemental Information on Event Involving Loss of  
Instrument Air Compressor and Subsequent Events

Supplemental Information On Event Involving Loss of Instrument  
Air Compressor and Subsequent Events

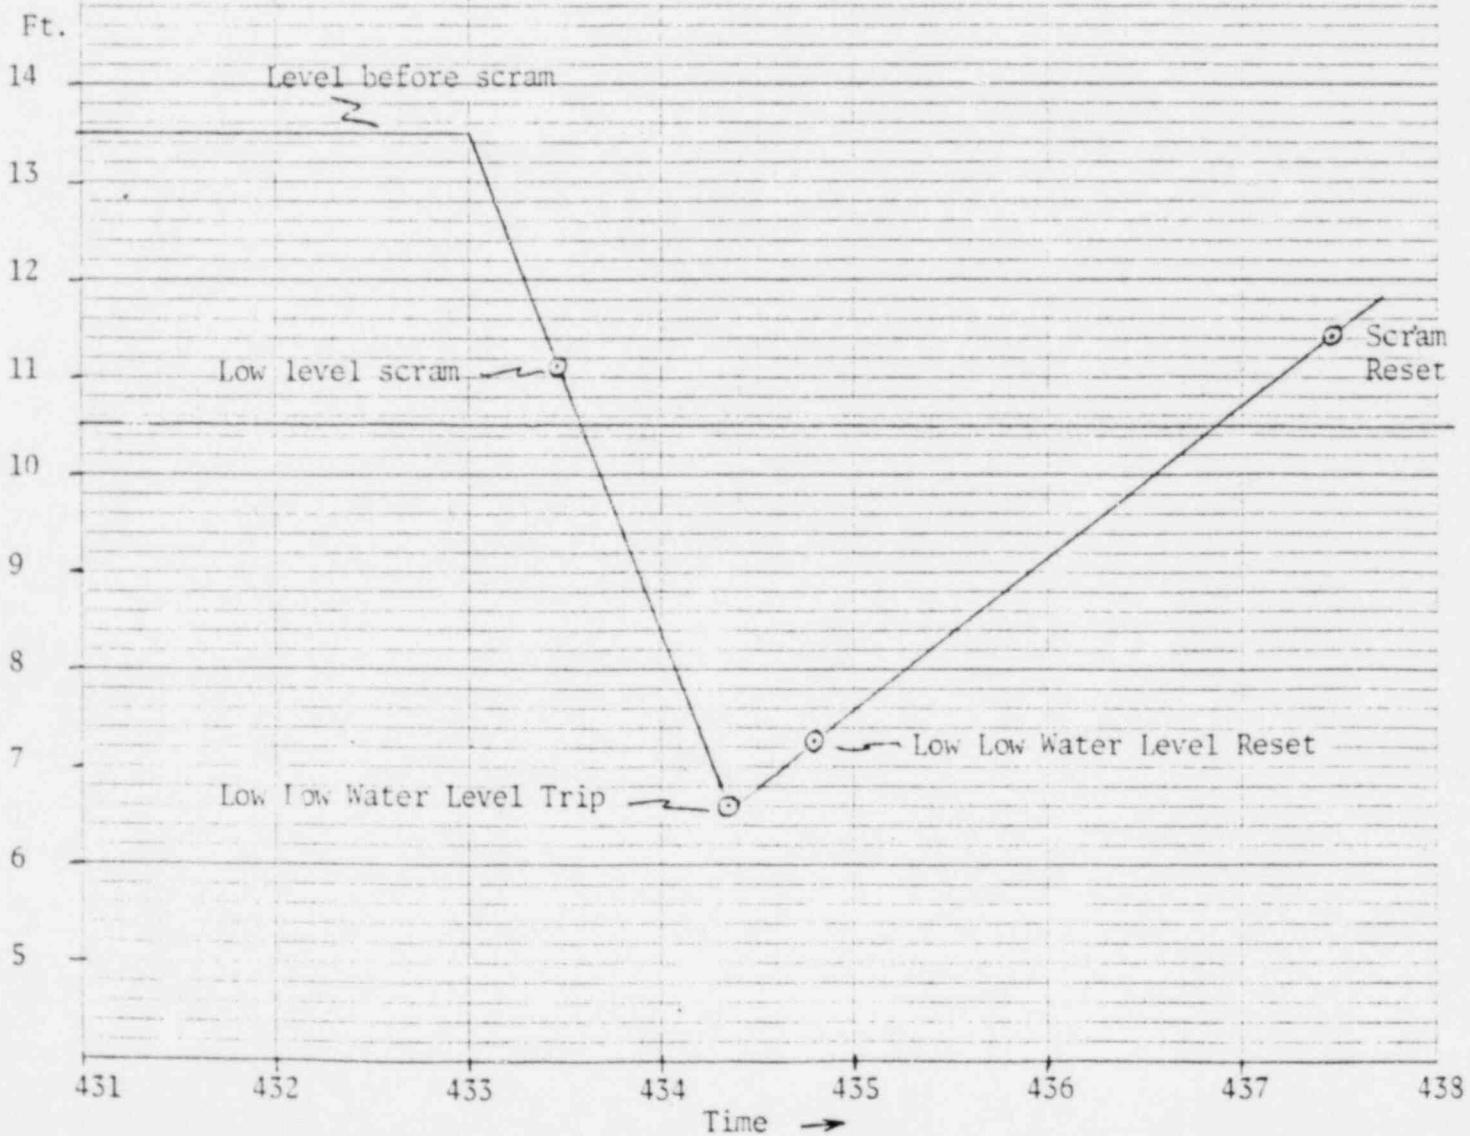
043447 to 043450 The four low-low water level switches reset as water level inventory recovered. A graphical analysis (Attachment 1) indicates that the water level didn't drop much below the low-low water level trip setpoint. This occurred due to the manual initiation of HPCI concurrent with low-low level trip. This would indicate that the lowest water level during the scram was 6'-6" above the top of the core.

Water level above top of Core.  
All Initiations and Resets are  
Relative to Yarway Switches.  
Setpoints are as found Feb 19, 1981

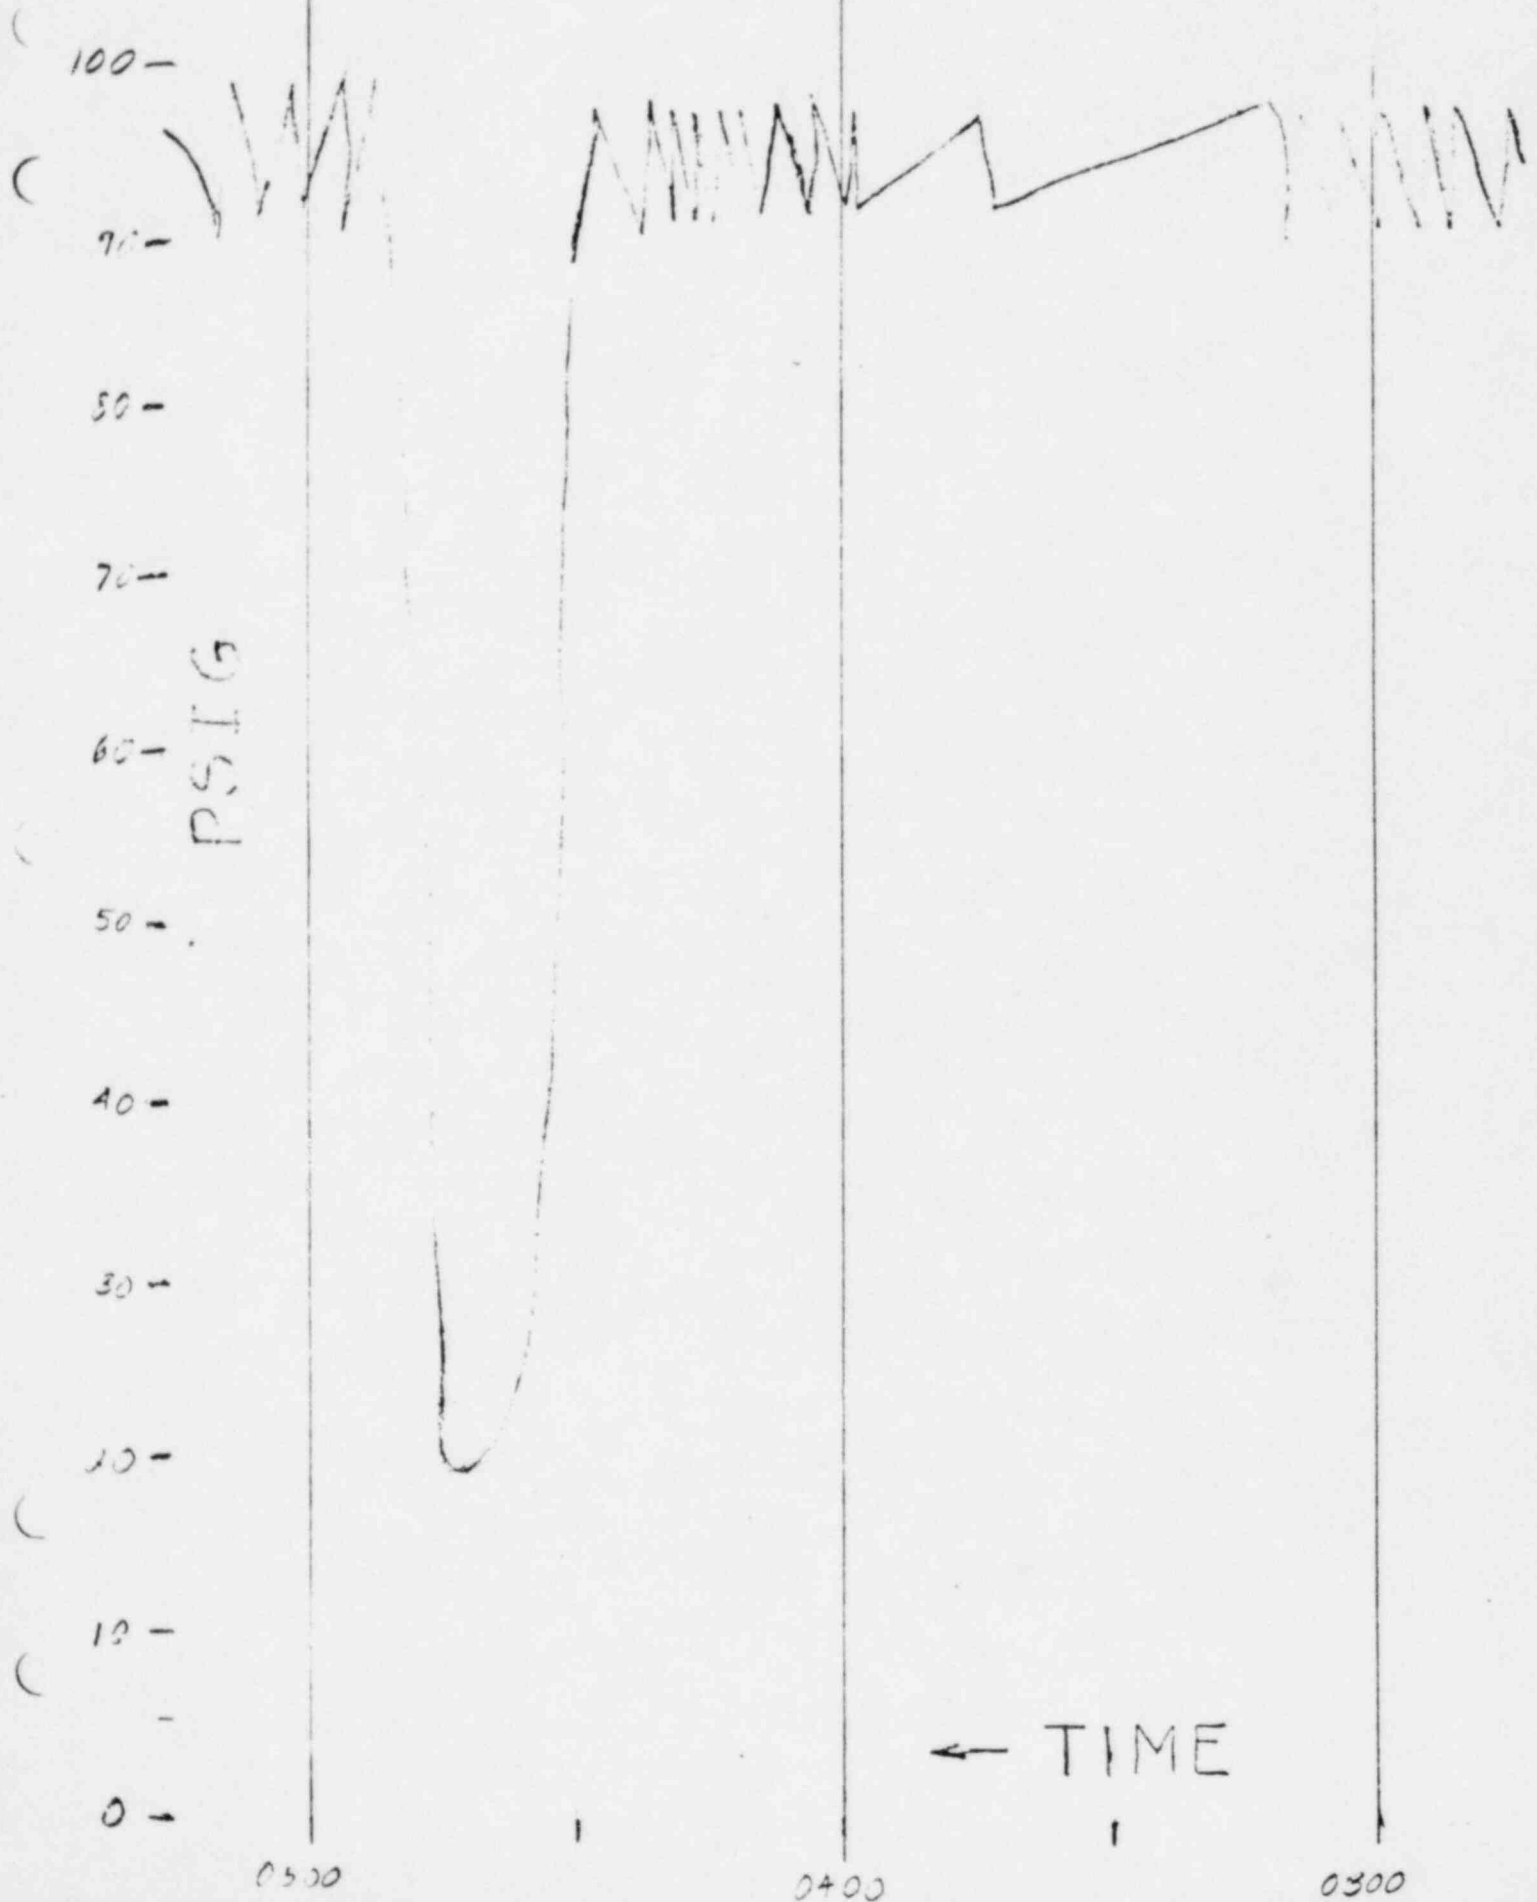
A chart of the instrument air pressure (Attachment 2) shows that the pressure dropped to as low as 18 psig before recovery occurred. Recovery was brought about by the isolation of the #13 compressor. Normal instrument air pressure was restored approximately 20 minutes after the initial blowdown occurred.
