LICENSEE EVENT REPORT (LER)

FACILITY NAME (1) Shoreham Nuclear Power Station Unit 1 DOCKET NUMBER (2) 0 5 0 0 0 3 2 2 PAGE (3) 1 OF 016

TITLE (4) RBCLCW split on low-low head tank level during placement of heat exchanger into service due to filling and venting problem

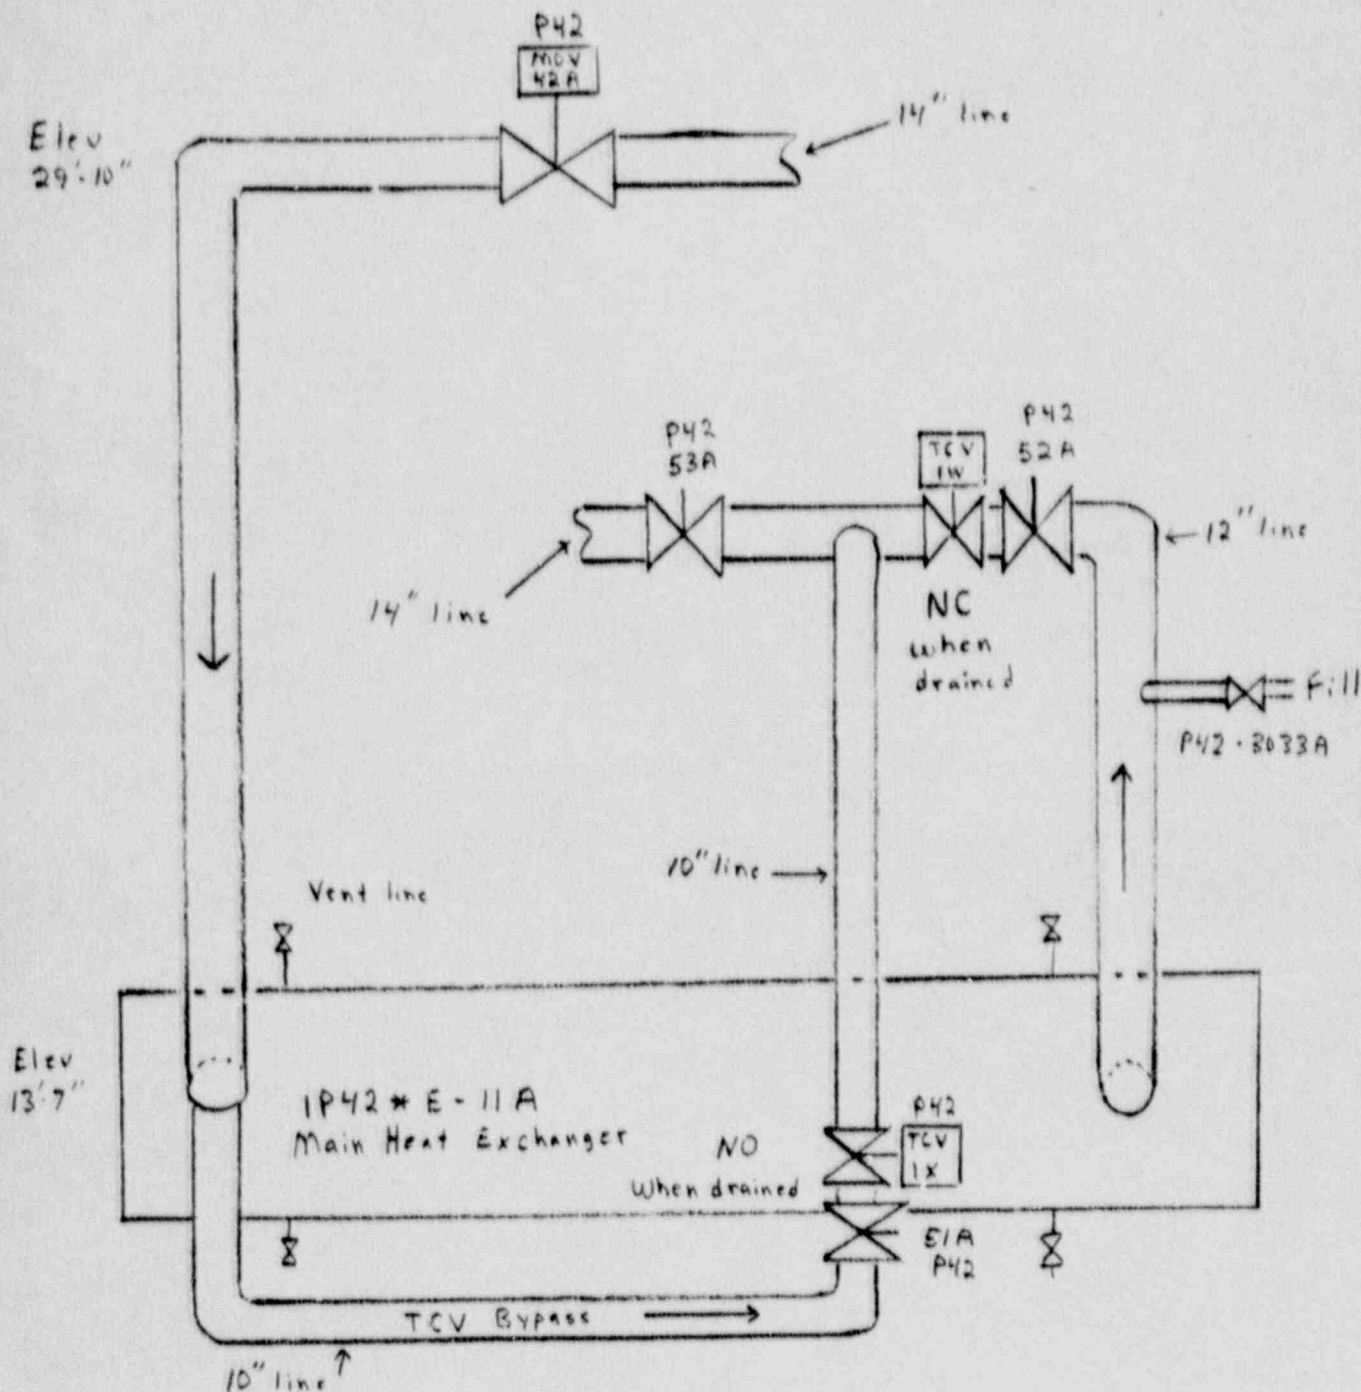
NOTE: A simplified diagram of the piping, valves and heat exchanger is included in this report. Refer to page 6 of 6.

The RBCLCW system split into its accident configuration due to a low-low water level in the "A" head tank. When the heat exchanger and its associated piping were drained and then refilled, a portion of the piping remained unfilled. When the heat exchanger inlet valve (MOV-42) was opened, the head tank drained to fill the remaining portion of the piping causing the system split. The cause can be attributed to a combination of procedural inadequacies and system design deficiencies.

The inlet valve (MOV-42) is located approximately 16 feet above the heat exchanger. Vents are located on the heat exchanger and are opened when the heat exchanger is being filled. The possibility does exist that the piping (14" line) leading to the inlet valve will not be sufficiently filled, creating a large void in the system (enough to allow the draining of the head tank below its accident signal level). There is no vent located at the inlet valve. This was the apparent cause of the present event.

1. As indicated previously, EEAR 87-119 has been initiated. This modification applies to the main and booster heat exchangers. It requires installation of vent valves on the inlet and outlet piping of each heat exchanger and also a bypass valve around the heat exchanger inlet isolation valves.
2. Because of the recurrence of this event, a more in depth review of the procedure (SP 23.118.01) was performed identifying deficiencies in the filling and venting of the heat exchangers. These deficiencies have been corrected.

3. Because of this most recent event, EEAR 89-011 has been initiated to change the control circuitry for the main and booster heat exchanger inlet isolation valves (1P42*MOV-033A/B and 1P42*MOV-042A/B). This modification will delete the seal-in circuitry and allow these valves to be bumped open when placing the heat exchangers in service.
