LA SALLE II  
UPPER VESSEL FABRICATION SUMMARY

June 29, 1990

General Electric  
Nuclear Energy  
175 Curtner Avenue  
San Jose, California 95125

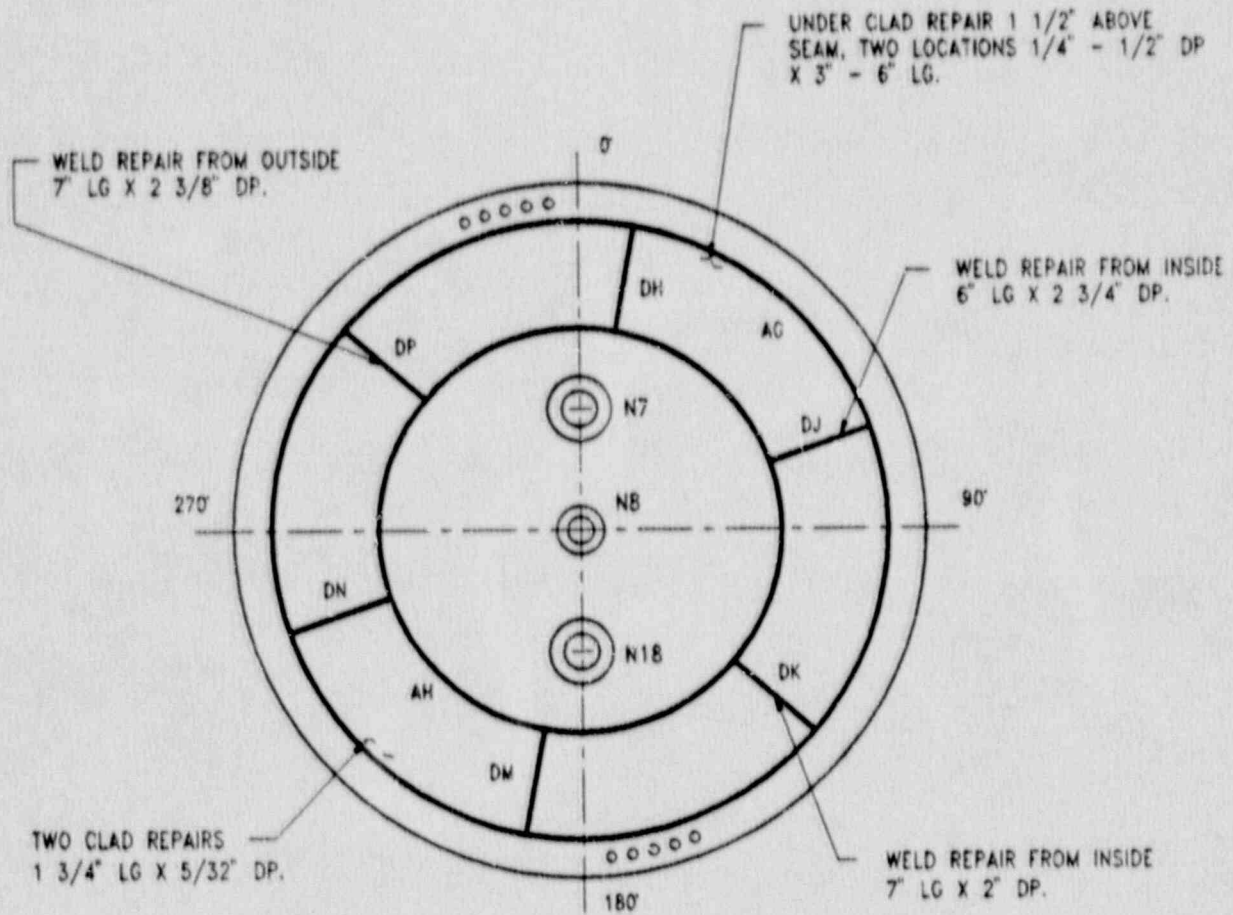
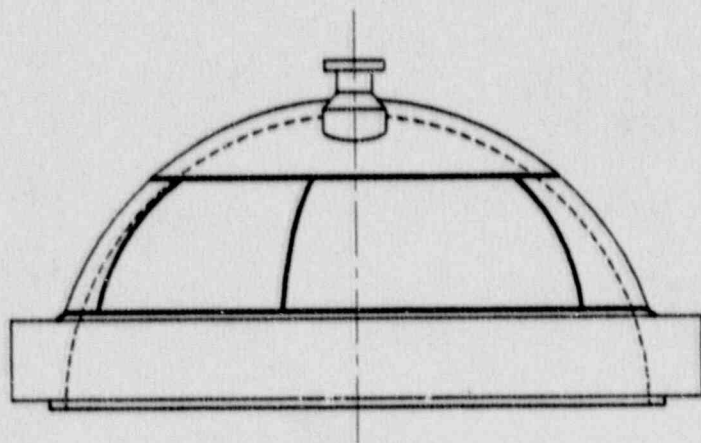
FIGURE 1  
-7-

After the completion of all six seam welds, the Torus subassembly received intermediate Post Weld Heat Treatment (PWHT) for two hours at 1100°F to 1150°F. This PWHT is documented in Furnace Heat Report (FHR) #73-314. After the PWHT each seam was examined by MT from inside and outside, followed by Ultrasonic Testing (UT) and Radiographic Testing (RT). Slag inclusion defects were found by RT examination in seam DJ, DK, and DP. The repair cavity dimensions before welding were:

RT examination of weld seam AG, after intermediate PWHT, revealed two slag inclusion areas 1-1/2" above the seam centerline. These slag inclusions were removed by grinding to the base metal below the cladding. Cavity dimensions before welding were: 6-1/2" long x 3-1/4" wide x 1/2" deep and 3-1/2" long x 3-1/4" wide x 1/4" deep. Weld repairs were made using SMAW process per Cladding Repair Procedure GRP-2, Rev. 4 with electrode E309 and E308L (2 layers). Repair areas were blend ground and examined by PT. The repair areas were outlined with punch marks on the cladding. Two other arc gouge marks, 42" below the Torus to Dollar Plate seam were removed by grinding 5/32" deep into the cladding, weld repaired with preheat and blend ground. Both repairs were performed before PWHT. The fabrication process sheets indicate that numerous minor repairs (cold pick-ups) were made without preheat on the cladding after visual and PT examinations. Locations were not documented.

Final PWHT was applied to the Top Head Assembly for 7 hours and 40 minutes at 1100°F - 1150°F (FHR #73-370). All weld seams on the Top Head Assembly were examined with UT. No indications requiring weld repair were reported. The surface for four stainless steel Steam Dryer Hold Down Brackets were prepared, examined, and the brackets were welded to the flange cladding. The assembly was released for machining of stud holes and flange O-Ring gasket grooves. Figure 1 illustrates weld locations and weld repair areas.

The repairs were made with SMAW, using electrode E8018NM. Following RT reexamination, the subassembly received intermediate PWHT for 5 hours and 49 minutes at 1100°F to 1150°F (FHR #73-317).

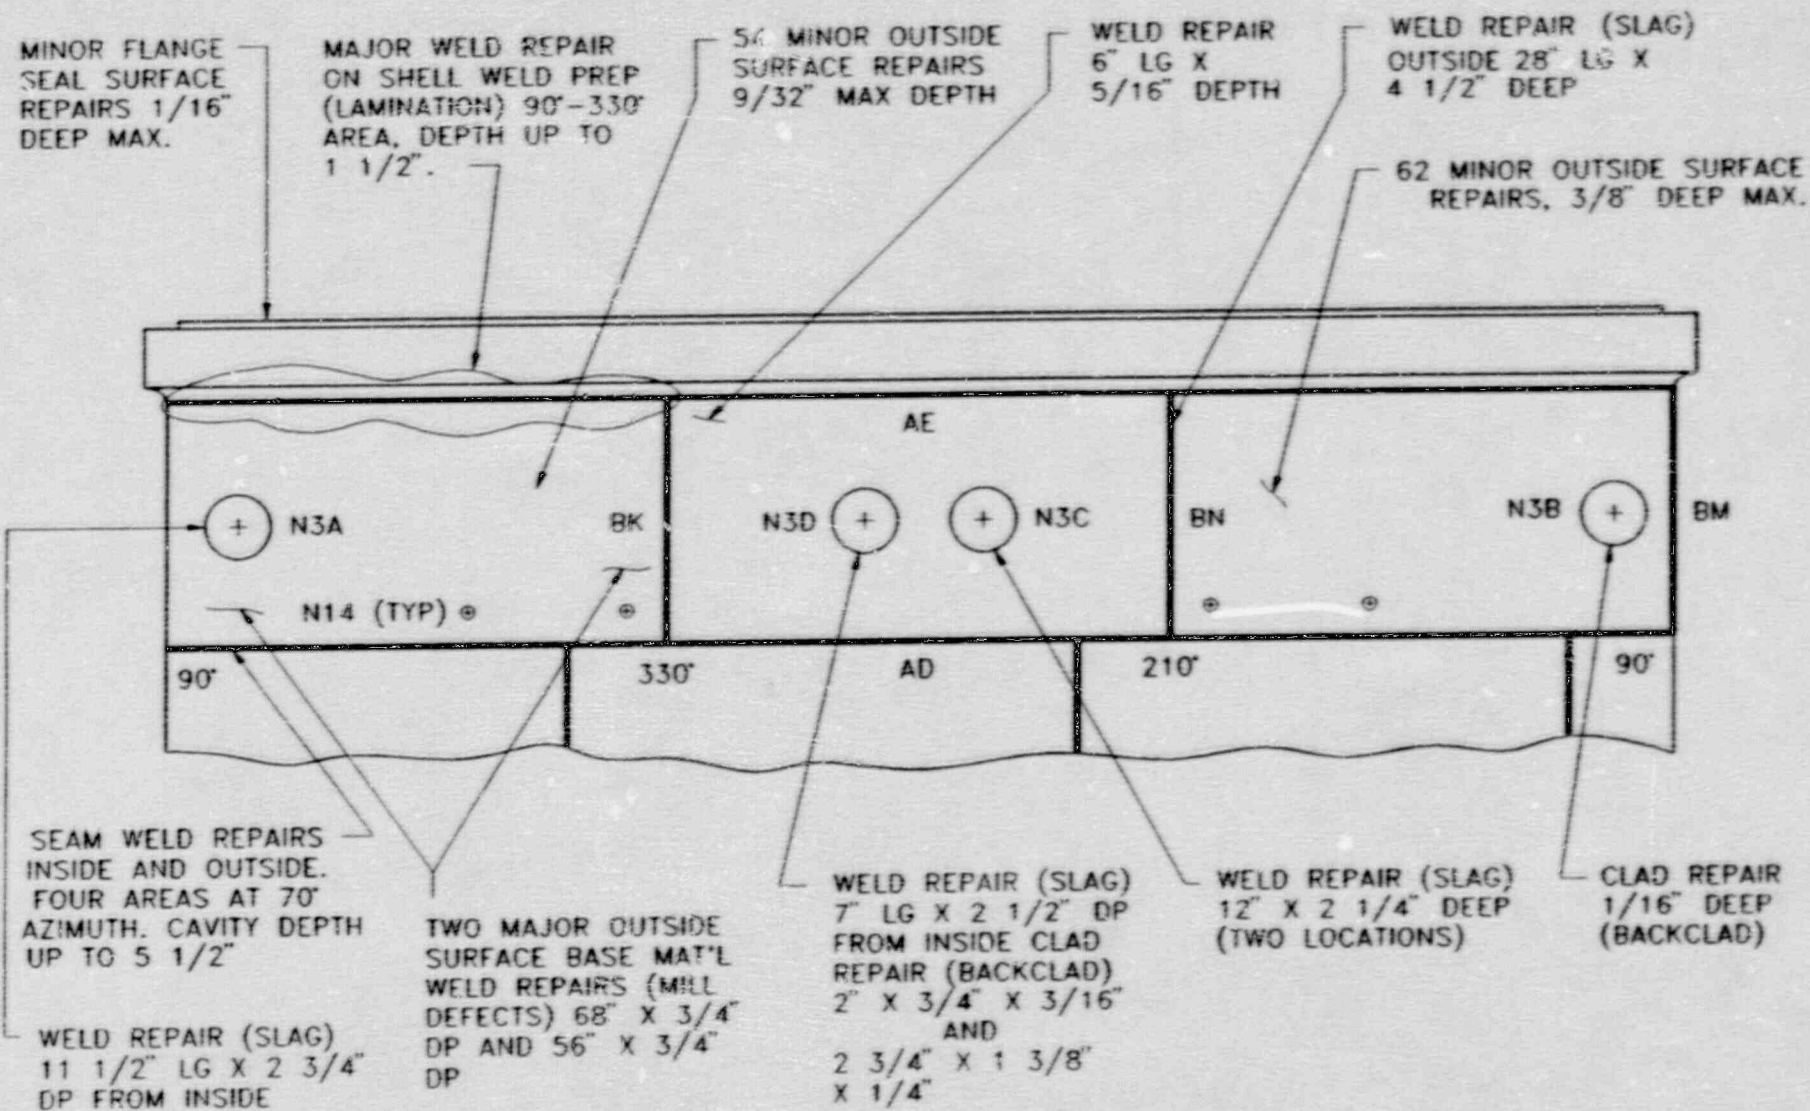
FIGURE 2

In-process chemical analysis and ferrite checks met the acceptance criteria requirements specified by CBI. After completion of the cladding, the subassembly received an intermediate PWHT for 1 hour and 25 minutes at 1100°F - 1150°F (FHR #73-265). The RT examinations of Seam AE revealed slag inclusions in four areas. Repairs were made from the inside and outside of Seam AE. Cavity dimensions before welding were: 15-1/2" long x 2" wide x 3-1/4" deep; 9" long x 2-1/2" wide x

3-1/2" deep; 7-3/4" long x 4-1/2" wide x 3-1/2" deep; and 15-1/2" long x 4-1/2" wide x 5-1/2" deep. Repair welding was made with SMAW process using Procedure GRP-1, Rev. 2.

- Nozzle N3C: Slag inclusions in two areas. Cavity dimensions from inside were 12" long x 2-1/4" wide x 2-1/2" deep and 12" long x 2-1/2" wide x 2-1/4" deep.
- Nozzle N3D: Slag inclusion. Cavity dimensions from inside were 7" long x 1-1/2" wide x 2-1/2" deep.
- Nozzle N3A: Slag inclusion. Cavity dimension from inside was 11-1/2" long x 1-3/4" wide x 2-3/4" deep.

UT examination of all seams on the Flange to Shell Ring #4 subassembly revealed slag and porosity in vertical weld BN. The cavity dimensions on the outside surface were 28" long x 2-3/4" wide x 4-1/2" deep. Weld repair followed with PWHT for 4 hours and 55 minutes at 1100°F - 1150°F (FHR #73-297).

The reviewed fabrication documents do not indicate weld repairs on the seam weld or the cladding. Seam AD was locally PWHT with actual soak time of 8 hours and 28 minutes at 1100°F - 1155°F (FHR Local #27). Figure 2 illustrates weld seam locations and weld repair areas.

The cavities were welded up with SMAW process Repair Procedure GRP-1, Rev. 2 using electrode E8018NM. The subsequent cladding over the repaired areas was made with electrodes E309L and E308L.
