QUAD CITIES II
UPPER VESSEL FABRICATION SUMMARY

June 29, 1990

General Electric
Nuclear Energy
175 Curtner Avenue
San Jose, California 95125

Quad Cities II Upper Vessel Fabrication Summary

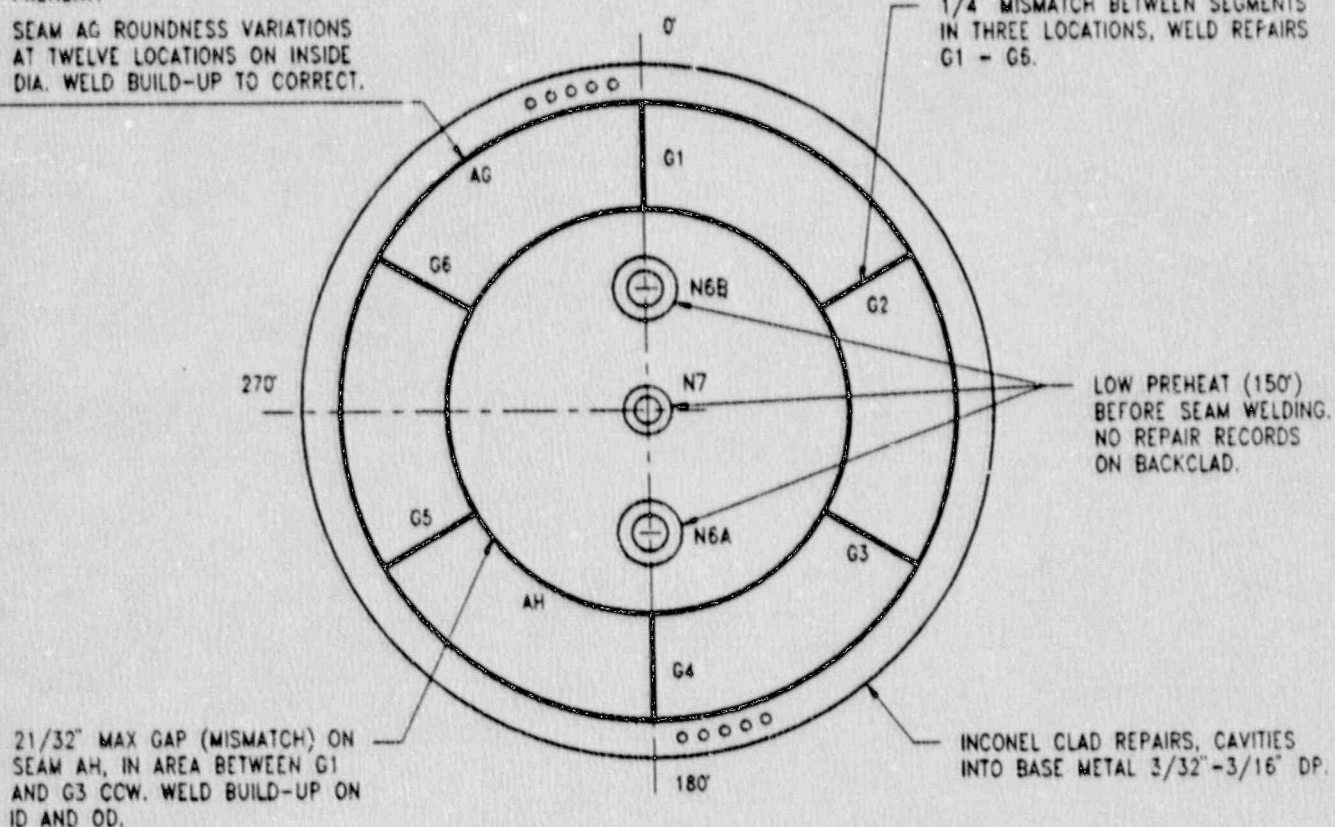
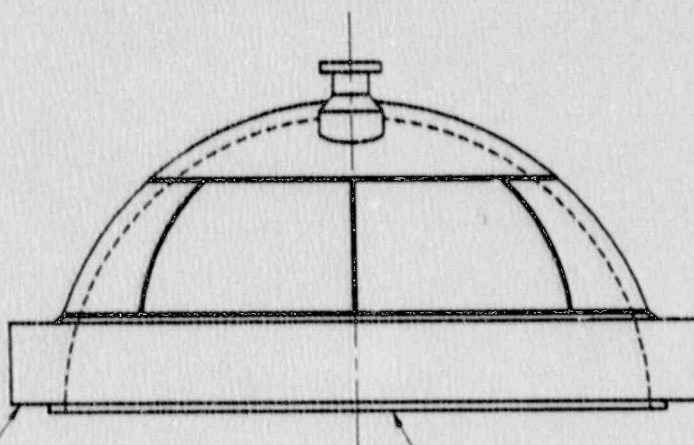
FIGURE 2

SEAM AG BACKCLAD, EXTENSIVE CLAD REPAIRS. UP TO FOUR CYCLES ON CAVITY REPAIRS.

1/2" - 1" ID MISMATCH 360°. WELD BUILD-UP ON FLANGE BORE AND TORUS OD. NUMEROUS WELD AND CLAD REPAIRS, LOSS OF PREHEAT.

SEAM AG ROUNDNESS VARIATIONS AT TWELVE LOCATIONS ON INSIDE DIA. WELD BUILD-UP TO CORRECT.

1/4" MISMATCH BETWEEN SEGMENTS IN THREE LOCATIONS, WELD REPAIRS G1 - G5.

21/32" MAX GAP (MISMATCH) ON SEAM AH, IN AREA BETWEEN G1 AND G3 CCW. WELD BUILD-UP ON ID AND OD.

LOW PREHEAT (150°) BEFORE SEAM WELDING. NO REPAIR RECORDS ON BACKCLAD.

INCONEL CLAD REPAIRS, CAVITIES INTO BASE METAL 3/32"-3/16" DP.

MAJOR WELD REPAIRS IN AREA 17 FEET LONG X 3" - 3/4" DEEP BEFORE CLADDING. MACHINING ERRORS, PWHT AND DIMENSIONAL VARIATIONS.

INCONEL CLAD REPAIRS ON MIN. OF 24 LOCATIONS. FOUR CAVITIES INTO BASE METAL. AFTER MACHINING CLAD REPAIRS IN TWO AREAS UP TO 3/16" DEEP.

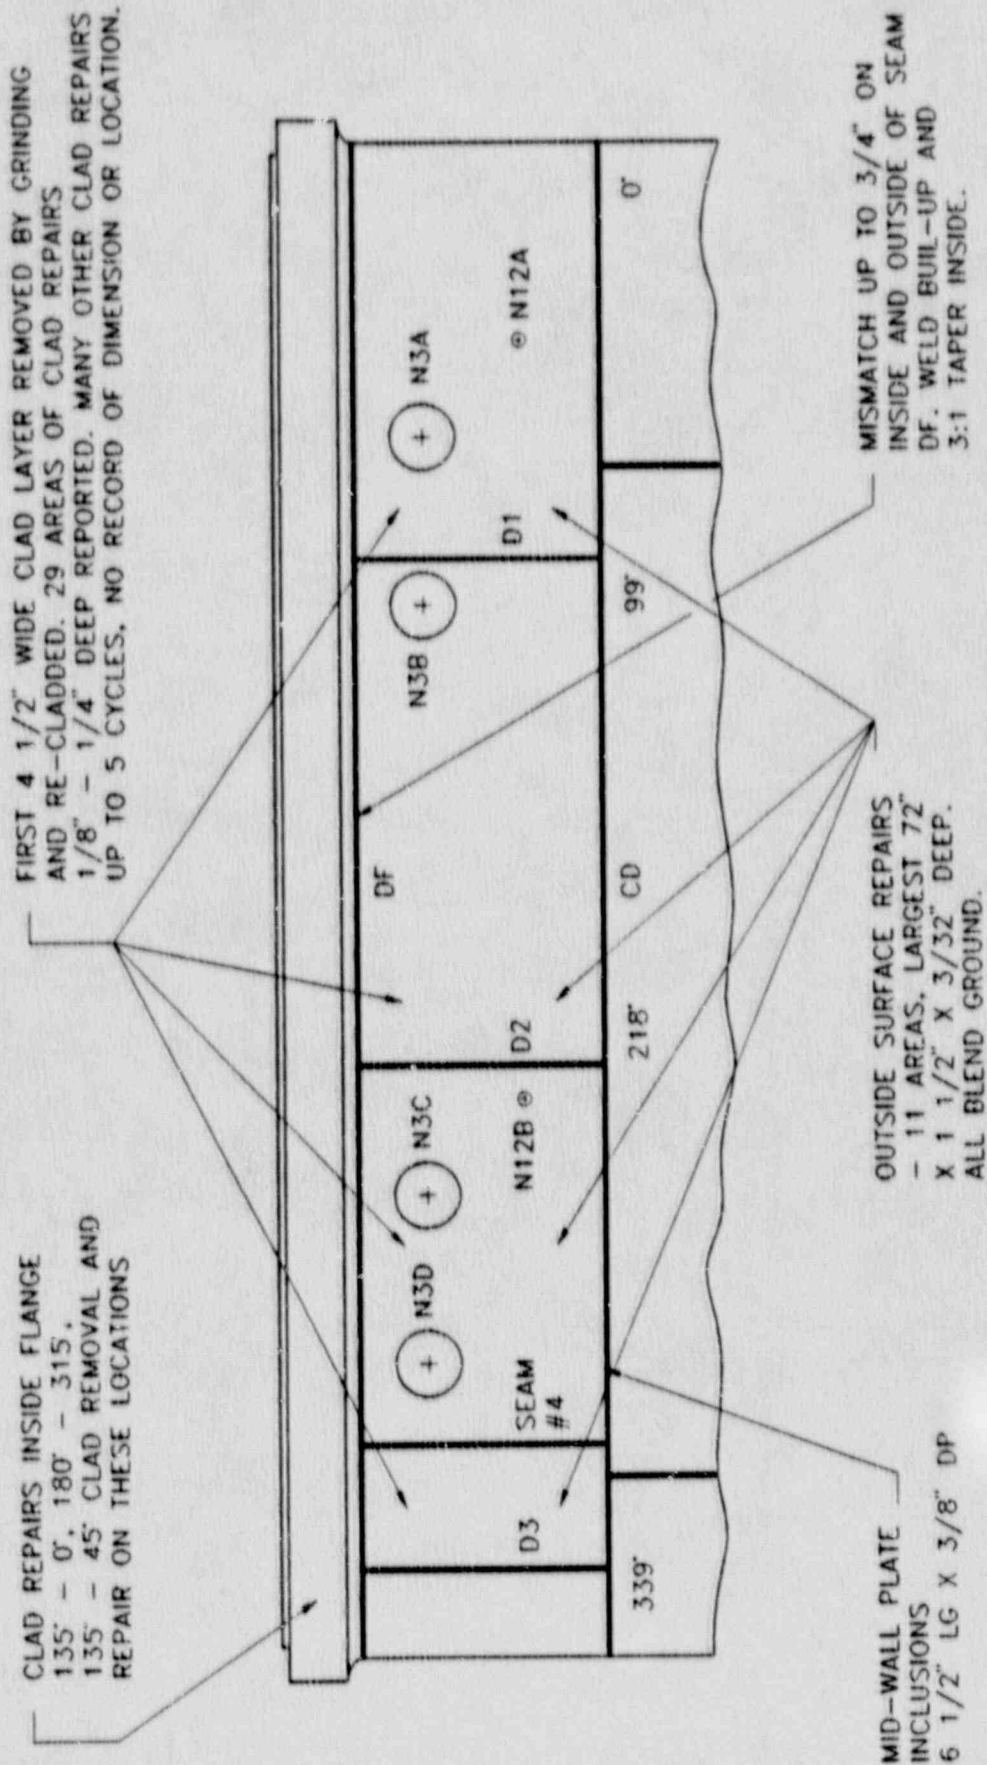
FIGURE 3

The steam dryer brackets and stabilizer brackets were attached with in-process and final surface examination performed in the next fabrication steps. Seam CD remained under preheat during the attachment of these brackets. The Final PWHT of Shell Ring #2,3, and the lower 3' of Shell Ring #4 performed and was documented on Furnace Heat Report #103. The Thermal History Report documents the soak time to be 10.91 hours at a temperature range of 1100 to 1150 degrees. This brings the accumulated soak time to 32.88 hrs. on the lower 3' of #4 Shell Ring and 17.41 on seam CD. (the shell flange plus the upper section of Ring #4 stuck out of the furnace and as insulated bulkhead was erected around the vessel where the furnace door would normally close. Therefore, this section of the vessel did not receive a PWHT). Figure 3 illustrates weld locations and weld repair areas.
