**Duke Power Company
McGuire Nuclear Station
Unit 2 Steam Leak
August 31, 1993**

September 5, 1993

Project Title: Unit 2 Steam Leak in Containment

Aug, 31, 1993 Steam Leak Inside Containment

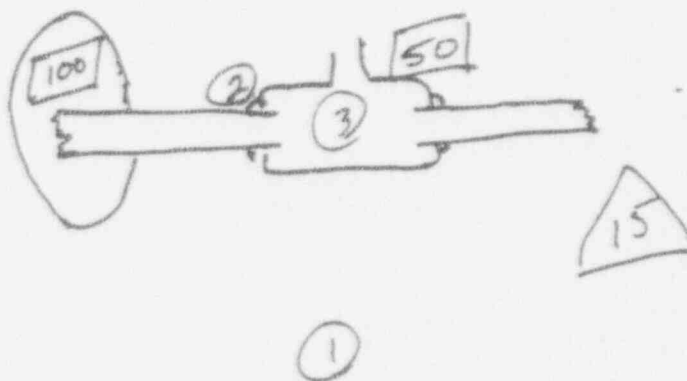
1. 800 FLOOR
2. 500 WELD ^{AREA} AFTER GRINDING
3. 20th VALVE

THE VALVE WAS DIFFICULT TO WORK DUE TO LOCATION. THE WORKERS GROUND THE WELD BUT COULD NOT GET TO THE BACK SIDE OF THE WELD... THEY COULDN'T REMOVE THE VALVE WE HAD WATER LEAKING W/ NO CATCH CMT. DEVICE SO & THE WORKERS GOT WET (BUT NOT CONTAMINATED) I STOPPED WORK GOT A CATCH CMT. & WORKERS RE-DRESSED. WORK WAS PERFORMED ON THE VALVE LATER THAT MORNING.

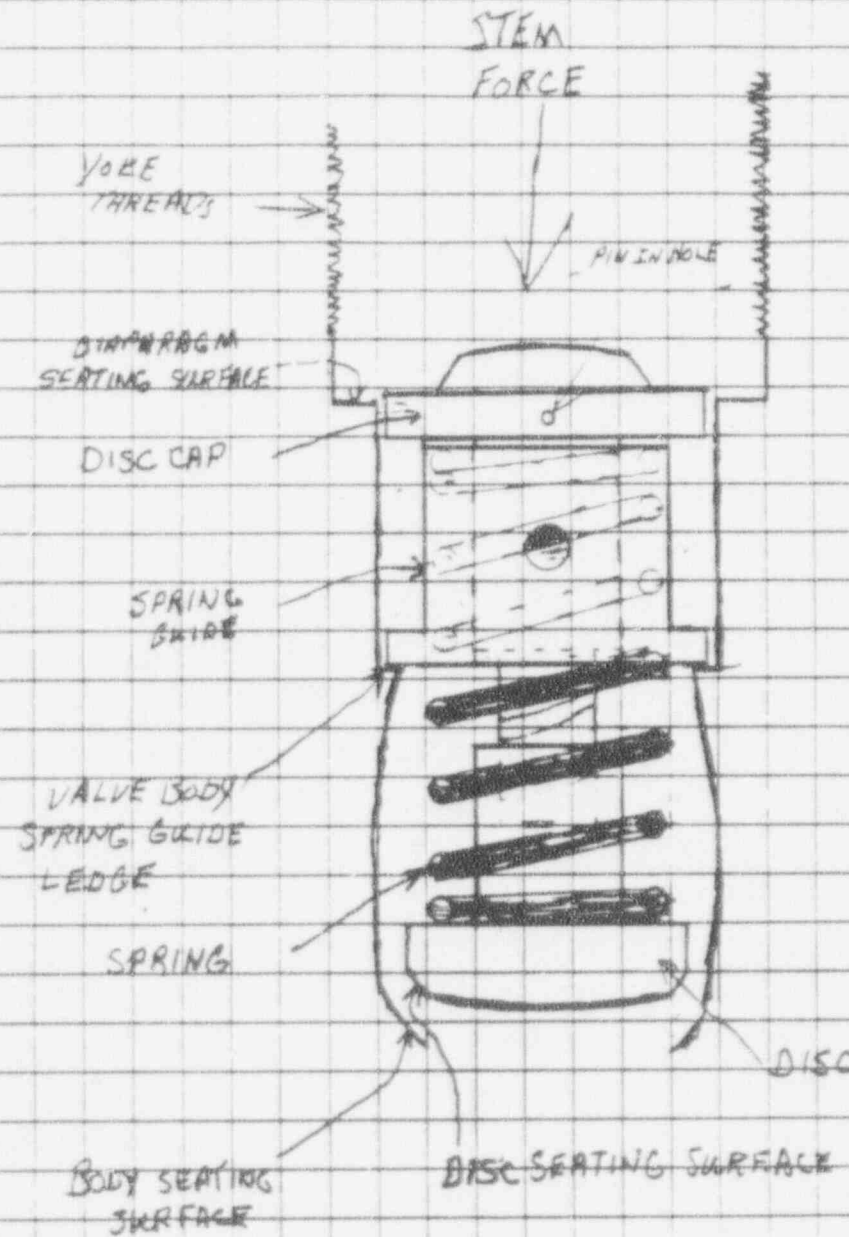
From the disassembly of 2CF-130, the cause of the valve leakage was the incorrect installation of the spring guide on the valve disc assembly. This caused the valve plug to be held off the seat and effectively locked the valve handwheel. The valve could not be closed under these conditions. Subsequent post maintenance testing failed to discover this condition until leakage was observed around the pipe cap downstream of the valve after the plant reached full temperature and pressure conditions.

The root cause of the failure of Kerotest drain valve 2CF-130 to isolate flow was the improper reassembly of the valve due to personnel error in following the maintenance procedures. During final reassembly of the disc assembly, the spring guide was installed upside down. When inserted in the valve, the improper configuration of the spring guide prevented the disc assembly from contacting the seat, prevented the diaphragms from seating and therefore prevented the valve from properly stroking. These conditions were verified during an as-found evaluation of valve 2CF-130 in the MNS Hot Machine Shop on September 2, 1993.

DISC ASSEMBLY WITH SPRING & SPRING GUIDE INSTALLED UPSIDE DOWN

STEM FORCE CAN'T MOV. DISC CAP AND DISC TOWARD SEAT

Emphasize to all valve technicians the consequences of improper spring guide installation and the importance of following procedures. The consequences of this event should be included in these discussions.

Prior to startup, evaluate the consequences of improper maintenance on other Kerotest packless valve applications and take appropriate action.

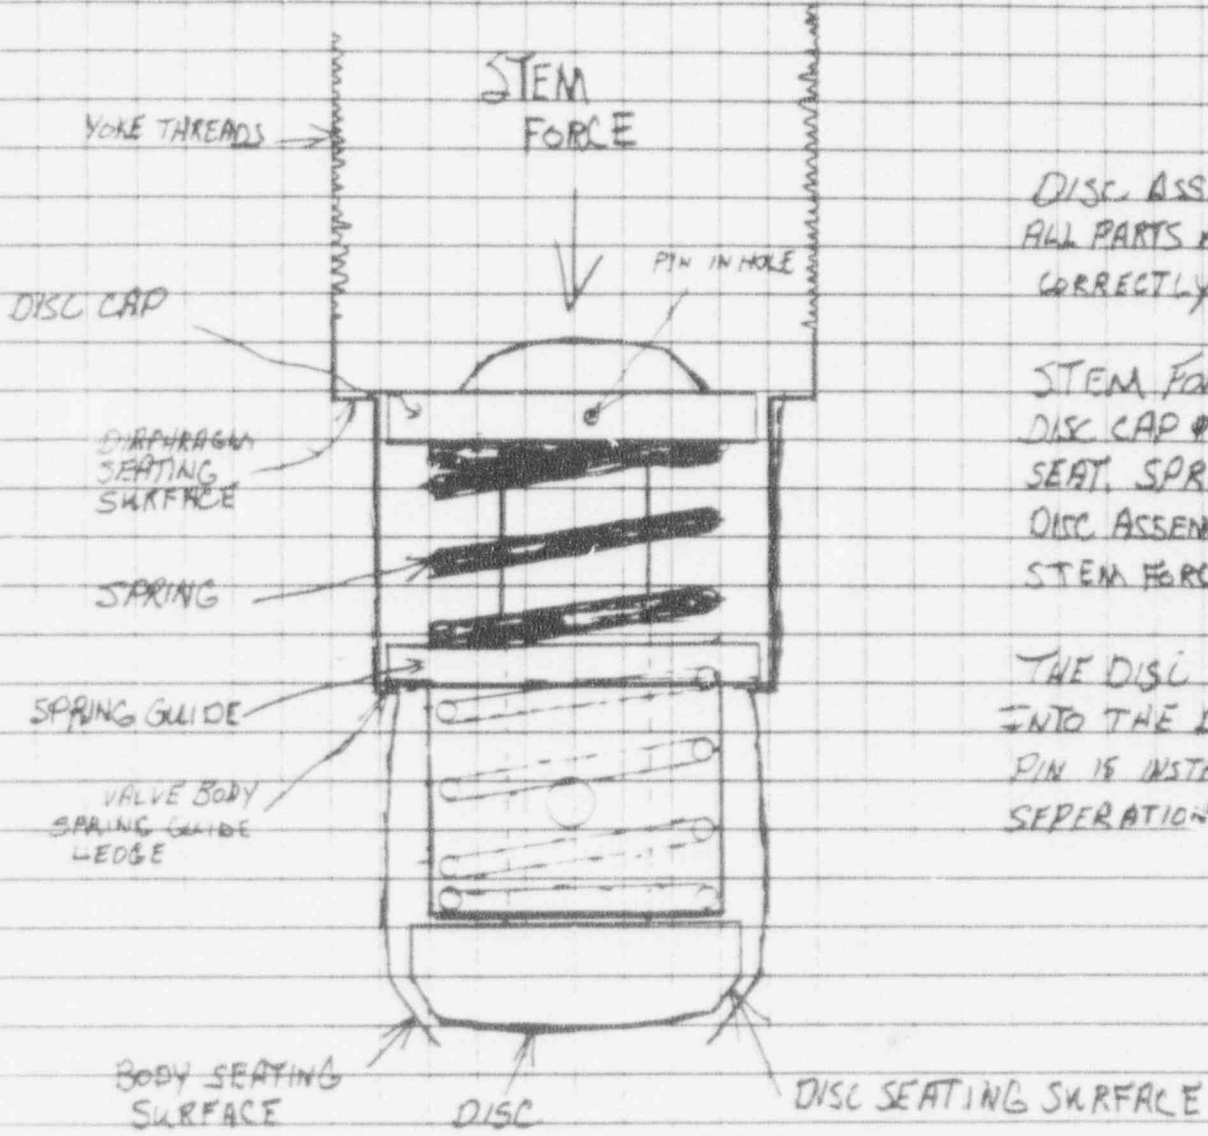
DISC ASSEMBLY WITH ALL PARTS ASSEMBLED CORRECTLY

STEM FORCE MOVES DISC CAP & DISC TO BODY SEAT. SPRING OPENS DISC ASSEMBLY WHEN STEM FORCE IS REMOVED
