SUBJECT: NRC REGION III AUGMENTED INSPECTION TEAM (AIT) REVIEW  
OF THE JULY 1 AND JULY 6, 1993, PALISADES FUEL HANDLING  
EVENTS

PALISADES BROKEN FUEL ROD AND STUCK FUEL ASSEMBLY

Areas Inspected: Augmented Inspection Team (AIT) inspection conducted in response to the broken fuel rod discovered on July 1, 1993, and the stuck fuel assembly event of July 6, 1993, at the Palisades Nuclear Plant. The review included validation of the sequence of events, evaluation of the licensee's failure mechanism determination and root cause analyses, review of the effectiveness of previous corrective actions associated with stuck assembly events, assessment of licensee's evaluation of potential precursors to the fuel rod failure, evaluation of ongoing refueling activities, assessment of the effectiveness of management involvement and the quality assurance organization related to these events, and evaluation of the licensee's corrective actions.

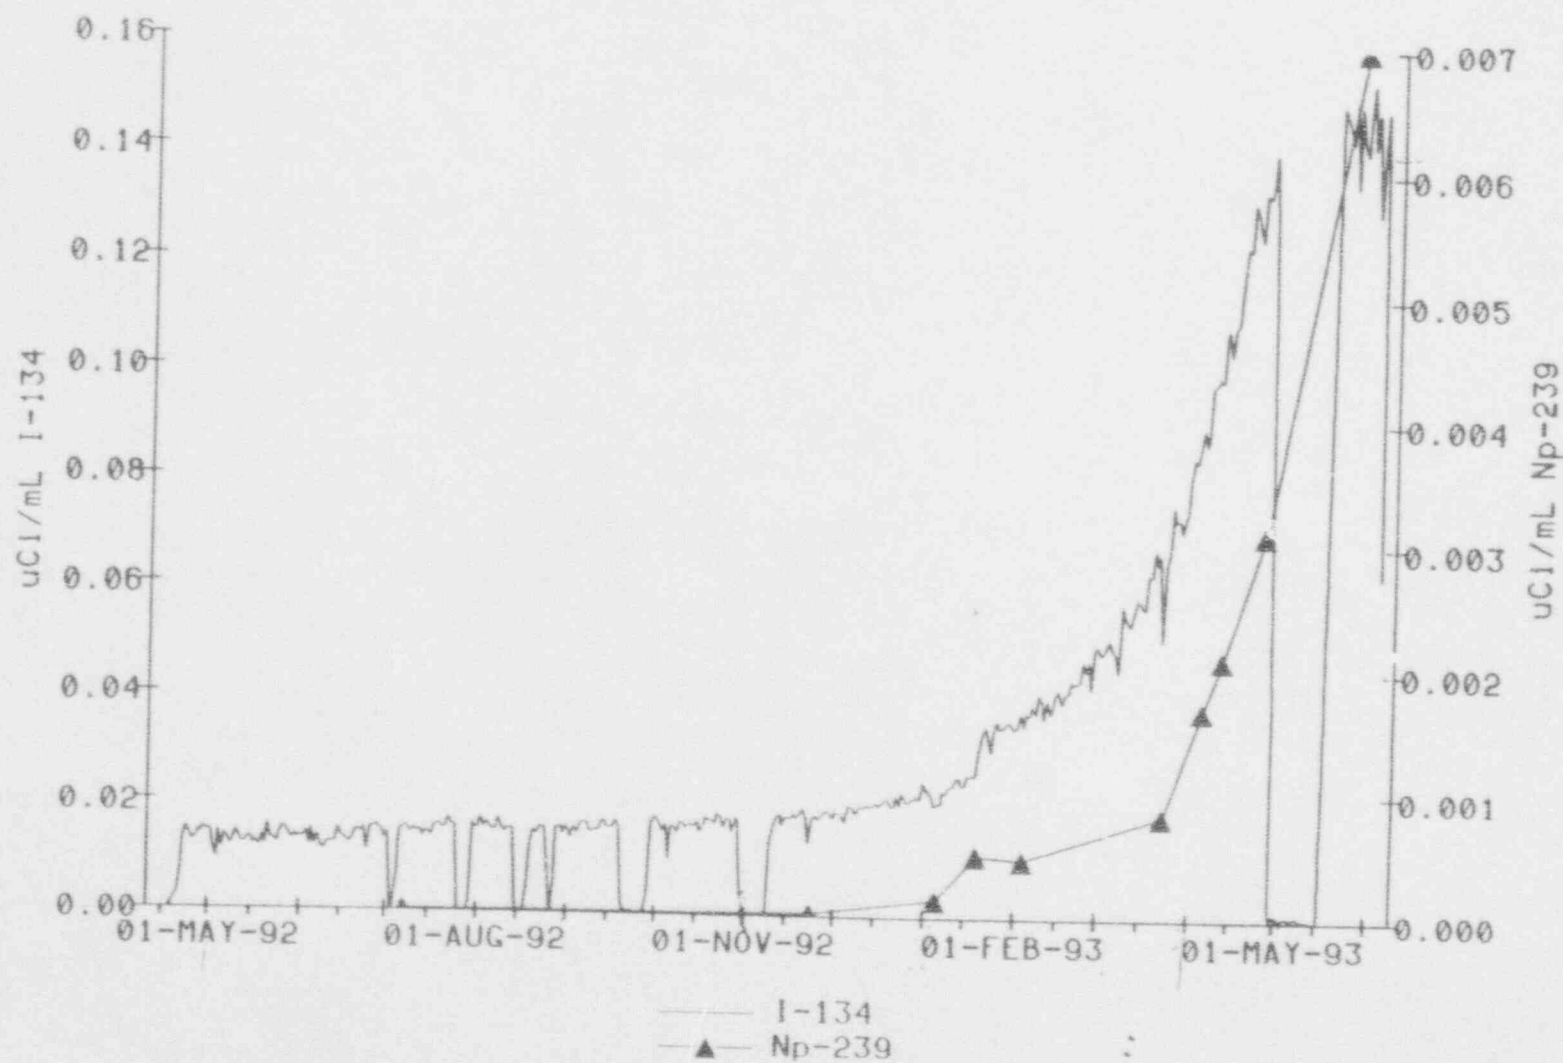
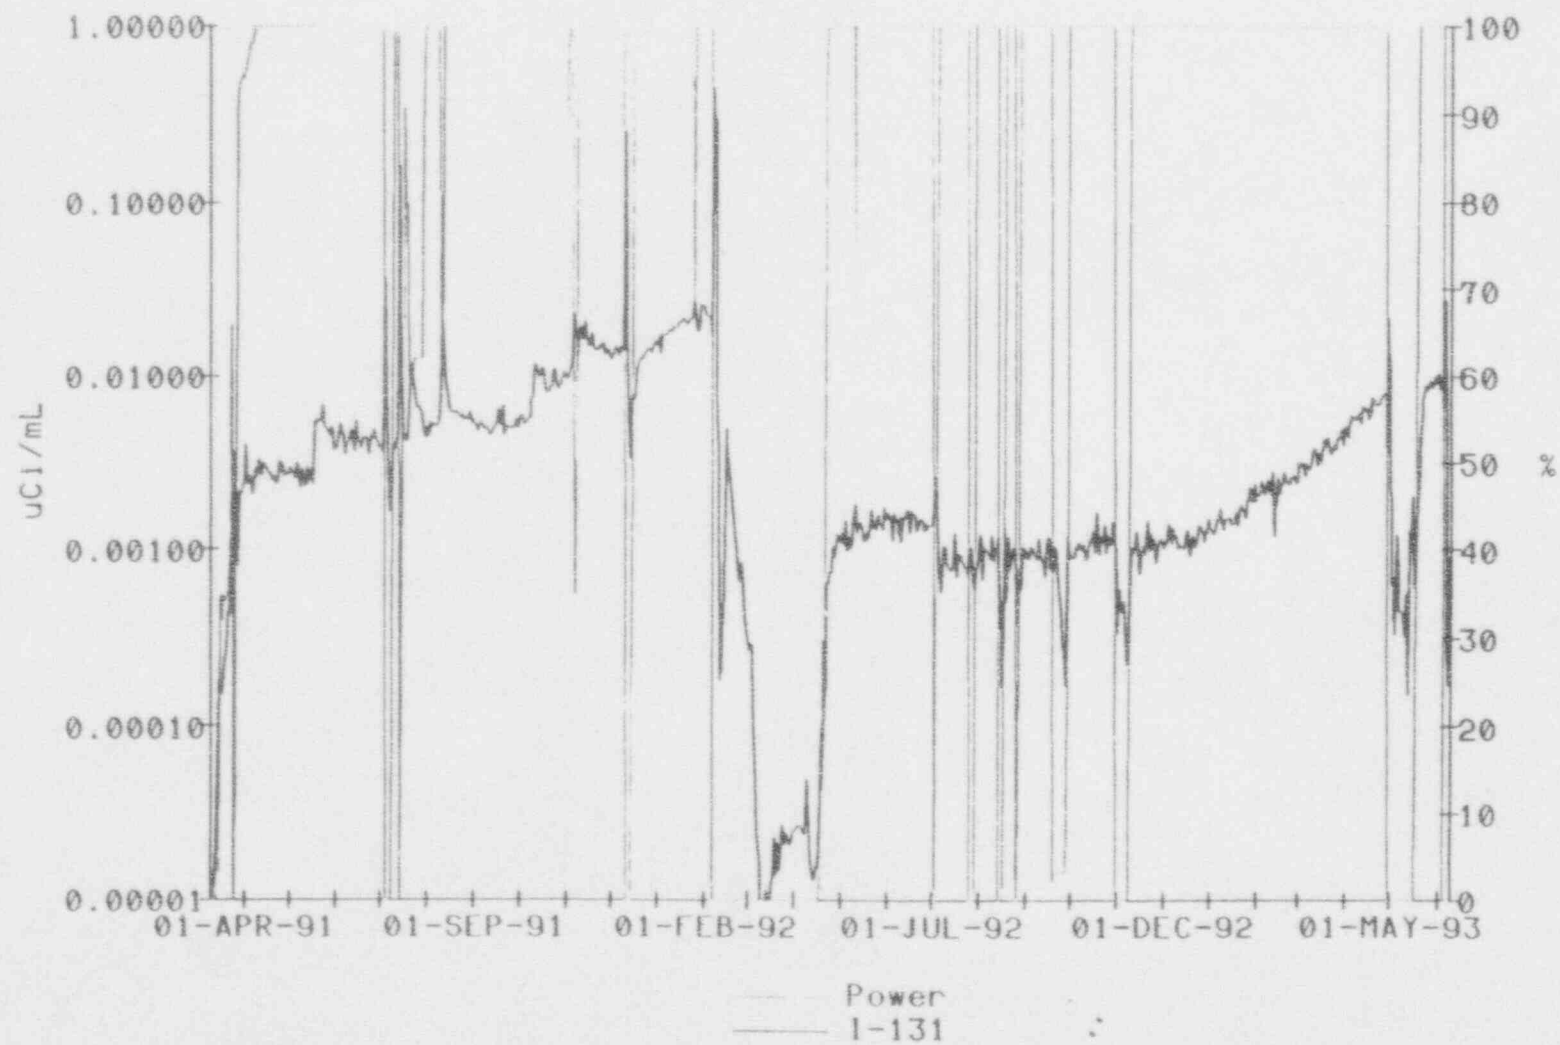
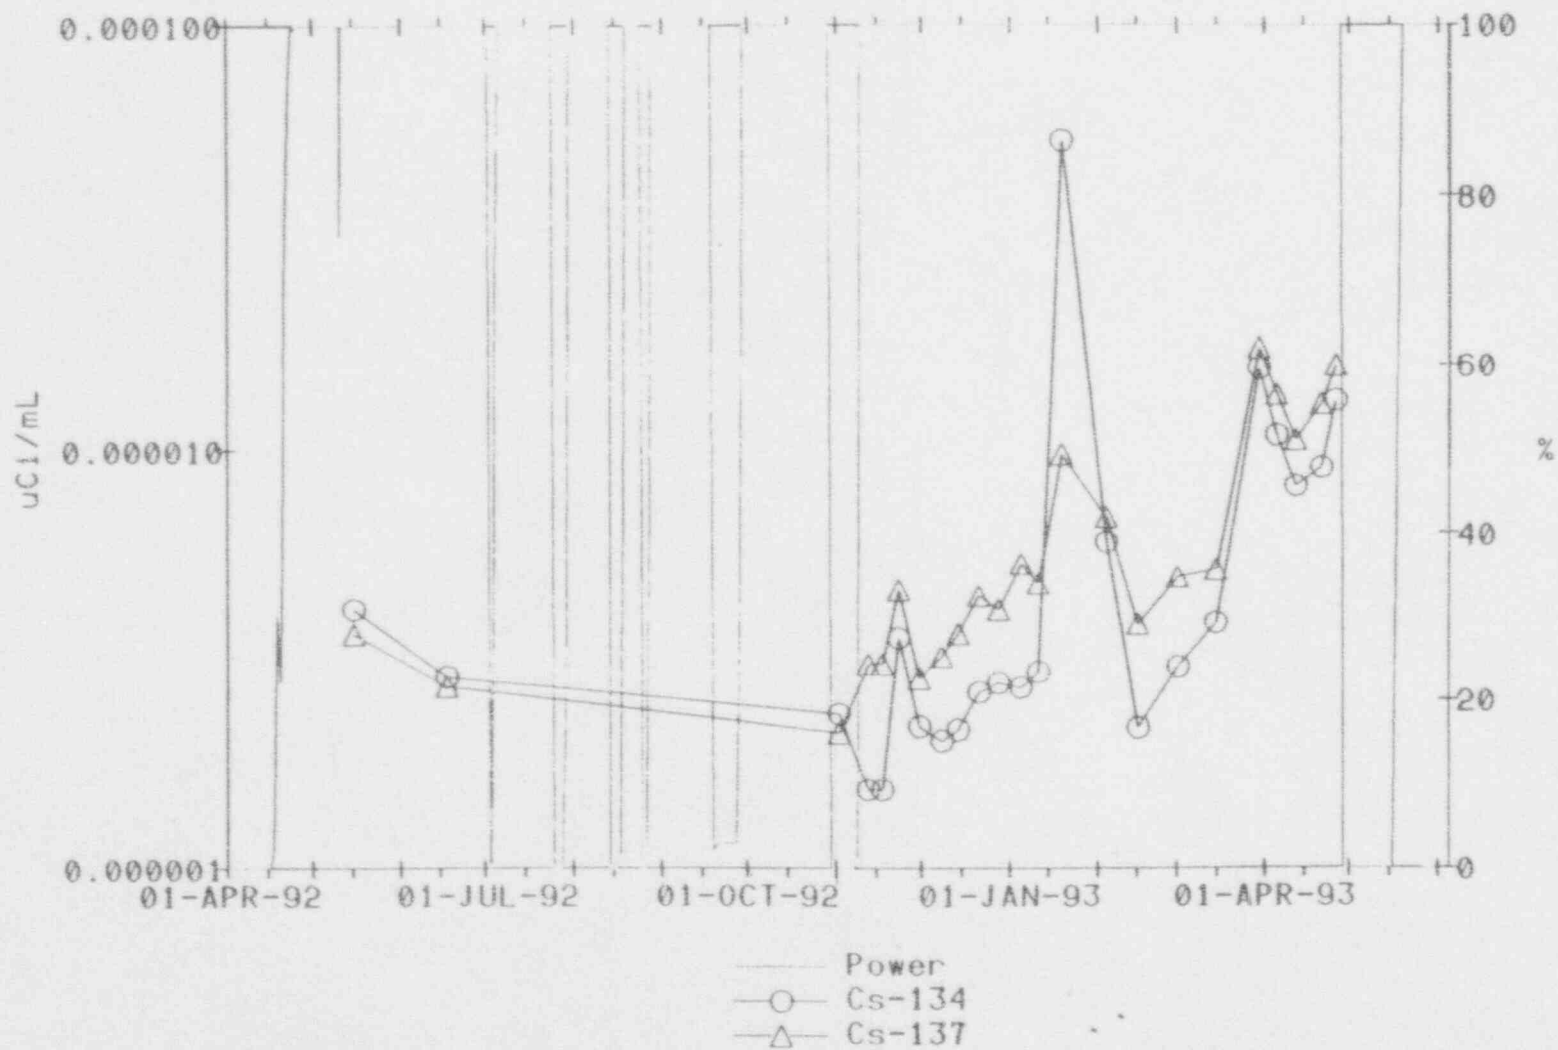
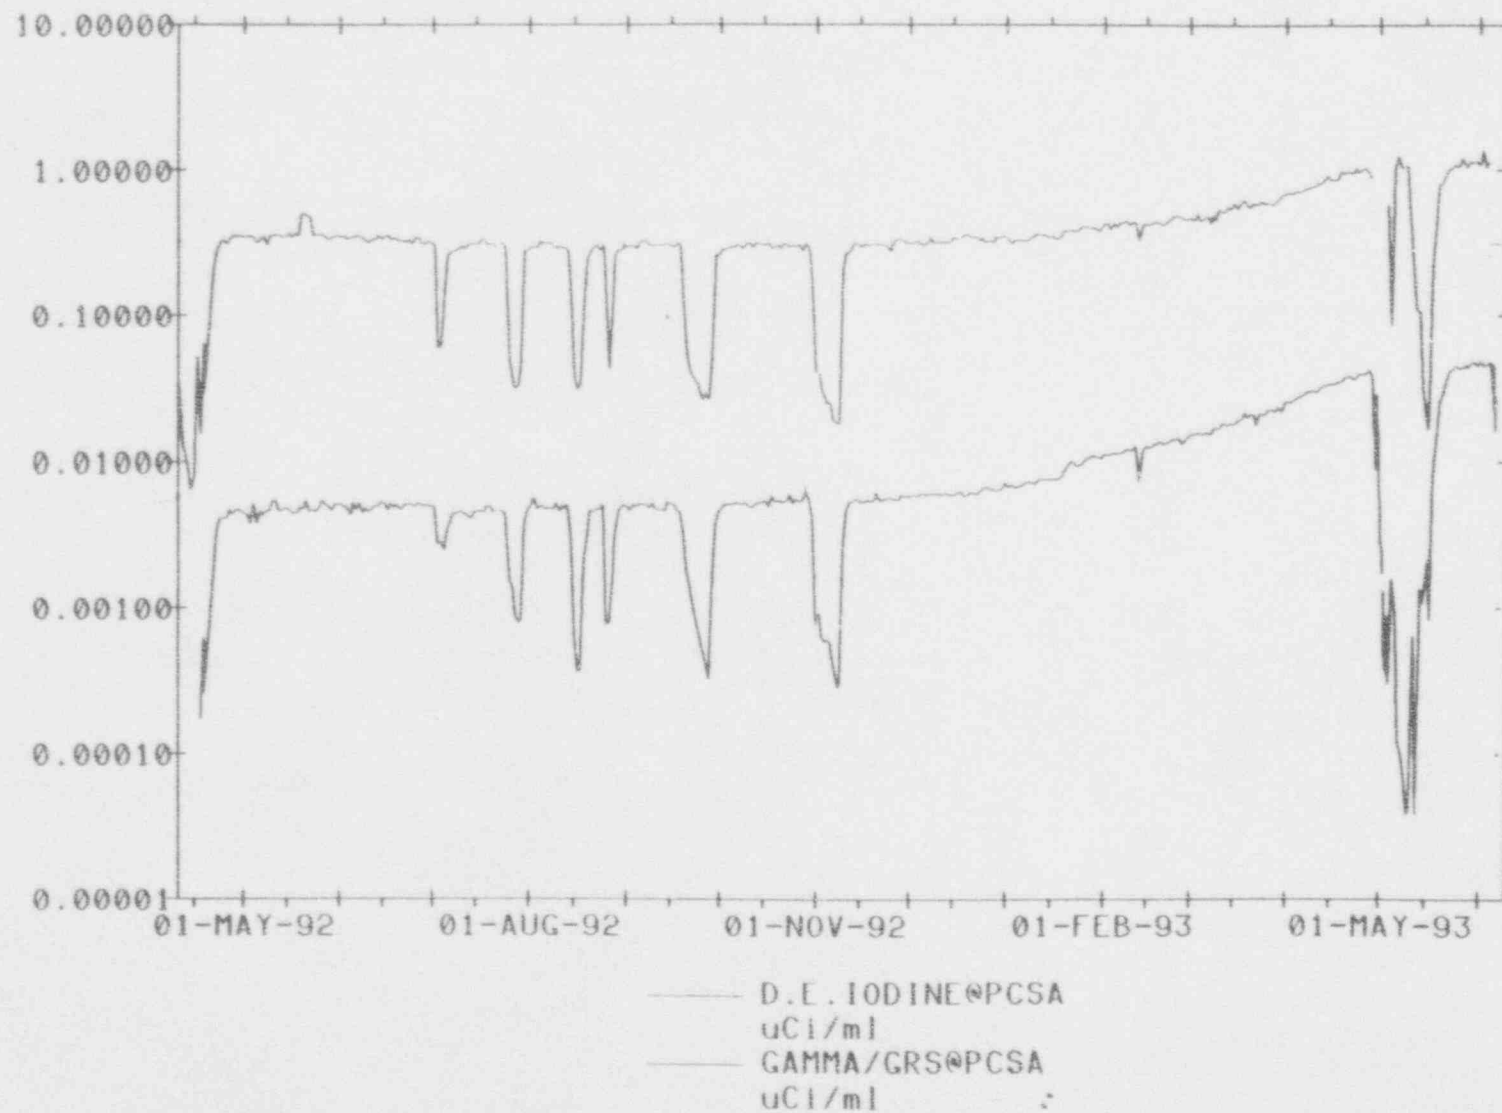
The licensee noted increases in fission isotopes, including Np-239, I-134, I-131, Cs-137, and gross gamma activities, in the primary coolant beginning in late 1992 (See Attachment F, Figures 1-4). In reviewing selected gamma spectroscopic data, the team noted that total fission gases (Kryptons and Xenons) had also increased along with the above mentioned isotopes. The licensee had not evaluated this data, focusing only on the behavior of Xe-133, which is a typical indicator of a fuel failure. Fission product activity in reactor coolant increased for approximately 6 months until the refueling outage began in June 1993. The fission isotope concentrations increased by factors of 5-8 during this period. The licensee noted that the overall activity levels of the reactor coolant were very low. They also noted that even though they attempted to induce iodine and xenon spiking during several power reduction evolutions, no spikes, which are often characteristic of fuel rod failures, were observed.

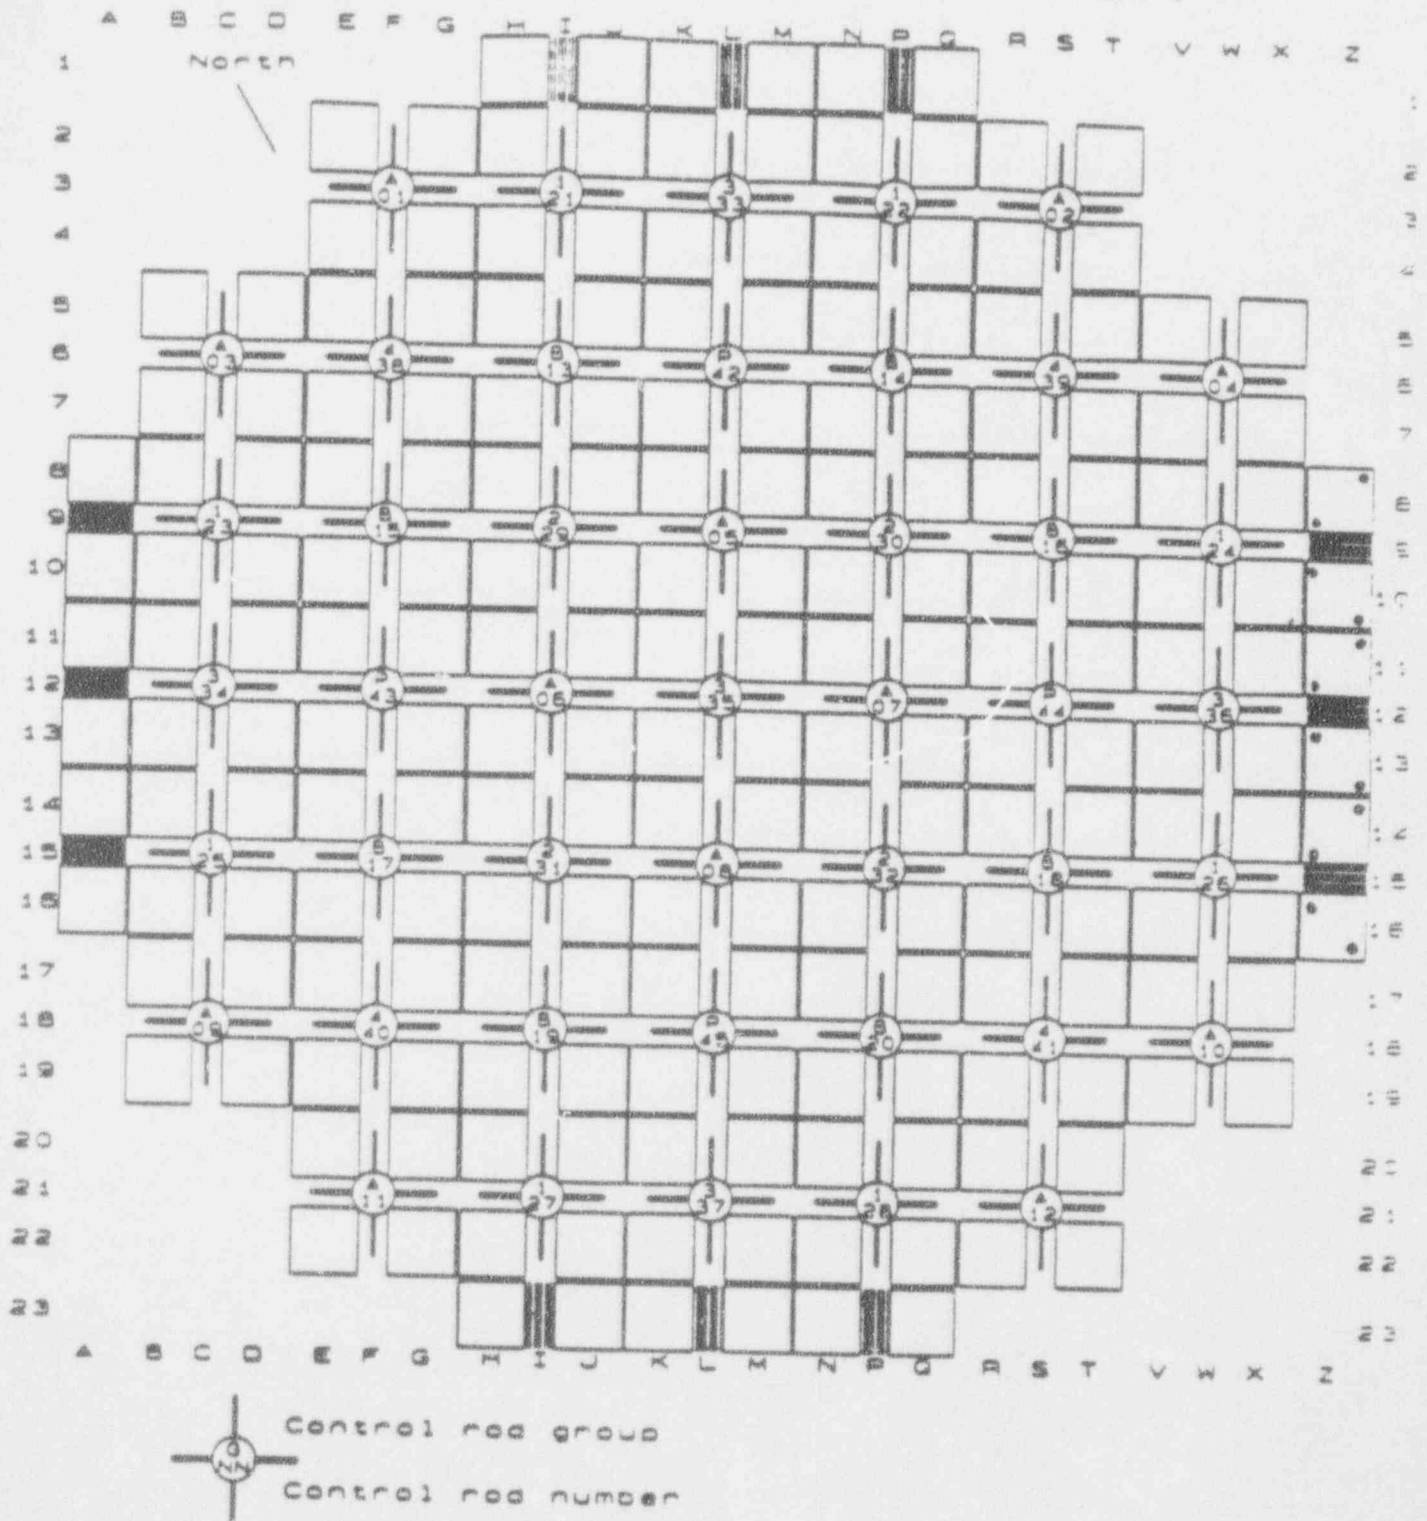
Figure 7

(X-19) (See Figure 7) to I-24 (B-19) and I-48 was in position B-19 during cycle 9. These three fuel assemblies were initially in a peripheral location in cycle 5, then placed in the center of the core for cycles 6 and 7. They were then placed in peripheral locations for cycles 9 and 10. All three of these fuel assemblies showed loose corner fuel rods during the pull test.
