Iowa Electric Light and Power Company

October 18, 1993  
NG-93-4416

Subject: Duane Arnold Energy Center  
Docket No: 50-331  
Op. License DPR-49  
Licensee Event Report #93-008

'B' Standby Diesel Generator Output Breaker Failure to Close

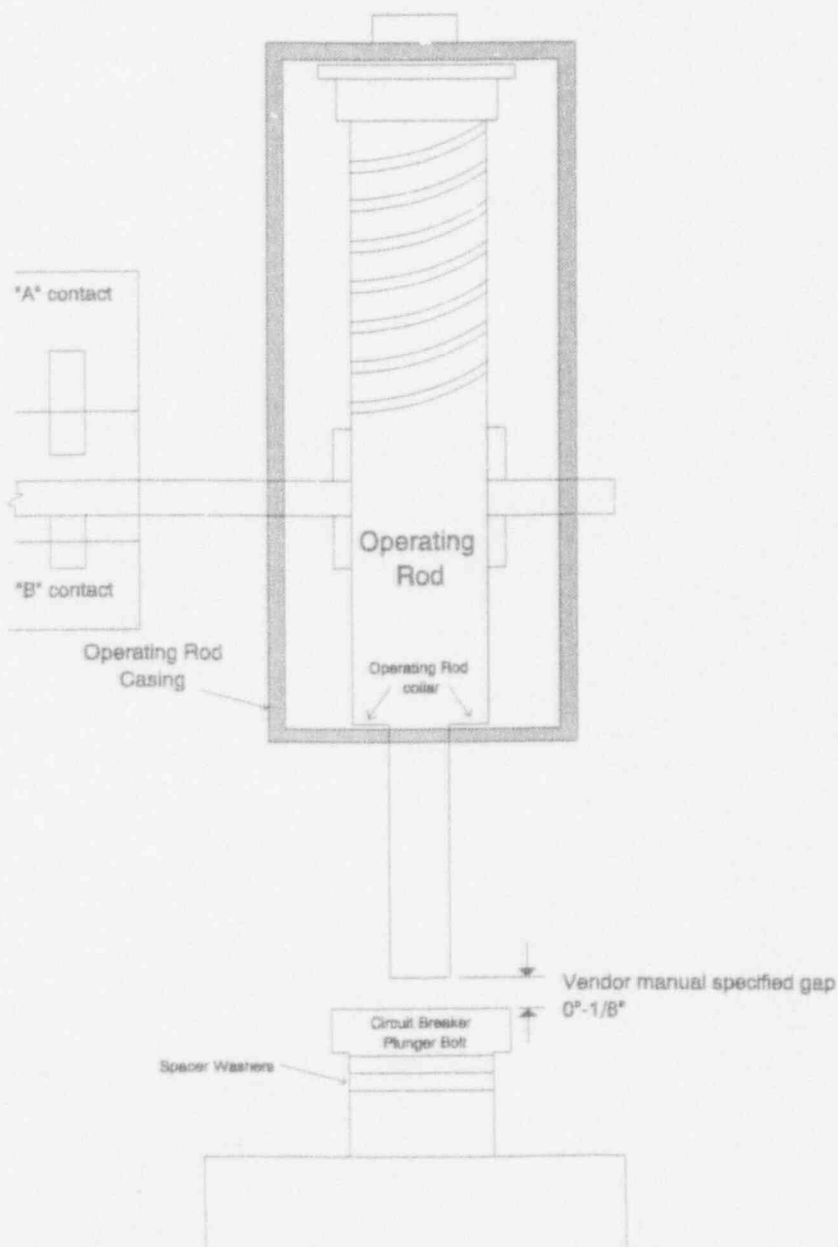
LER 93-008 Figure 1

Troubleshooting conducted by the plant Electrical Maintenance and Systems Engineering groups pinpointed the source of the problem to the 7-8 contacts on the stationary auxiliary switch mechanism in the switchgear cubicle for the Standby Transformer feeder breaker to essential bus 1A4, 1A401. The stationary auxiliary switch is operated by a plunger on the breaker (see figure 1) that causes the 'a' switch contacts to close when the breaker is closed and causes the 'b' contacts to close when the breaker is open. Contacts 7-8 are 'b' contacts and should have closed during the LOOP-LOCA test when 1A401 opened to provide a signal to the logic that bus 1A4 was disconnected from the Standby Transformer and that the 'B' SBDG output breaker could safely close on the bus. In situ testing of contacts 7-8 indicated that continuity existed between them but that they failed to pass sufficient current to energize one of the logic's relay coils. The switch was removed, its contacts were burnished, and the switch was reinstalled. When the LOOP-LOCA test was rerun on September 22, breaker 1A411 again failed to close. At that time it was discovered that, with breaker 1A401 racked in and open, the breaker plunger was depressing the stationary auxiliary switch operating rod approximately 3/16 inches. This caused enough rotation in the switch mechanism to cause contacts 7-8 to be partially open and maintain poor contact as identified during testing described above.

In addition, the General Electric maintenance manual for Metal Clad switchgear (GEH-1802) states that, with the breaker racked in and open, that the gap between the breaker plunger and the operating rod on the stationary auxiliary switch mechanism should be from 0 to 1/8 inches and that any adjustment in this dimension must be made on the auxiliary switch setting. This measurement is a final check to make sure that the plunger and auxiliary switch perform as intended. However, the auxiliary switch is pinned in place and is not adjustable. General Electric has stated that removing this pin is inappropriate. Establishing this gap can only be accomplished by adding or removing washers from the plunger. The Duane Arnold Energy Center's maintenance manual did not address the need to establish this gap.

## Breaker Open Position

1. The proper gap between the 1A401 auxiliary switch operating rod and the breaker plunger was established on September 23 and the LOOP-LOCA surveillance test, STP 48A002-CY was successfully completed on September 24.
2. Plant procedures have been revised to address the need to establish the auxiliary switch - breaker plunger gap.
3. A review was completed on all of the stationary auxiliary contacts in the essential busses and RPT breakers to identify those contacts with functions important to plant safety. All such contacts were either tested or verified to have been tested since the last time the breaker plunger had been adjusted. No failures were identified.

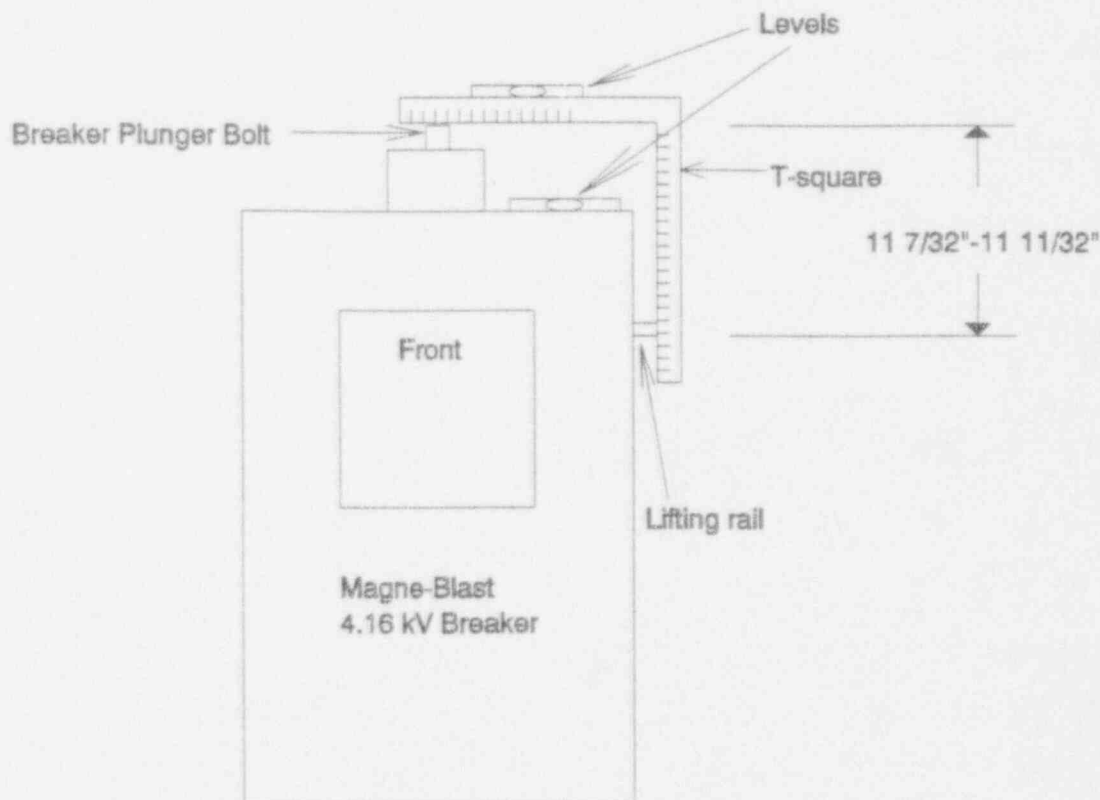
**LER 93-008 Figure 2**

A review of plant records revealed that during the performance of periodic maintenance on breaker 1A401 on July 21, 1993, a spacer had been added to raise the plunger. The addition of the spacer restored one of the breaker's dimensions to within the vendor's specifications, but caused the relationship between the breaker plunger and the auxiliary switch operating rod gap to fall outside acceptable limits. The breaker plunger was readjusted and the LOOP-LOCA test was successfully completed on September 24.

The cause of this event was procedural inadequacy. The General Electric maintenance manual for Magne-Blast AM-4,16-350-2 circuit breakers (GEK-7320) states, under Auxiliary Devices-Plunger Interlock, that the distance from the top of the plunger bolt to the bottom of the lifting rail should be 11-7/32 to 11-11/32 inches with the breaker closed (see figure 2). The manual also states that washers should be added or removed from the plunger as necessary to achieve this dimension. This dimension assures that the 'a' contacts on the auxiliary switch will close when the breaker is closed and also establishes uniformity between individual breakers to make them interchangeable. Iowa Electric's maintenance procedure is based largely on GEK-7320 and it was this dimension that was being restored when the washer was added to the plunger on 1A401 on July 21.

**Breaker Lifting Rail-to-Plunger Bolt Measurement**
