Palo Verde Nuclear Generating Station

Unit 1
Steam Generator
Inspection Report

October 1993

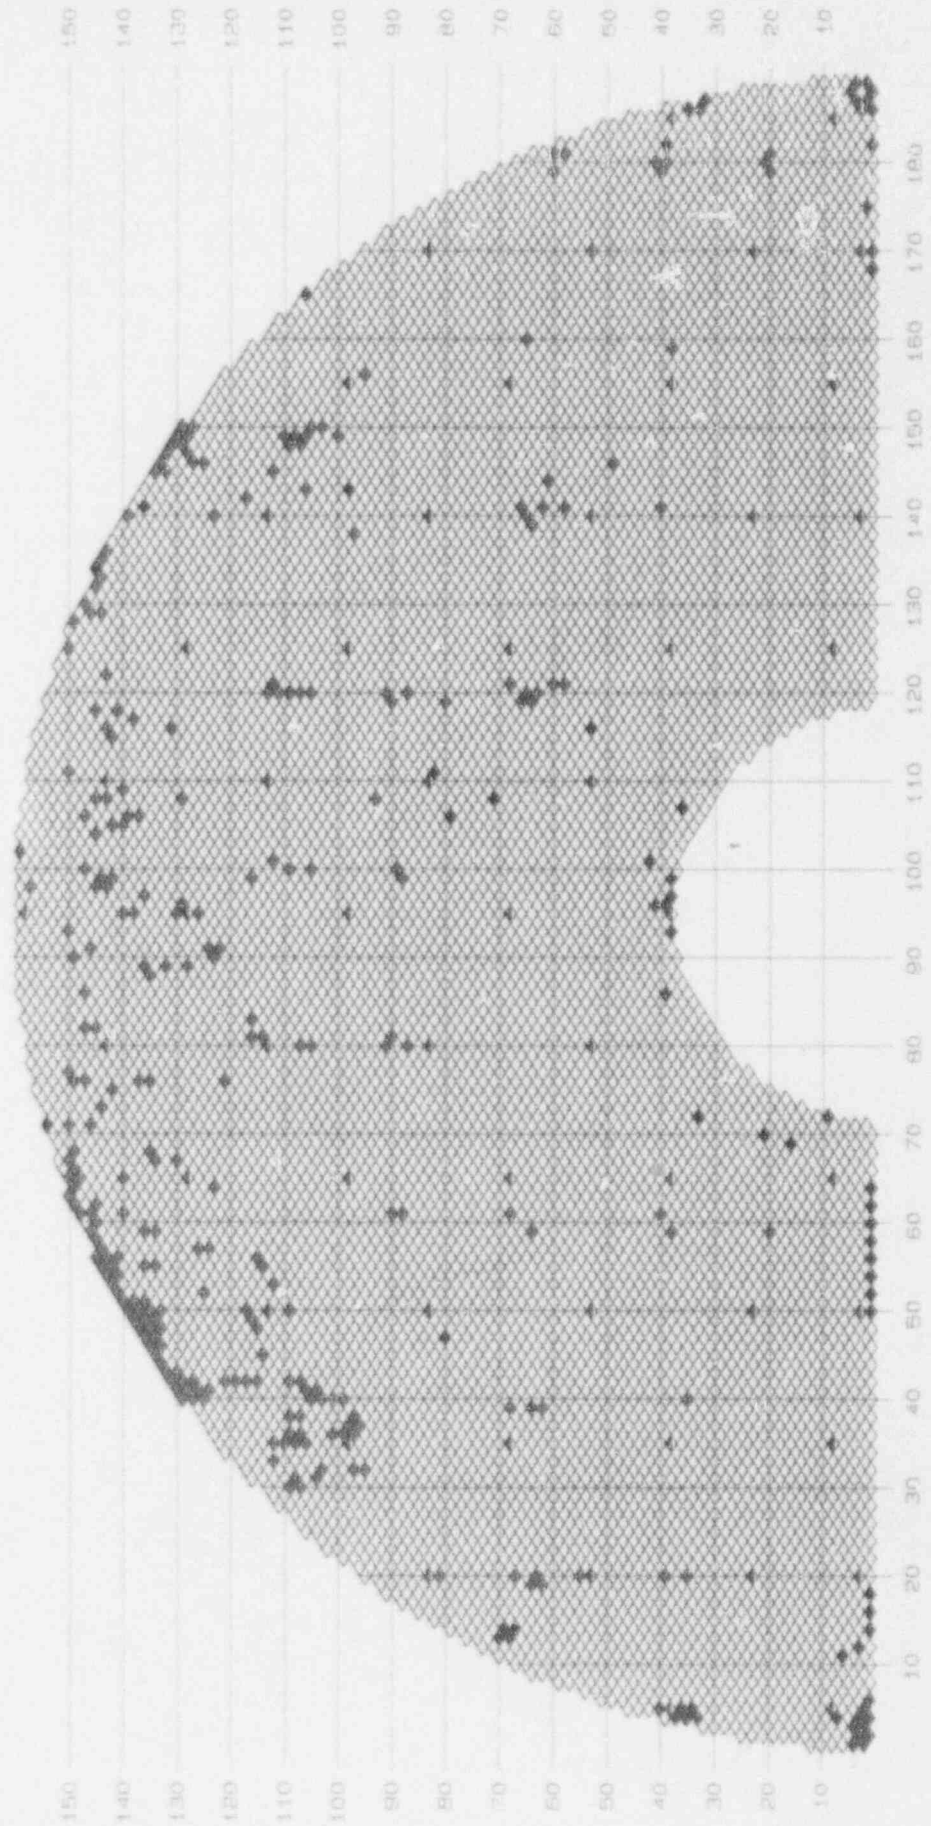
FIGURE IV-2, POSSIBLE DEPOSIT LOCATIONS, SS 12

This discovery of slight corrosion related damage in the arc region is not unexpected. The analysis performed in support of the Unit 2 SG tube rupture event indicated a region of deposit formation and contaminant concentration. The lack of significant resin intrusion and improved chemistry control could explain the difference in quantity and severity of defects found in Unit 1 as compared to those found in Unit 2. Based upon the SG inspection it is concluded that the accelerated damage mechanism found in Unit 2 is not active in Unit 1 SGs. Consequently, the basis for the transportability position taken in APS Letter 102-02585 (Reference 13) is supported by the U1R4 inspection results.

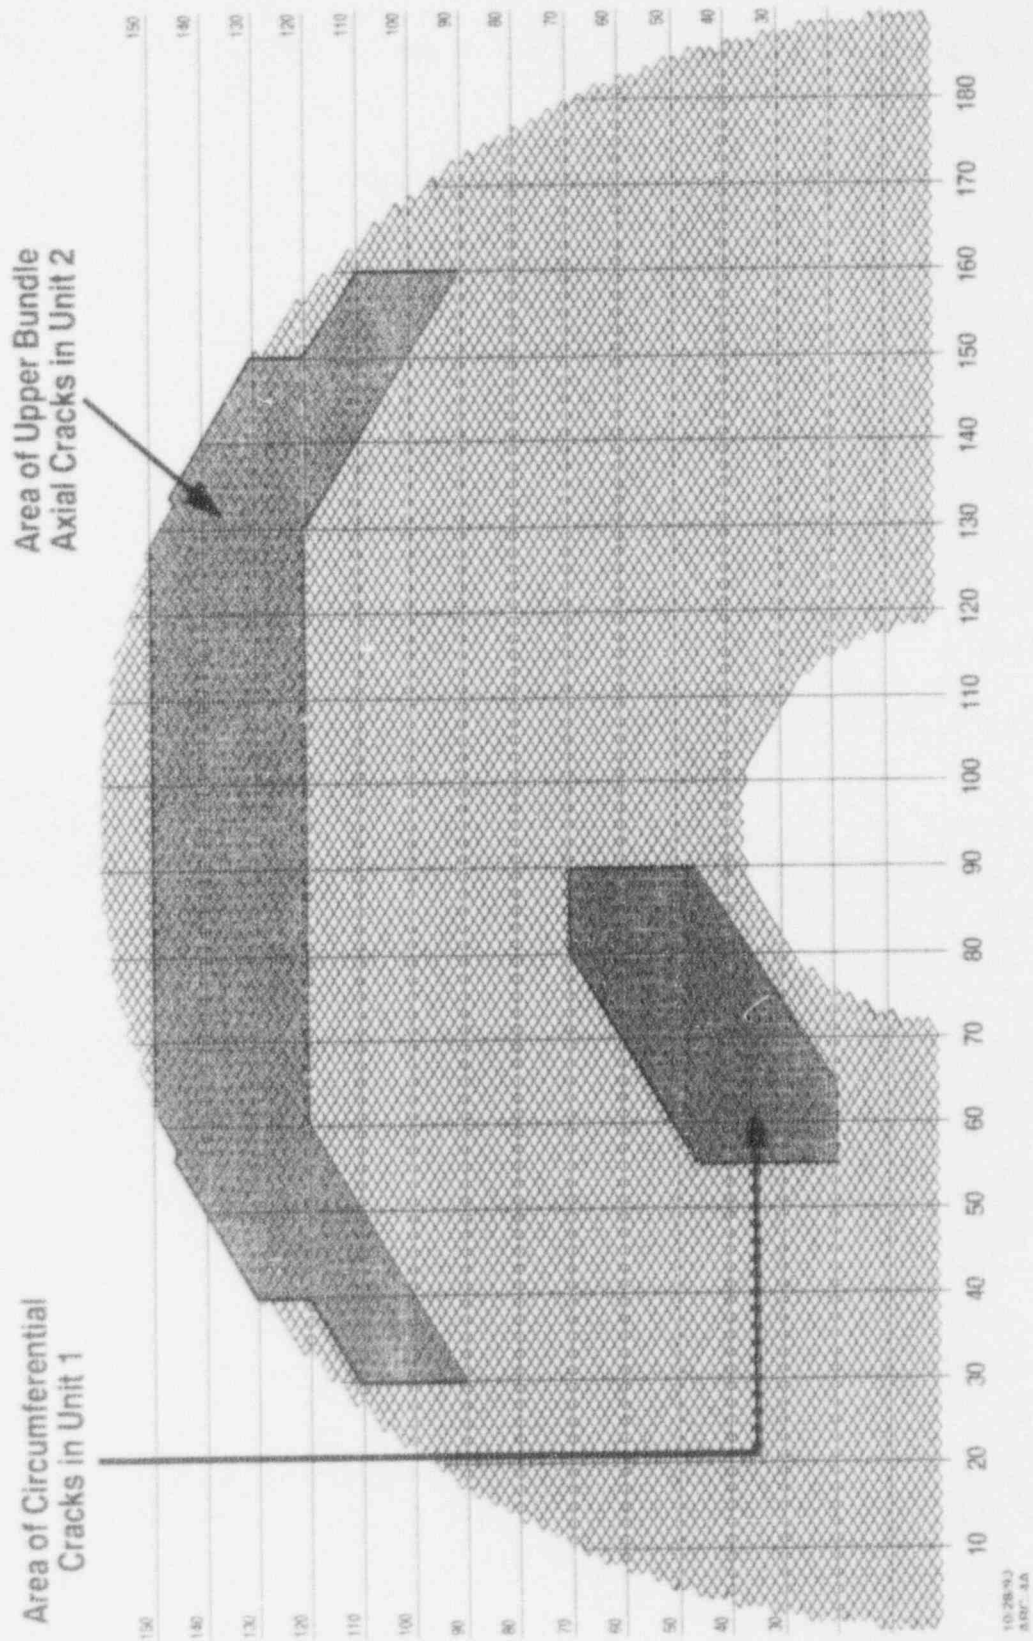
FIGURE V-1
Palo Verde Steam Generator Tube Map
Areas of Tube Cracks

The bases of the initial scope was to perform bobbin coil inspections to provide assurance that a widespread pattern of flaws did not exist, and to perform MRPC inspections for several known issues. These issues included inspection for tubesheet circumferential cracking noted elsewhere in the industry, inspection for lower support axial cracks noted in previous PVNGS outages, inspection for axial cracks in the area shown to be susceptible in the U2R4 outage, and inspection of a sample at high elevations to ensure defects do not exist outside the arc regions (see Figure V-1).

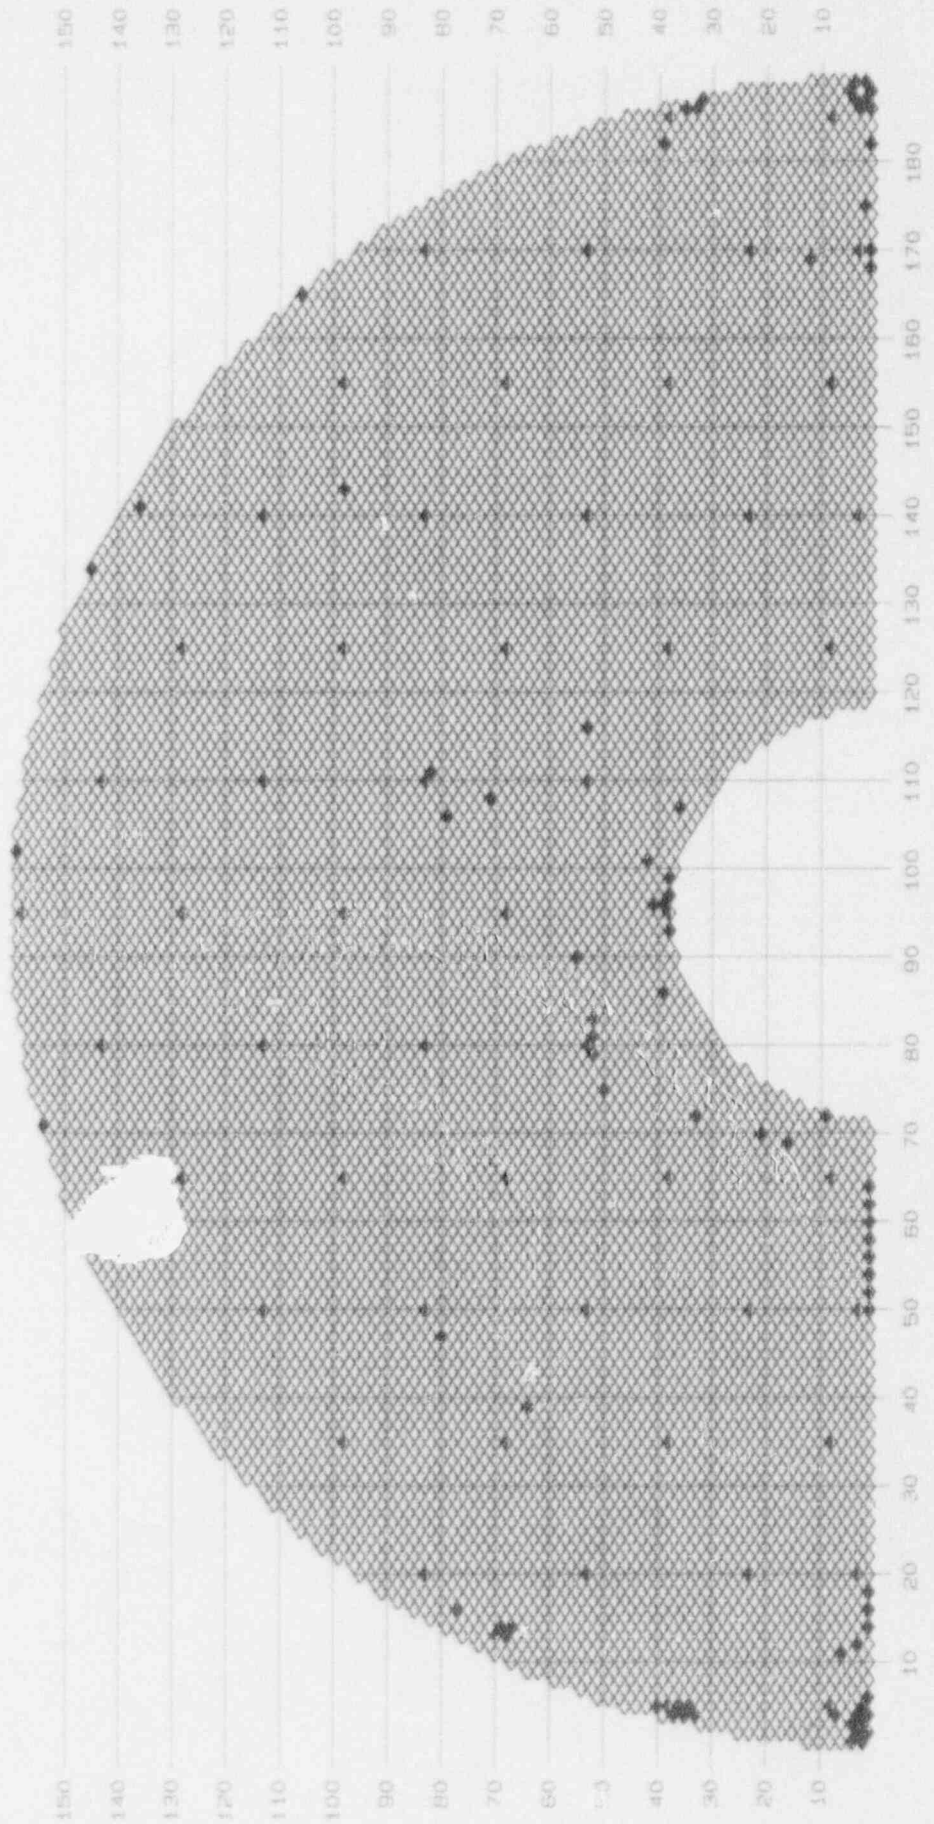
FIGURE V-2, CIRCUMFERENTIAL INDICATIONS, SG 11

During this inspection no axial defects were noted in the areas inspected from the 08H to vertical support area of the steam generators. A total of 7 circumferential cracks were found at the hot leg tubesheet in SG 11, and 76 circumferential cracks were found at the hot leg tubesheet in SG 12. These are the final results after expanding the ECT scope. Tubesheet maps indicating the location of all circumferential cracks are included as Figures V-2 and V-3.

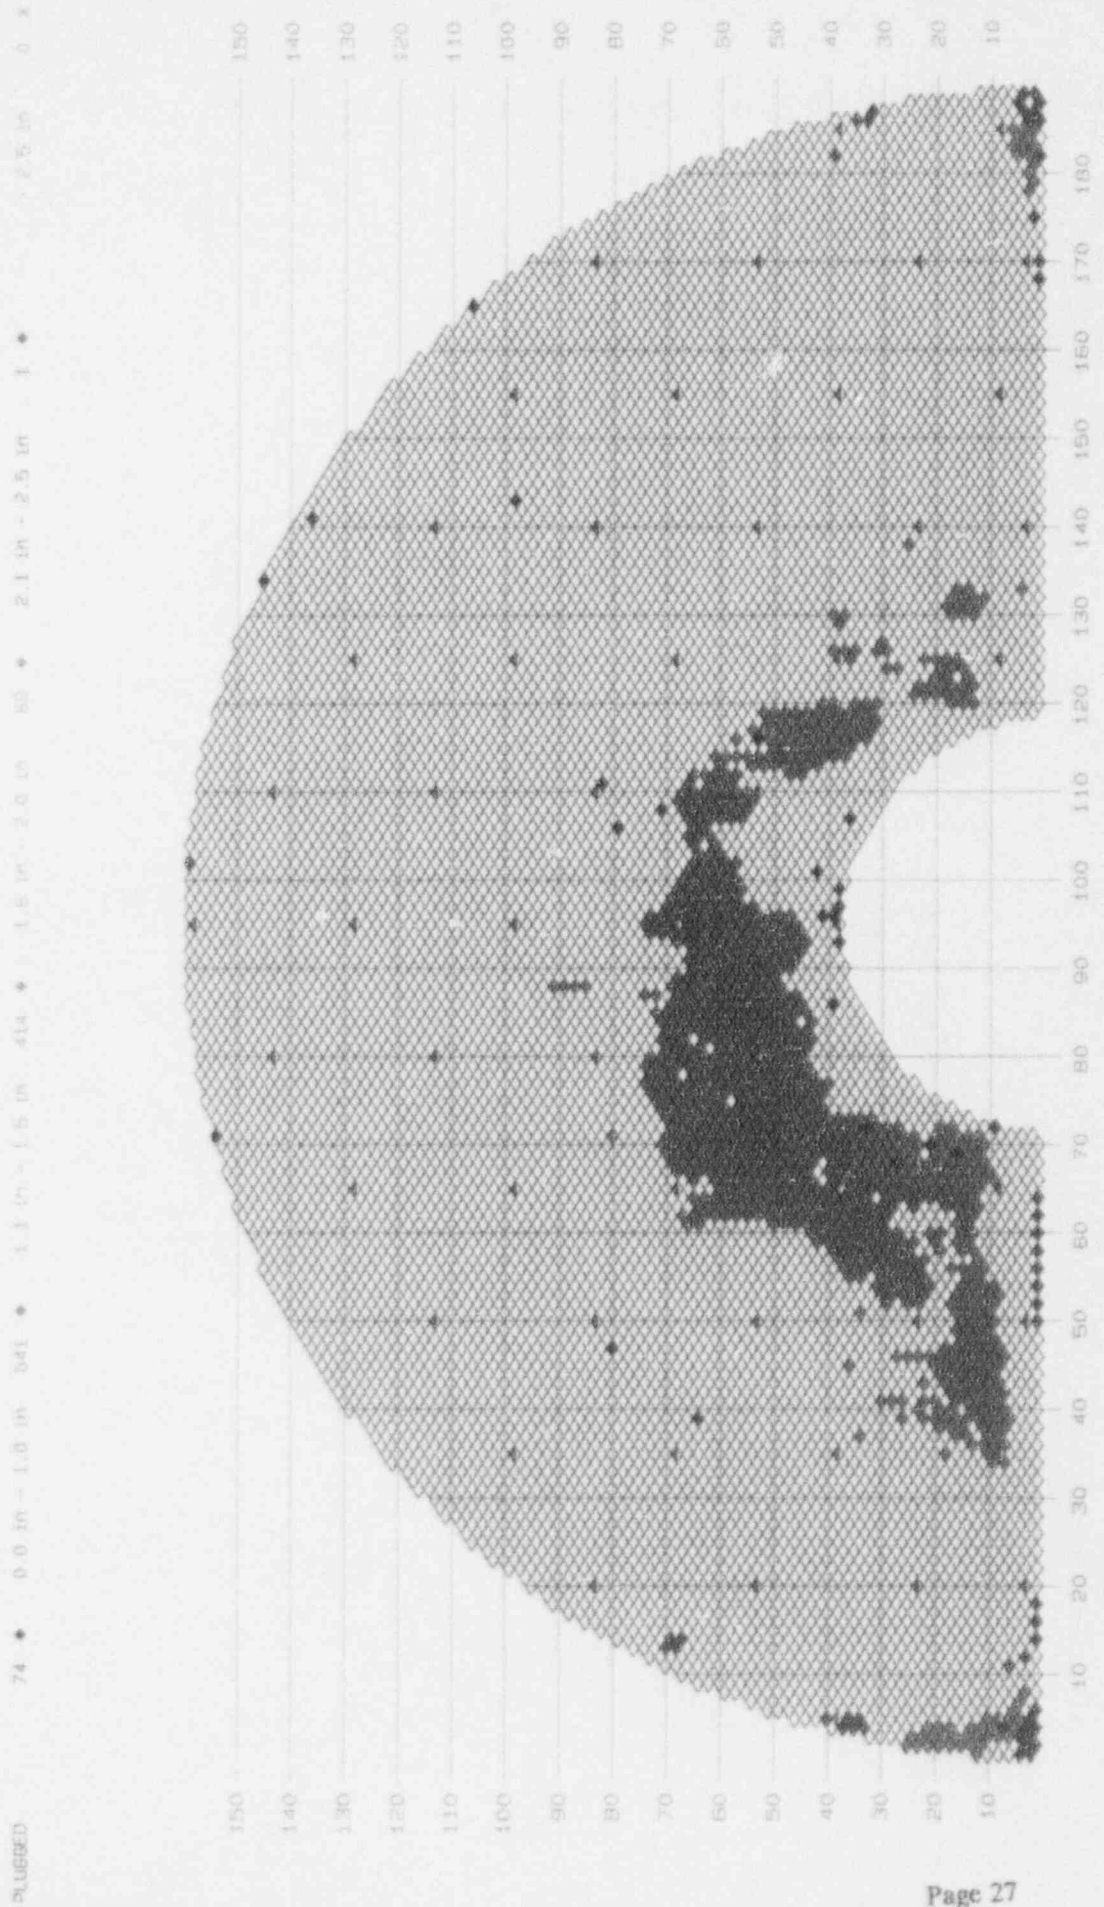
FIGURE V-4, SLUDGE LOCATION AND DEPTH, SG II

Of those cracks identified as OD, all but one occurred in tubes located in the sludge pile. Figures V-4 and V-5 show the location and depth of the sludge pile in both SGs. An UT evaluation was undertaken to compare lengths of indications found during ECT, compare whether the indications were ID or OD initiated, and to estimate the depth of the circumferential indications.

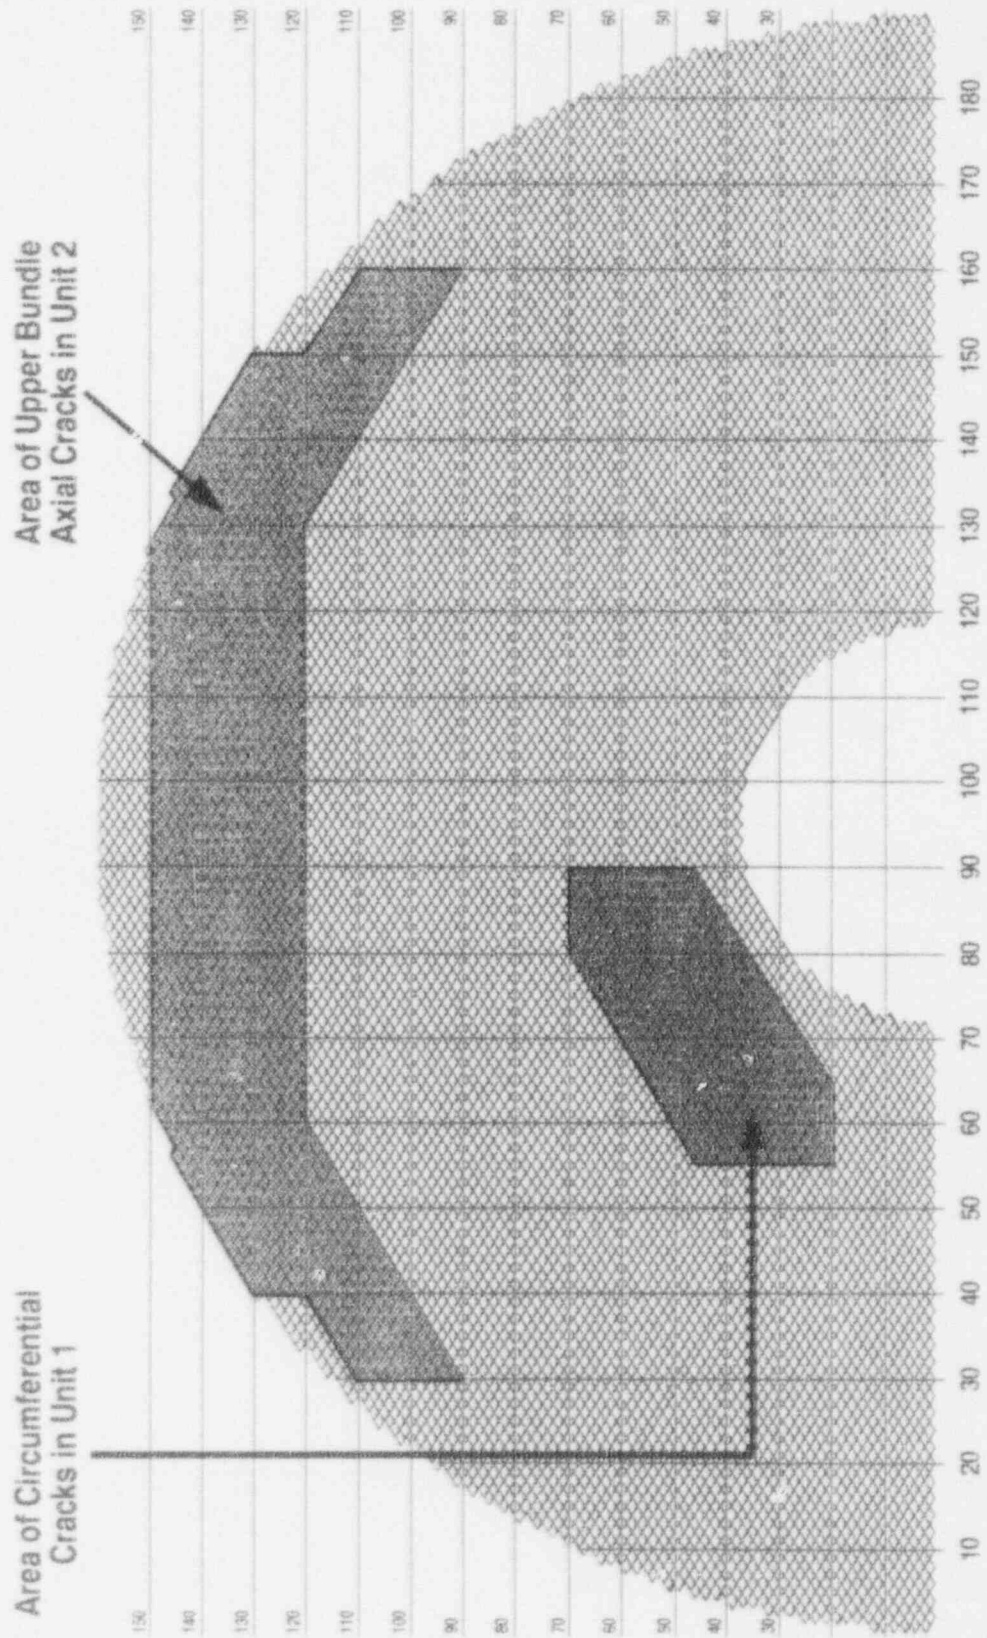
FIGURE VI-1
Palo Verde Steam Generator Tube Map
Areas of Tube Cracks

Circumferential and axial outside diameter cracks at the top of the tubesheet were observed at Palo Verde Unit 1. As is the case for the tubes exhibiting PWSCC, the circumferential defects are predominantly located within the hot leg kidney bean area, with the cracks originating within the tube expansion transition zone near the top of the tubesheet. The axial cracks were predominantly located in tubes with incomplete or nonexistent tubesheet expansion. The axial orientation of these defects would be expected since the residual stresses of a roll transition are not present and only applied hoop stresses define the stress field.

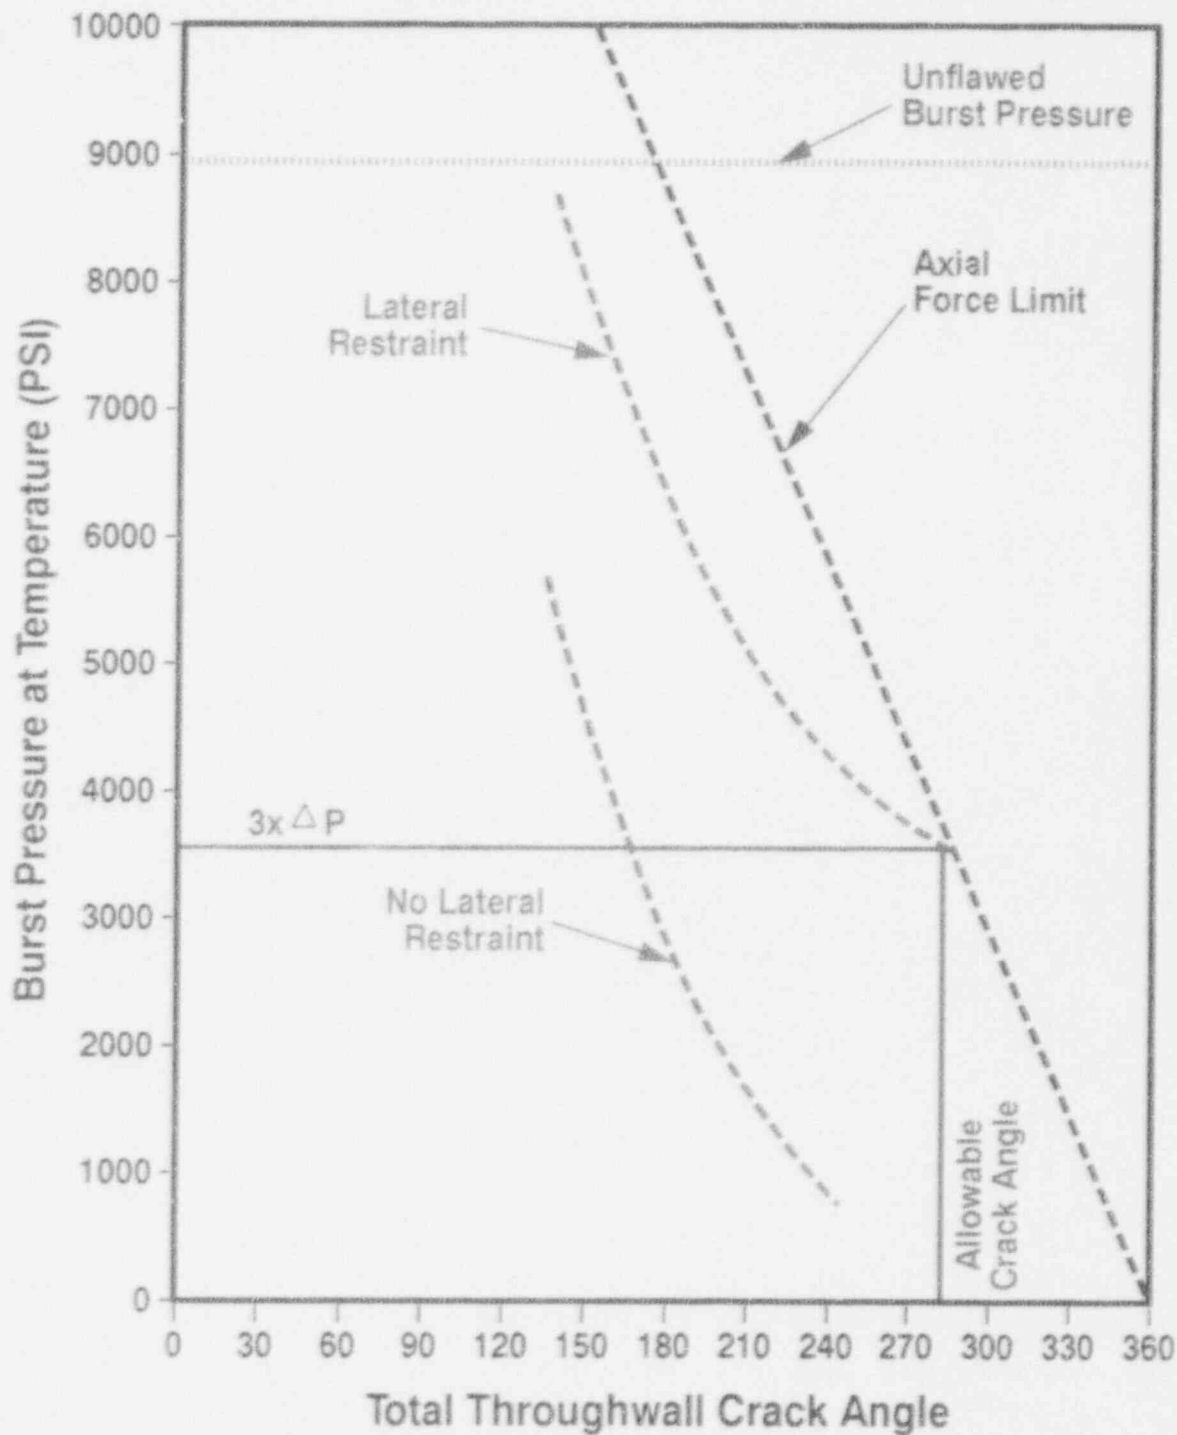
FIGURE VII-1

Based on the MRPC and UT examinations, several cracks appeared to approach or exceed the conservative maximum allowable crack length of 1.6 inches and potentially did not maintain the required safety margins over the previous operating cycle. Therefore, 5 tubes were selected to be in-situ pressure tested for final determination as to whether the required safety margins had been maintained. These cracks were chosen as being the bounding, or worst case cracks, based on length or potential through wall depth. All 5 tubes were pressurized to 3900 psia, based on the limiting differential pressure of 3540 psi adjusted for room temperature conditions, and held for approximately 8 minutes. All 5 tubes, as tabulated below, were successfully pressure tested to 3900 psi, indicating the required safety margins against bursting were maintained.
