U. S. NUCLEAR REGULATORY COMMISSION

Report No. 50-255/93020(DRS)

Facility Name: Palisades Nuclear Plant

Inspection Summary

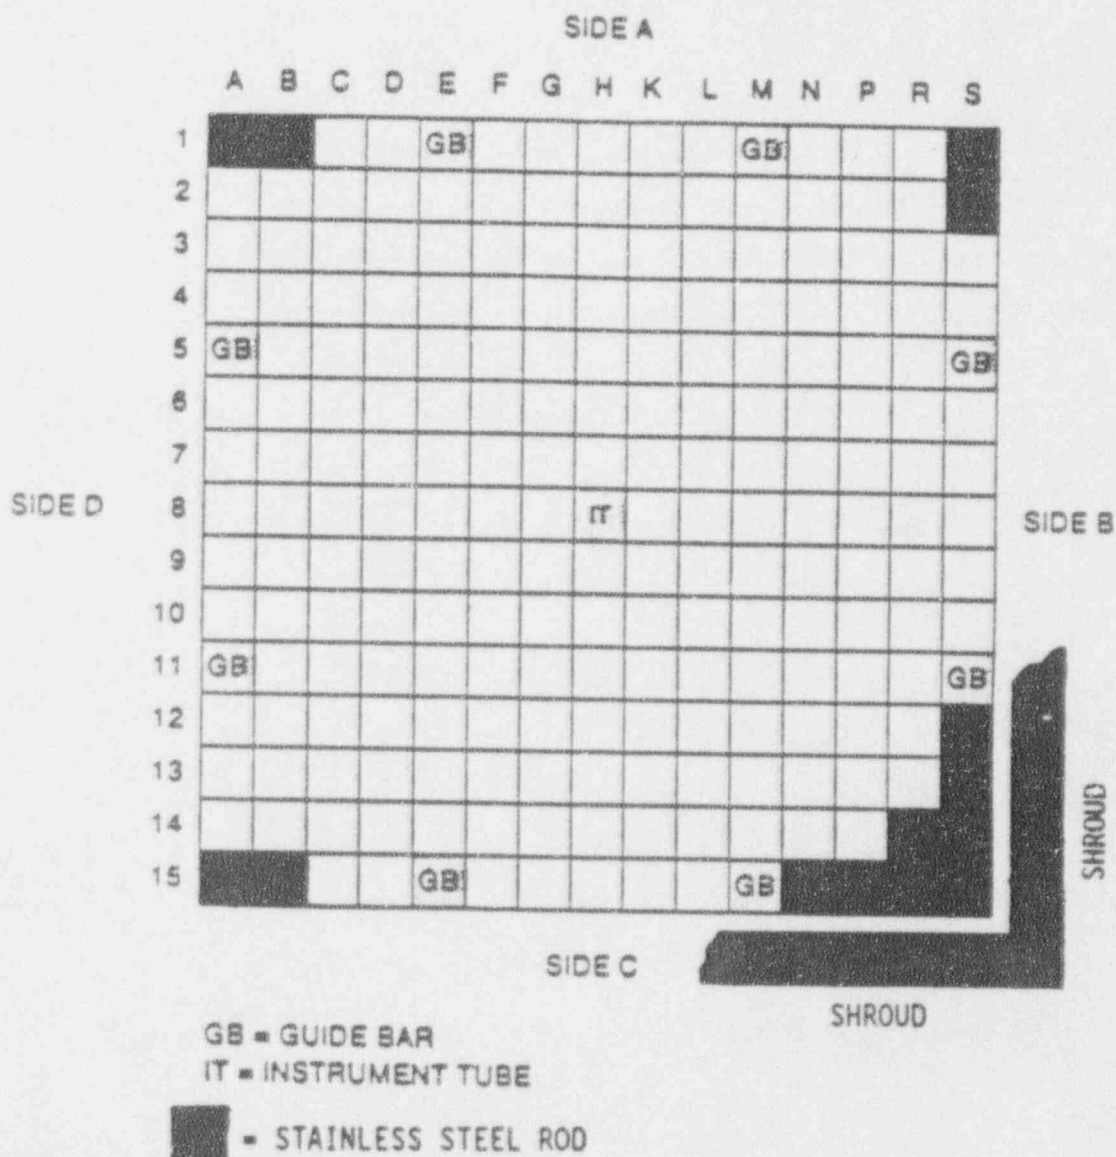
Figure 1 - Revised L-assembly for Cycle 11

The M-assemblies, N-assemblies, O-assemblies, and SAN-assemblies have not been altered for the revised Cycle 11. The L-assemblies have been reconstituted for the revised Cycle 11 by replacing 14 fuel rods with 14 solid stainless steel rods. Eight stainless steel rods were placed in the corner of the fuel assembly in the shroud corner with the stainless steel rods placed from the guide bar to the corner plus the location next to the corner location as shown in Figure 1. Each remaining corner of the fuel assembly contains 2 stainless steel rods as shown in Figure 1.

The stainless steel rods are 0.437 inches in diameter while the fuel rods they replaced were 0.417 inches in diameter. The licensee proposed that the larger diameter rods will reduce the probability of fretting damage during Cycle 11 due to an estimated increase in spring force of 0.6 pounds. The licensee proposed that the corners with 2 stainless steel rods will be less likely to fret and that the load on adjacent fuel rods will be symmetrically increased, decreasing the probability of fretting on the adjacent fuel rods.

The stainless steel rods in the reconstituted L assemblies are slightly larger in diameter than the fuel rods. The larger stainless steel rods in the corner will exert more force on the lantern spring, thereby tightening up the adjacent fuel rods. This results in higher spring force on fuel rods to compensate the spring relaxation during irradiation. The fuel vendor's analysis and testing results confirmed that there was higher spring force on the adjacent fuel rods. Since SPC has confirmed that the bimetallic spring relaxed as expected, the use of larger stainless steel rods tends to reduce the potential for fretting between the fuel rods and spacer springs. Thus, the team considered the use of larger stainless steel rods acceptable.

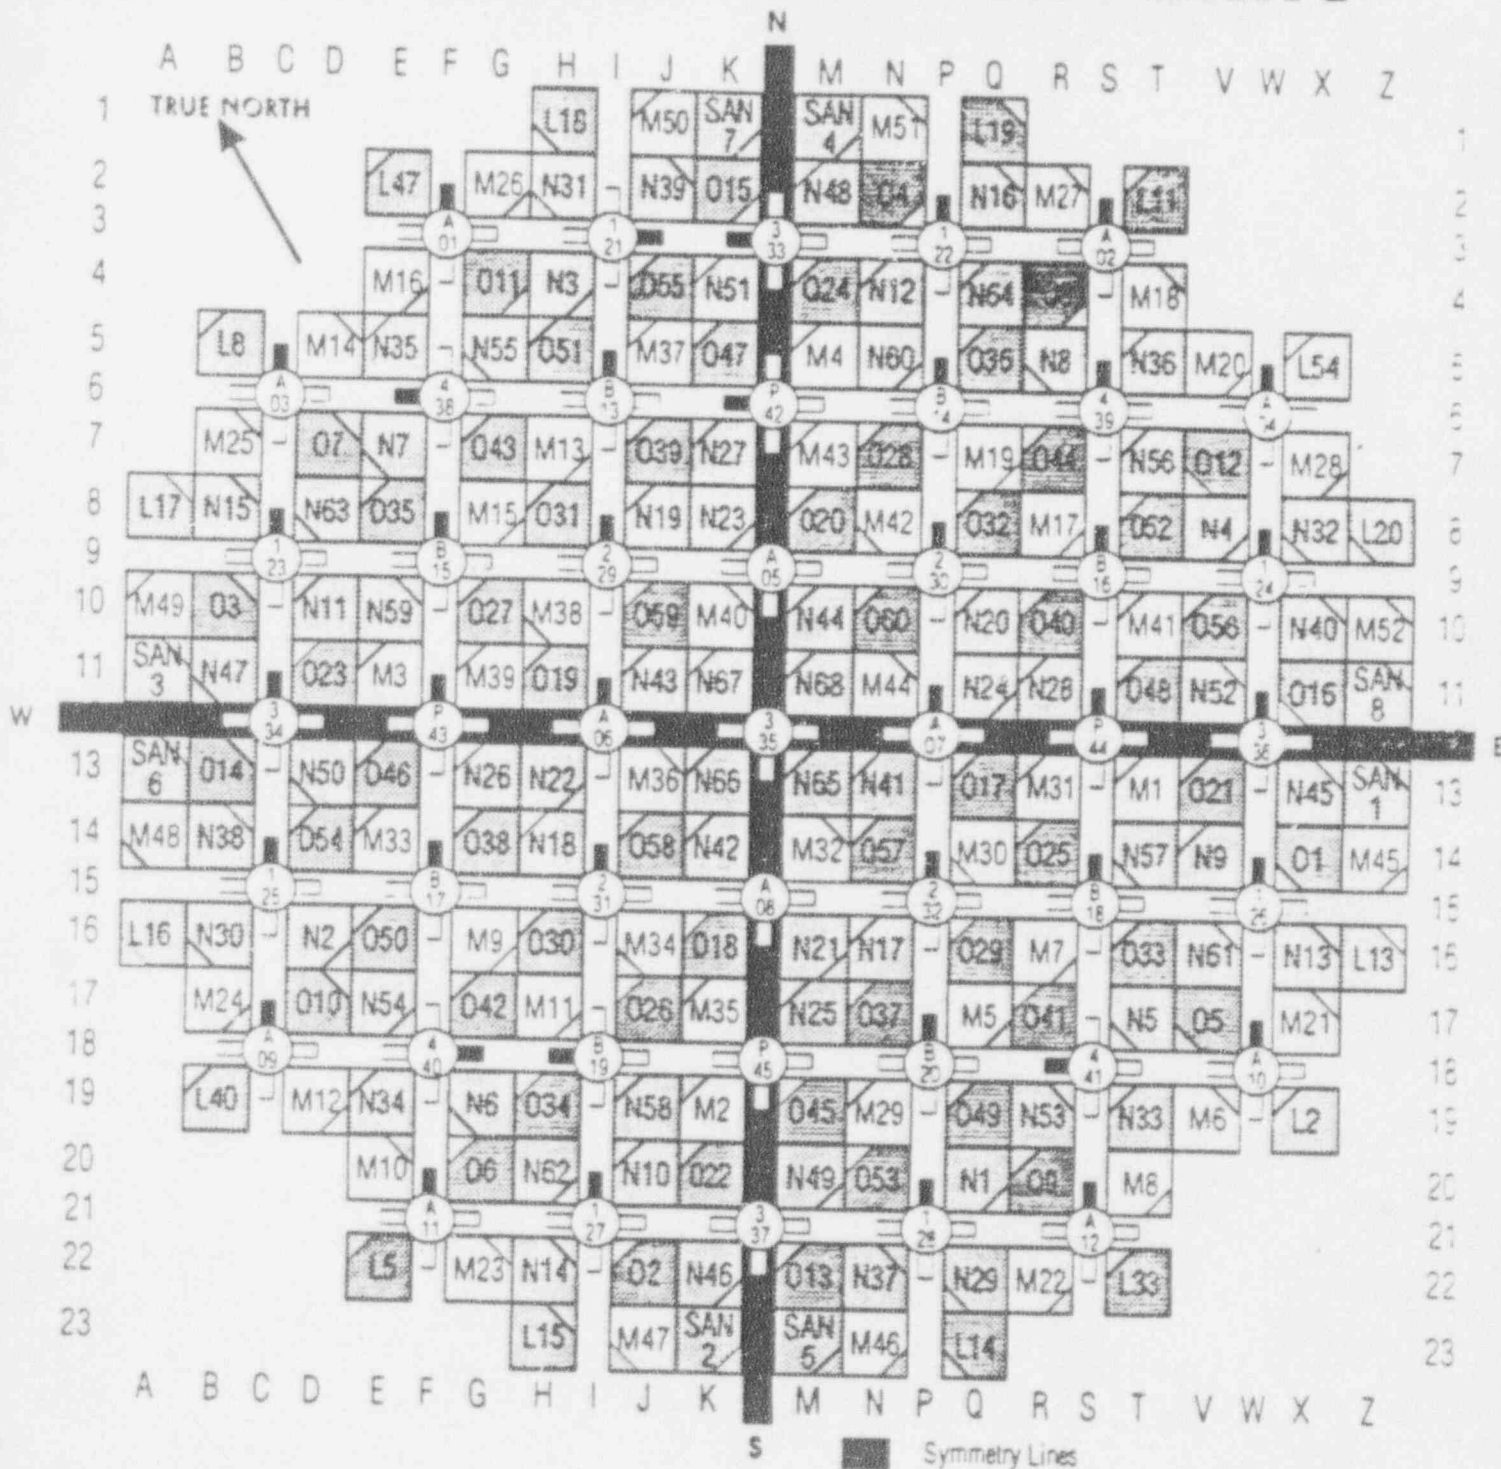
# Revised CYCLE II CORE PLAN PALISADES NUCLEAR PLANT

The revised Cycle 11 core contains 52 twice-burned M-assemblies, 68 once-burned N-assemblies, 60 fresh O-assemblies, 8 once-burned N Shield Assemblies (SAN), and 16 modified thrice-burned L-assemblies with 14 solid stainless steel rods inserted in the assembly corners. The difference between the revised and the original Cycle 11 core designs is the 16 reconstituted L-assemblies and the relocation of the selected M and N assemblies (20 assemblies in each batch). Figure 2 shows the revised Cycle 11 core design.

For fluence reduction purposes, the revised Cycle 11 core is a low radial leakage core incorporating 8 SAN assemblies in the flat peripheral regions and 16 reconstituted L-assemblies in the core corner locations. A higher initial reactor coolant boron concentration is needed to offset the additional reactivity in the revised Cycle 11 because of the revised L-assemblies (which are more reactive as compared to the I-assemblies), because the O-assemblies have enrichment higher than previous fuel assemblies, and because of less gadolinia used in Cycle 11 fuels as compared to previous cycles.
