U. S. NUCLEAR REGULATORY COMMISSION

NRC Inspection Report: 40-8027/90-04  
License: SUB-1010

Facility Name: Sequoyah Facility

Inspection Conducted: August 27 through August 29, 1990

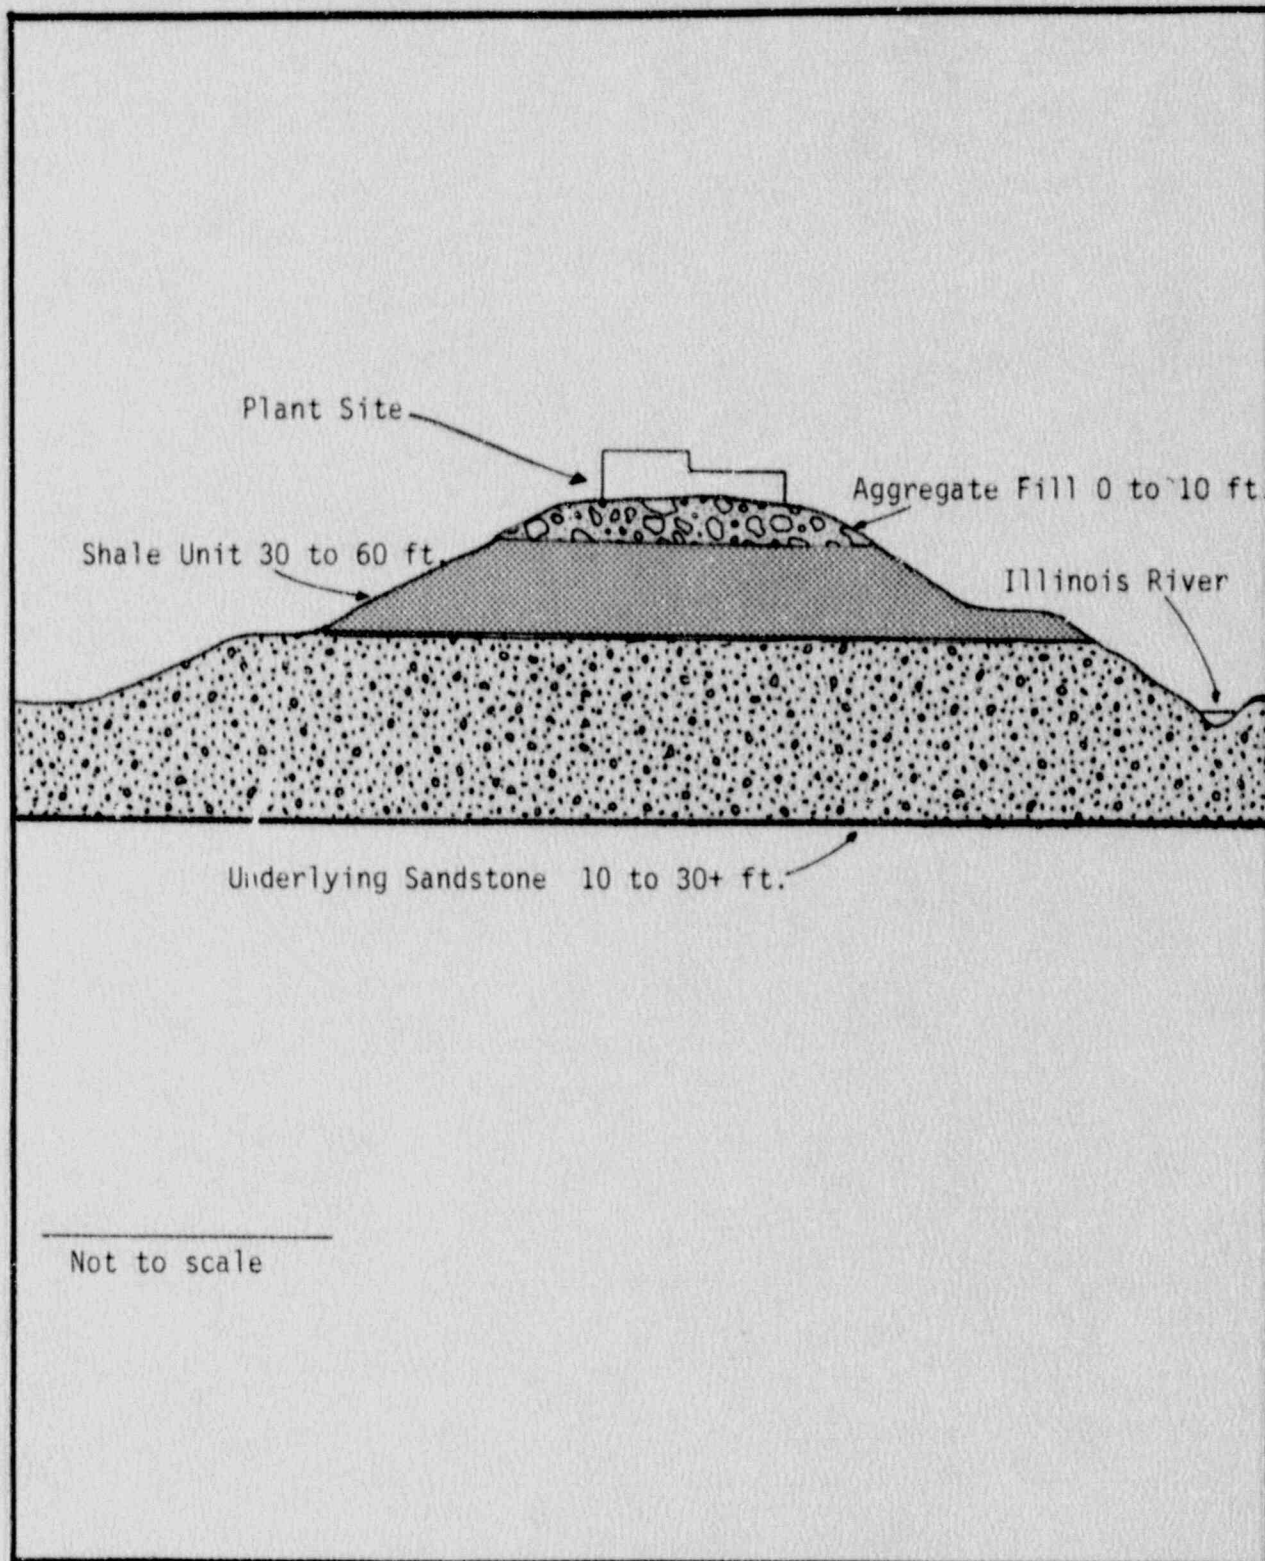
FIGURE 1 TYPICAL STRATA UNDERLYING THE SEQUOYAH FACILITY

The SFC site is located in a rolling upland near the confluence of the Illinois and Arkansas rivers. Typical geology at the site consists of a shaley unit that rests upon a hard, dense, and well cemented massive sandstone. The upper 3 to 5 feet of the shaley unit is often weathered to dense low-permeability clay that acts as a barrier to vertical water movements. Over the site, it is common to have 0 - 10 feet of construction related aggregate on top of the natural sequence. A typical section is shown in Figure 1.

The five borings supplied sufficient information to construct a typical section around the SX building. Generally there is an aggregate fill ranging from 1 to 2 feet in thickness underlain by a weathered shale zone that is about 3 to 5 feet thick. This unit lies directly upon its parent material, a shale that is at least 12 feet thick, with occasional sand stringers. The underlying sandstone was not encountered in any of the borings, although it is known to occur stratigraphically below the shale. Observations made in the hexane vault excavation confirm this geologic sequence adjacent to the SX building.

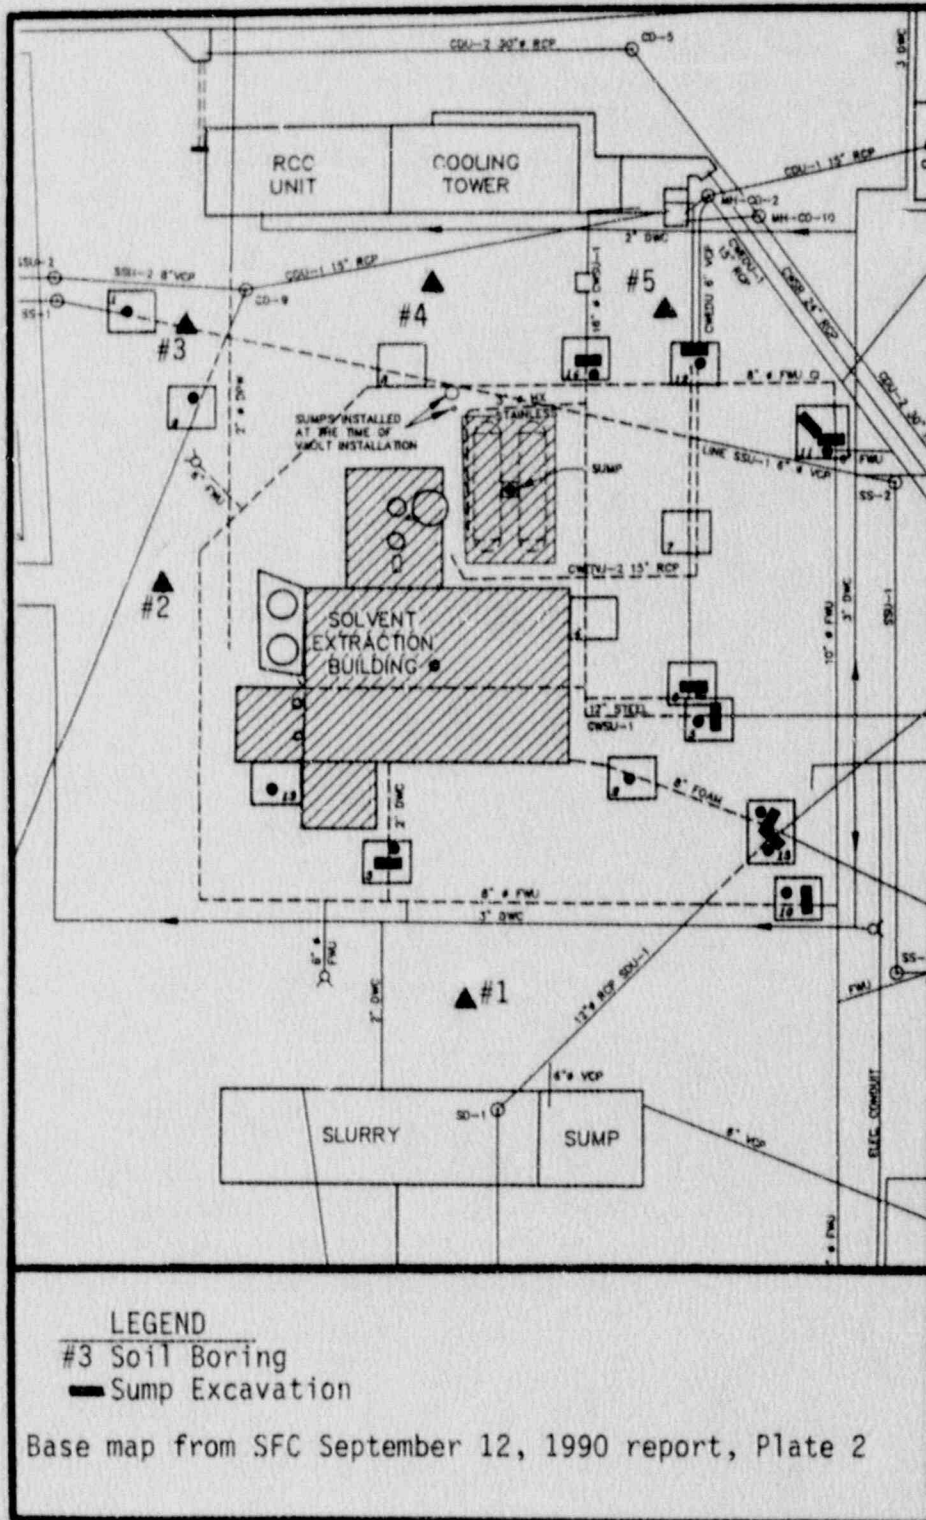
FIGURE 2 SOIL BORING AND SUMP EXCAVATION LOCATIONS

the underlying sandstone. To explore the extent of these stratigraphic units and their effect on the transport and containment of the solution known to have leaked, five borings into the shale were made by the licensee. These borings were advanced utilizing an air rotary rig and logged as they were drilled. The approximate boring locations are shown on Figure 2.

In addition to five borings that were made by the licensee, 15 soil excavations were made around known pipelines. The locations of these excavations are also shown on Figure 2. These excavations, although not logged, were sampled to determine uranium concentrations in the soil and water.

Although five borings were made, they were not developed to be utilized as ground-water monitor wells. The lack of casings in these bore holes allowed cross communication of the various stratigraphic units to take place. Due to this the water quality samples that were obtained from these borings may represent water that has seeped into the boring from overlying strata. The data that was obtained from these five borings did supply valuable information to make preliminary conclusions as to the extent of contamination. Part of the licensee's plans called for locating properly completed monitoring wells in this area.

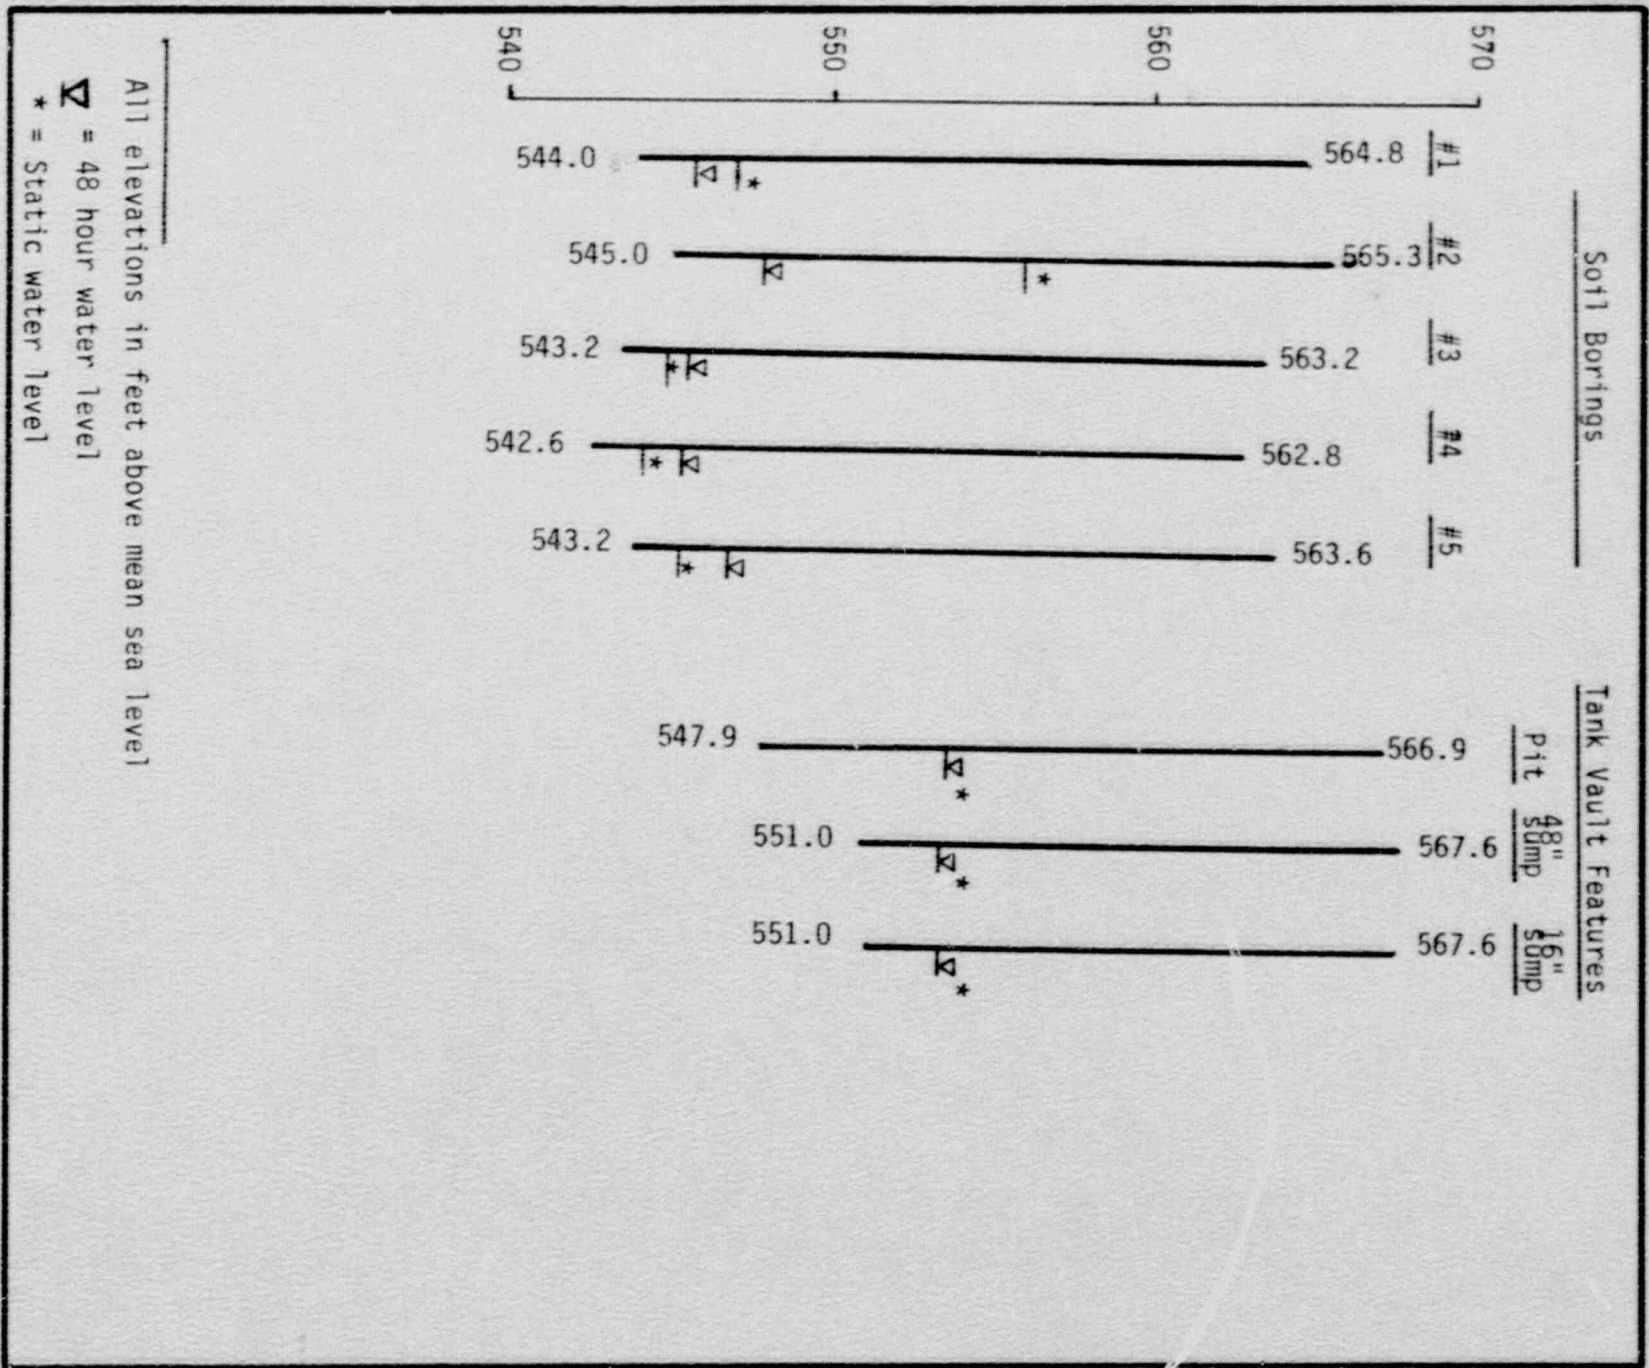
FIGURE 3 SOIL PENETRATIONS AND ASSOCIATED WATER LEVELS

The above data indicate that water levels adjacent to the SX building and in the aggregate fill are generally over 6.0 feet above the levels noted in the bore holes completed in the shale unit. This water level variation indicates that a potential exists for ground-water movement to take place. Because the water was noted to be flowing in the vault excavation there is a potential for the water to be at some higher level in the strata adjacent to the excavation.
