LICENSEE EVENT REPORT

REPORTABLE OCCURRENCE 77-36

FORT ST. VRAIN NUCLEAR GENERATING STATION
PUBLIC SERVICE COMPANY OF COLORADO
P. O. BOX 361
PLATTEVILLE, COLORADO 80651

REPORT NO. 50-267/77-36/03-L-1

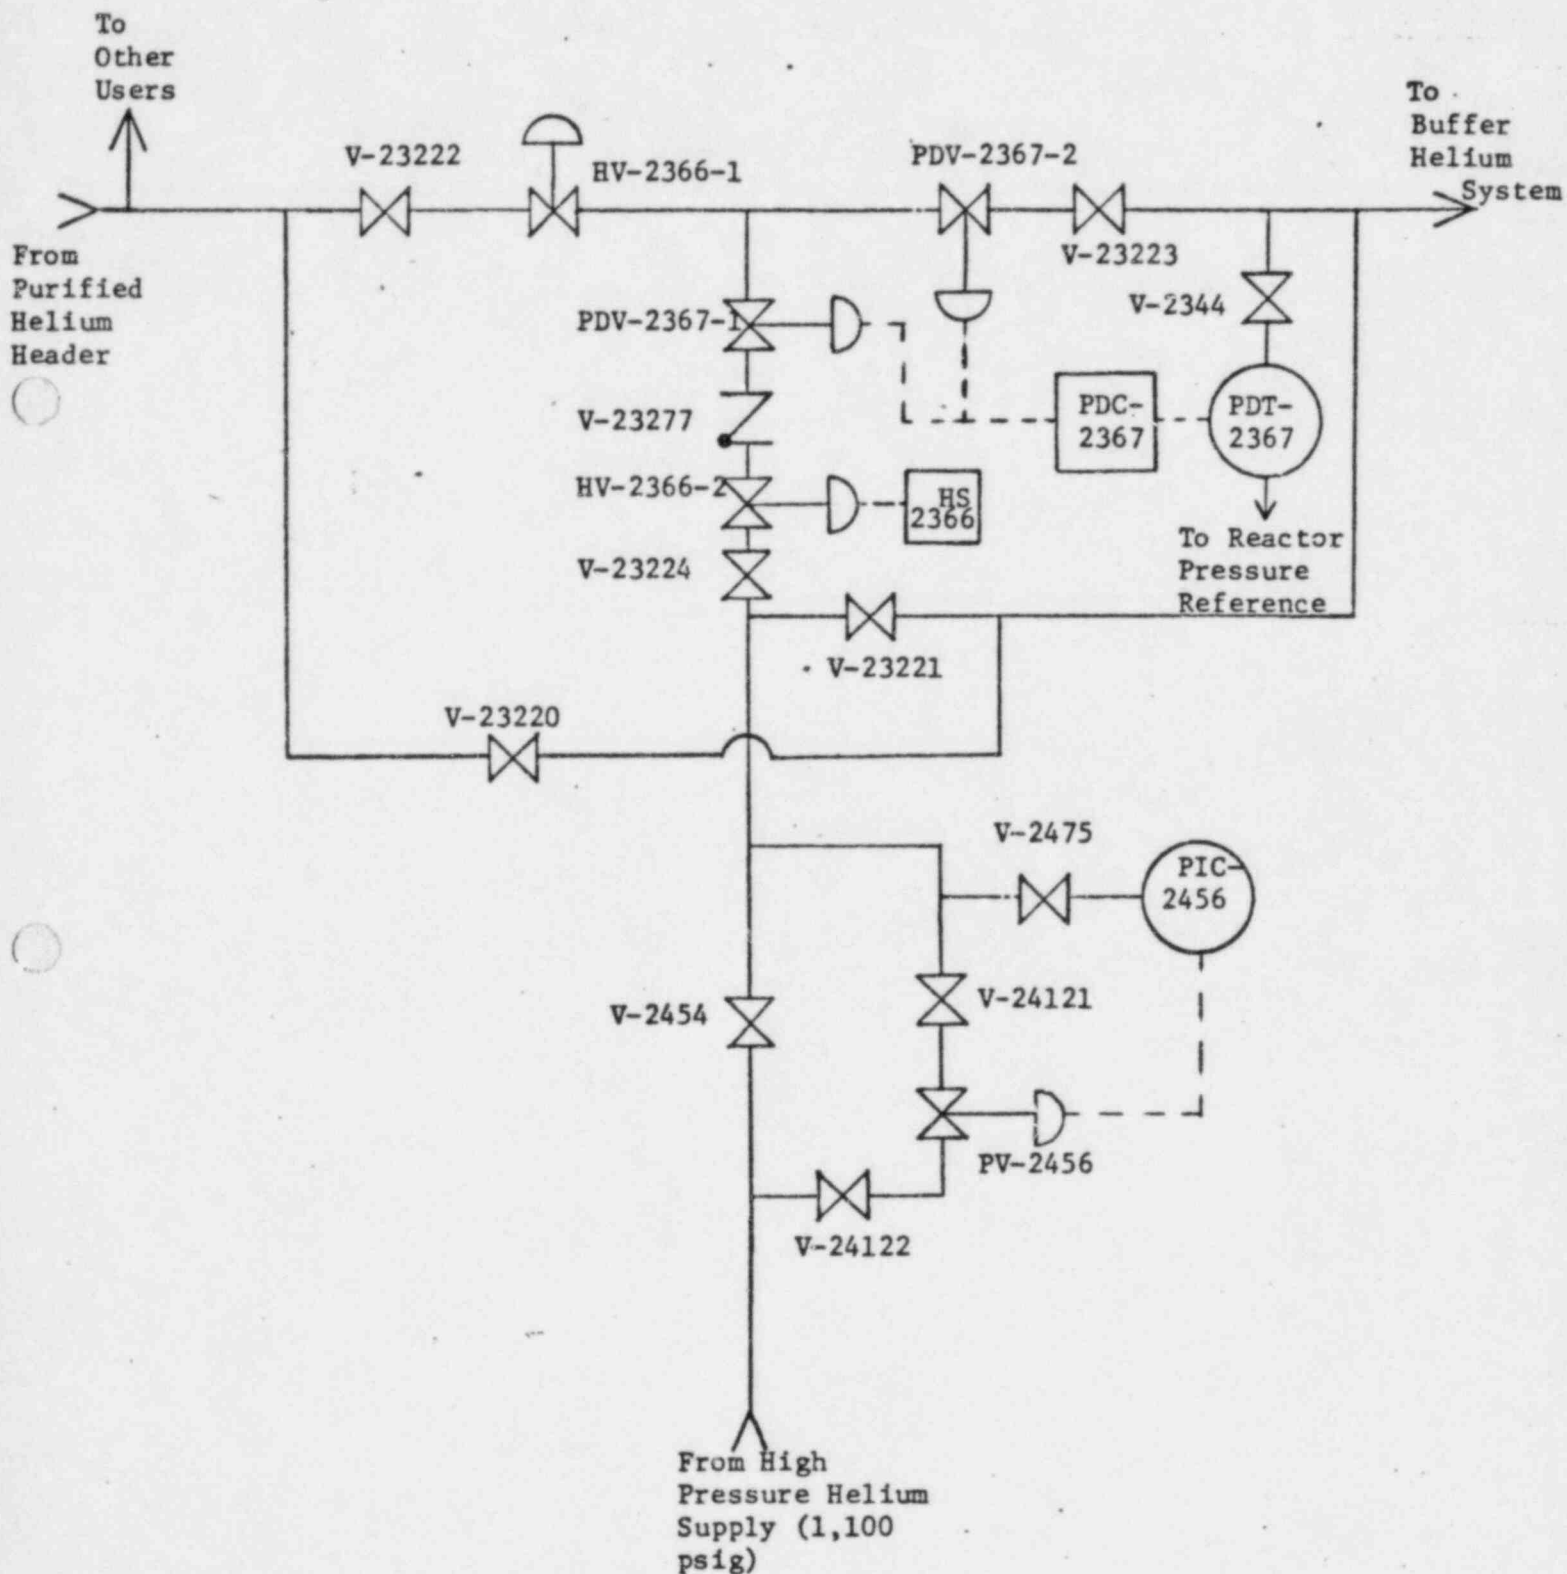
FIGURE 1

On November 8, 1977, the primary coolant system was being depressurized. When the pressure reached 100 psia, preparations were begun to supply helium circulator buffer helium makeup from the helium storage system. Figure 1 shows the arrangement of both normal and alternate buffer helium makeup.

During normal operation buffer helium makeup is supplied from the purified helium header. Isolation valve HV-2366-1 is open and HV-2366-2 is closed. Bypass valves V-23220 and V-23221 are also closed. Pressure differential transmitter PDT-2367 senses the difference between the buffer helium makeup pressure and reactor primary coolant pressure and outputs a signal proportional to this difference to PDC-2367. Pressure differential controller PDC-2367 is set to maintain 4 to 5 pounds by opening or closing PDV-2367-1 and PDV-2367-2 as required, although only PDV-2367-1 is actually controlling pressure and thereby flow.

During operation with buffer helium makeup supplied from the high pressure helium supply, HV-2366-1 is closed and HV-2366-2 is opened. V-23220 and V-23221 remain closed. Control of helium supply is by means of PV-2456 and pressure indicating controller PIC-2456 with V-2454 closed and V-24122, V-24121, and V-2475 closed. Pressure indicating controller PIC-2456 is set to control the high pressure helium, which can be as high as 1,100 psig, to 88 psig in order to provide sufficient pressure for buffer helium makeup.

During a depressurization of the primary coolant, at 100 psia V-2454 is closed and V-23224 is opened. At 75 psia, HV-2366-1 is closed and HV-2366-2 is opened. On November 8, 1977, the operator omitted the closing of V-2454 so that when HV-2366-2 was opened high pressure helium was supplied to the buffer helium system before PDC-2367 could close and maintain the desired 4 to 5 pound differential. The sudden surge of buffer helium caused 1B and 1D helium circulators to trip and inject water into the primary coolant from the bearing water system.

The error in valve operation of November 8, 1977, was discussed with the operator involved and all Reactor Operators were directed to review the applicable procedures.

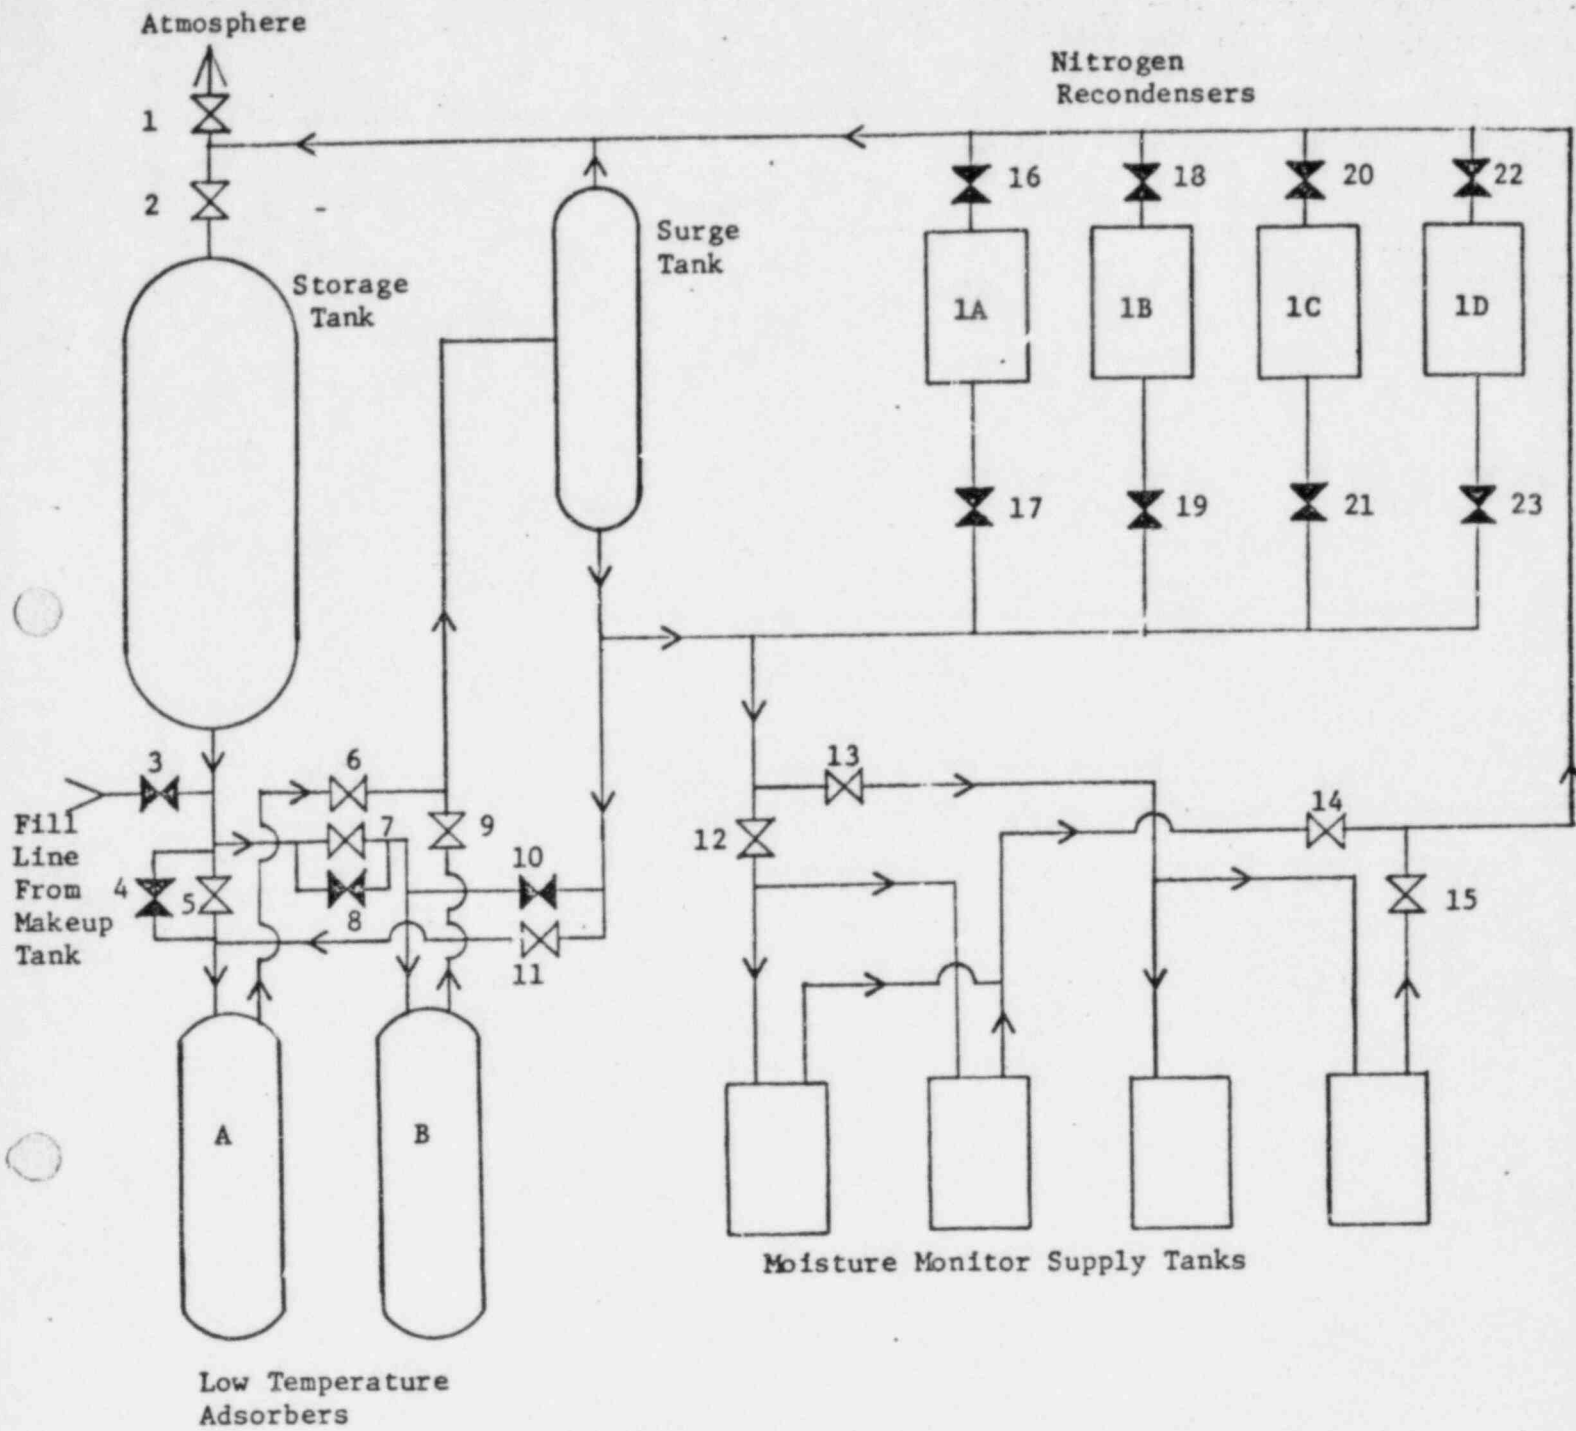
FIGURE 2

Figure 2 is a simplified diagram of the nitrogen system. During normal operation, nitrogen vapor with entrained liquid nitrogen from low temperature adsorbers of the helium purification system, flows to the liquid nitrogen surge tank, where liquid is separated from vapor. The liquid is returned to the low temperature equipment by gravity. The vapor, including vapor from the moisture monitor nitrogen supply tanks, is recondensed by the nitrogen recondensers. The liquid formed flows by gravity back to the low temperature absorber, moisture monitor supply tanks, and the surge tank.

Referring to Figure 2, the normal valve lineup and the lineup in use on November 20, 1977, are listed below:

On November 20, 1977, when the surge tank had been filled with liquid nitrogen from the storage tank the operator closed valve (11). A few minutes later a second operator noticing the high level in the surge tank and being aware of the abnormal valve lineup used to fill the surge tank, closed valve (5). With both sources of liquid nitrogen isolated, the low temperature adsorber began to warm up. When the operator realized that the low temperature adsorber cooling was shut off, he opened valve (11) and re-established cooling.

During the time the liquid nitrogen flow was interrupted, the low temperature adsorber temperature increase released some of the gaseous impurities previously removed from the primary coolant. As a result, a small quantity of the oxidants trapped in the low temperature adsorber were released to the primary coolant system, causing an increase of total oxidant concentration to 50 ppmv. As soon as cooling was re-established an immediate downward trend in primary coolant total oxidants was noted. On November 22, 1977, the total oxidant level had reached 11.3 ppmv and it was decided to proceed with the power escalation. The power escalation resulted in an average core outlet temperature exceeding 1,200°F, and an increased oxidant level to 14 ppmv due to some additional graphite outgassing. A downward trend was re-established by the helium purification system and total contaminants remained below 10 ppmv after November 24, 1977.

Total primary coolant oxidants were reduced by the helium purification system to below 10 ppmv following return of liquid nitrogen cooling to the low temperature adsorber. The error in operation of November 22, 1977, was discussed with the operator involved.
