AEOD/E90-09

ENGINEERING EVALUATION REPORT

ADDITIONAL FACTORS AFFECTING THE LIFT SETPOINT
OF PRESSURIZER SAFETY VALVES

October 1990

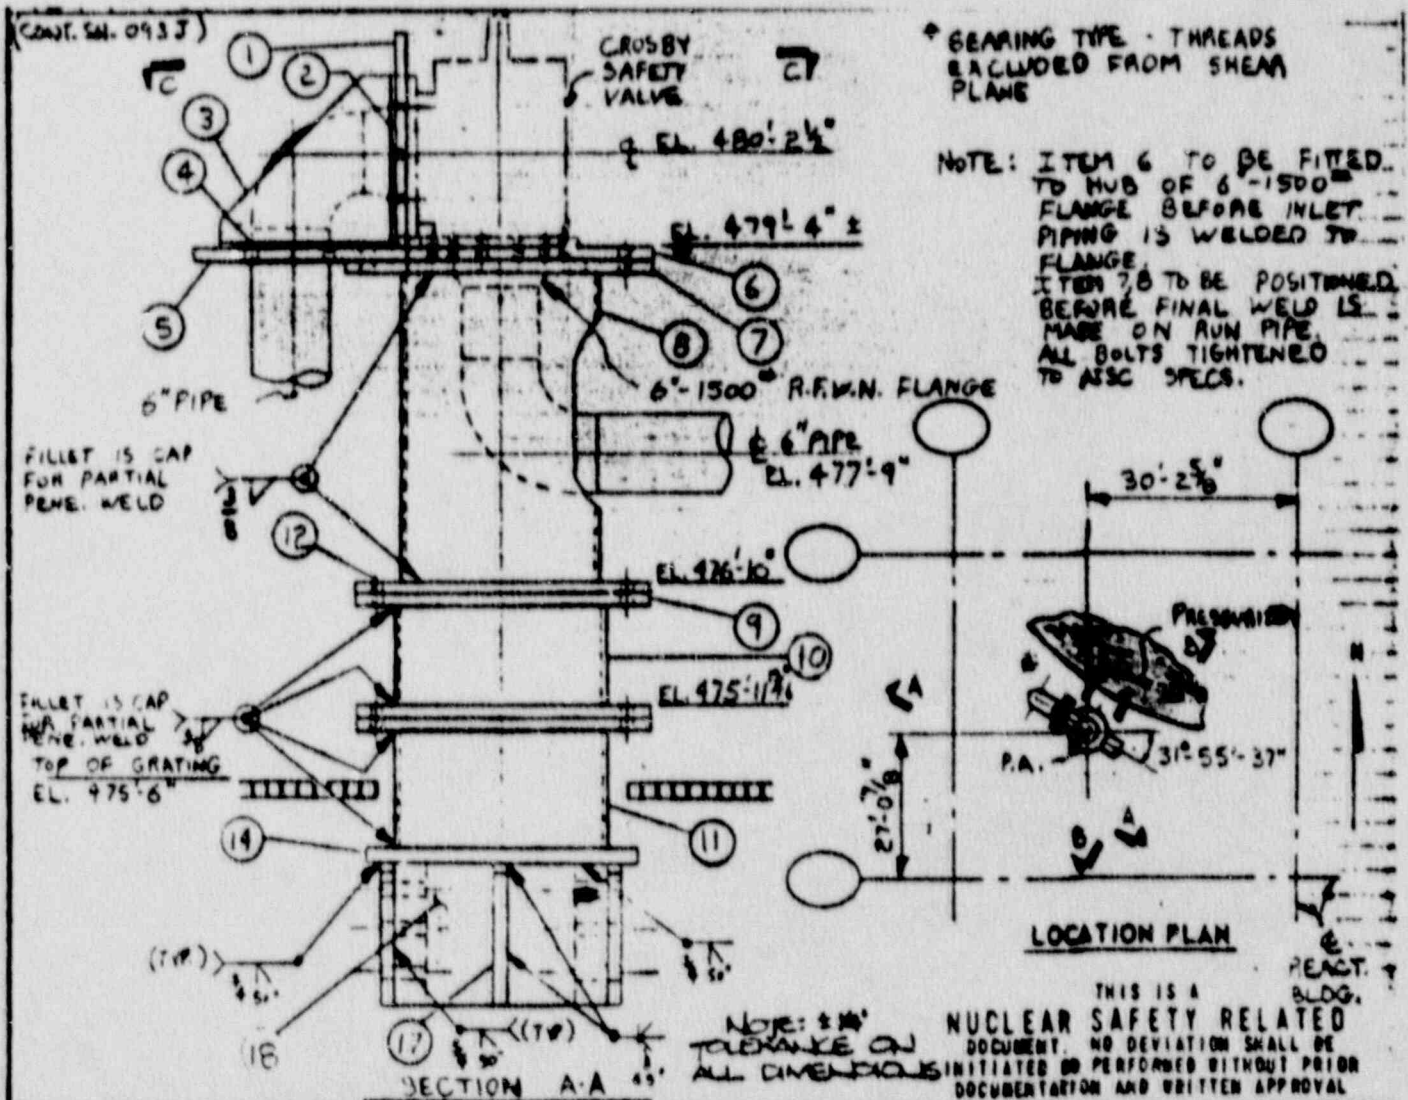
At Summer, the pressurizer safety valve structural support was attached to the pressurizer (see Enclosure 1). The safety valve tailpipe was designed to pass through a mounting plate (Item 5) with a gap of 1/16 to 1/8 inch all around. Normal pressurizer heat-up caused elongation of the pressurizer, which lifted the safety valve structural support upward. As the other end of the 50 to 60-foot long 6-inch pressurizer safety valve tailpipe is supported along its length and attached to the pressurizer relief tank (quench tank), stress was induced into the body of the safety valve when the pressurizer elongated.

Deformation of the irregular flame cut surfaces in the hole of the mounting plate where the plate contacted the tailpipe flange were apparent. Licensee calculations determined the stress levels in the valve body were 4,925 psi. Although this stress level was only approximately 18 percent of allowable, the licensee concluded some disc-to-nozzle misalignment resulted in seat leakage. The non-symmetrical pattern of steam leakage degradation of the disc and nozzle seating surfaces identified during valve disassembly also confirmed that some misalignment was present.

Licensee corrective actions included re-analysis of tailpipe configurations, removal of tailpipe mounting plates, and modification of tailpipe supports and hangers.
