In the Matter of
SOUTH CAROLINA ELECTRIC & GAS COMPANY
(Virgil C. Summer Nuclear Station, Unit 1)
Docket No. 50-395

SUBJECT: NRC FIRE PROTECTION RESEARCH TEST

SUBJECT: UL FIRE PROTECTION TESTS

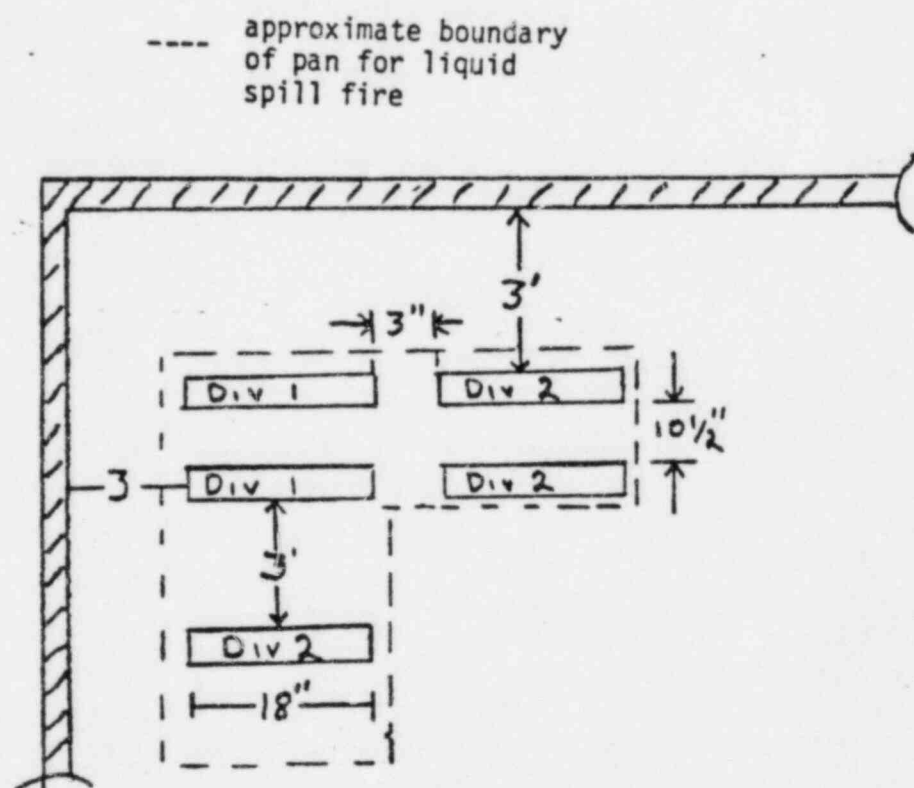
The configuration of the fire test was selected to simulate a section of a plant area with vertical cable trays containing redundant safety divisions arranged such that the redundant divisions could be simultaneously exposed to a potential fire resulting from an inadvertent spill of flammable liquid in the area. The arrangement of the cable trays and the designation of the redundant tray divisions is shown in Figure 1 taken from the User Request Memorandum.^{1/} Figure 2 shows the location of the fire detectors and the three groups of sprinklers. Each of the five cable trays was enclosed in a separate mineral wool blanket fire barrier from floor to ceiling in accordance with the manufacturers specifications currently recommended to their customers. The sprinkler and detector arrangement was as permitted by NFPA Code.

At about 3 minutes there was an indication of a short circuit in cable trays 3, and after 7 minutes indication of a short in tray 1. After 5-7 minutes the height of the flames appeared to subside; however, residual flames continued for about 40 minutes. It was reported that apparently the highest measured temperature inside any cable bundle was less than 150 F; however, damage to the cables indicates that higher temperatures were reached in the trays at the bottom regions, below the location of the thermocouples.

Test results are still being analyzed and no firm conclusions can be drawn at this time. Preliminary information received from RES subsequent to the test indicates that the flammable liquid or flames penetrated an opening in the protective barriers at the bottom of the vertical trays and caused fire damage to the PVC cables in four of the five trays. The electrical short to ground that occurred in cable tray 3 probably was caused by the fire. The second electrical short in tray 1 apparently was caused by a broken instrument connection, and is not considered to be related directly to the fire. On subsequent 500-volt megger tests, it was found that another cable in tray 2 had also experienced some damage.

The most probable cause of the fire damage in certain cable trays appears to be related to the absorption and/or seepage of heptane under the mineral wool blanket at the juncture with the floor. Once the heptane entered the interior regions of the cable tray, then ignition apparently occurred via the small opening at the floor or through a vapor/air path within the joints. It is believed that this type of failure mode could be prevented by using a seal material that would prevent the absorption or the seepage of heptane under the mineral wool blanket. There is some indication that some cable damage was caused by absorption of the inside of the barrier (wicking effect) which heated a cable tray ladder, causing damage to a cable in contact with the ring. The investigation of the results is still underway, and while no definitive findings can be stated, damage did occur to cables in several trays due to the fire. The slow response of the sprinkler system was not predicted. The ingress of the heptane into the mineral wool needs to be further evaluated since this appears to be the most significant failure mode.

Vertical Tray Corner Test

The test results are still being analyzed and it would be premature to establish firm conclusions at this time; however, the results now available indicate: (a) fire detectors located approximately 15 feet away from the fire promptly (~ 15 sec) detected the fire; (b) some small fires may not actuate sprinkler heads; and (c) protective barriers should be designed to prevent the entry of flammable liquids.
