SUBJECT: THE OPERATING REACTORS EVENTS MEETING  
 OCTOBER 10, 1990 - MEETING 90-25

OPERATING REACTORS EVENTS BRIEFING 90-25  
EVENTS ASSESSMENT BRANCH

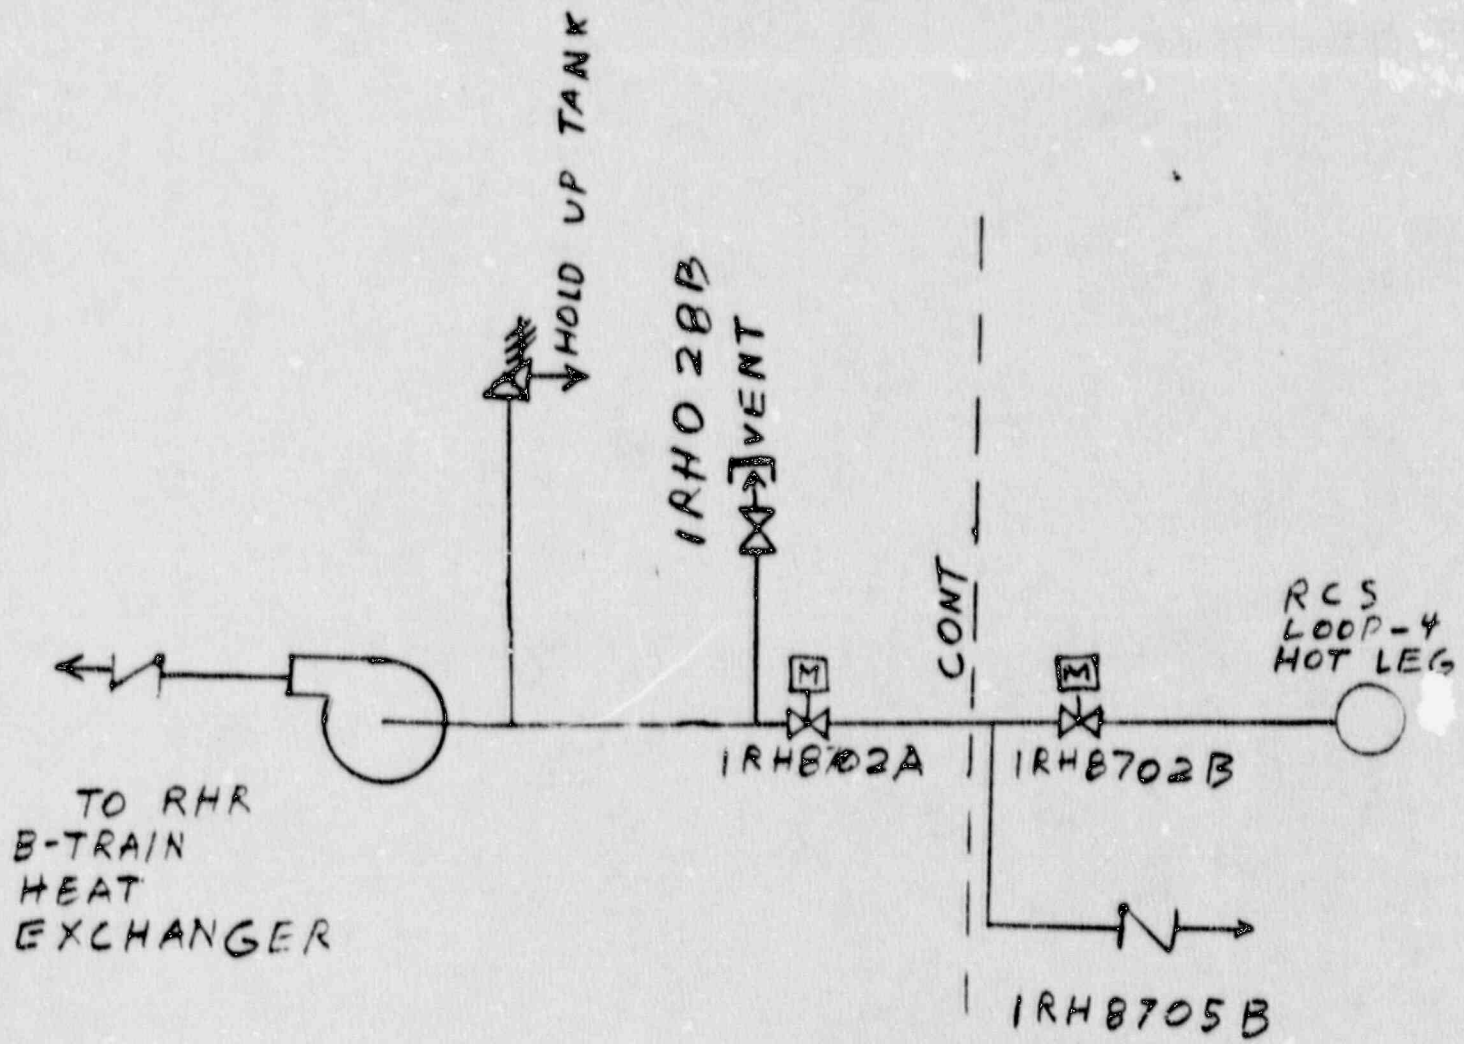
BRAIDWOOD UNIT 1  
RHR B-TRAIN

REACTOR COOLANT LEAK INTO AUX BUILDING CONTAMINATED THREE INDIVIDUALS.

PREMATURE OPENING OF 1RH8702B HOT LEG ISOLATION VALVE WITH THE VENT VALVE IN THE SAME LINE STILL OPEN.

- o PLANT IN MAINTENANCE OUTAGE SINCE 09/29/90 TO INVESTIGATE SPURIOUS SAFETY INJECTION SIGNALS.
- o REQUIRED SURVEILLANCES BEING PERFORMED ON THE RHR SUCTION ISOLATION VALVES.
  - INDIVIDUAL VALVE LEAK TESTING.
  - STROKE TIME TESTING.
- o REACTOR SYSTEM AT 360 PSIG AND 180 F.
- o THE REDUNDANT RHR TRAINS HAVE INDEPENDENT SUCTION LINES FROM THE HOT LEGS.
- o ON THE B-RHR TRAIN WITH SUCTION VALVE 1RH8702A OPEN, LEAKAGE THROUGH CLOSED 1RH8702B BEING COLLECTED AND MEASURED THROUGH VENT VALVE 1RH028B.
- o LEAKAGE TEST REPORTED TO BE COMPLETED.
- o VENT VALVE 1RH028B REQUESTED TO BE CLOSED.
- o ISOLATION VALVE 1RH8702B OPENED FROM THE CONTROL ROOM FOR STROKE TIME TESTING.
- o VENT VALVE 1RH028B NOT YET CLOSED.

- o TYGON MEASURING TUBE BROKE LOOSE.
- o TWO TEST ENGINEERS SPRAYED WITH COOLANT, ONE EQUIPMENT ATTENDANT WAS BURNED (ALL THREE WERE CONTAMINATED).
- o 620 GALLONS OF COOLANT LEAKED INTO AUX BUILDING.
- o 5% LOSS IN PZR LEVEL.

- o AIT SENT TO THE SITE TO INVESTIGATE EVENT INCLUDING ROOT CAUSE; ADEQUACY OF OPERATOR PERFORMANCE, PROCEDURES AND ADMINISTRATIVE CONTROLS.
- o CONFIRMATORY ACTION LETTER ISSUED TO LICENSEE BY REGION III.

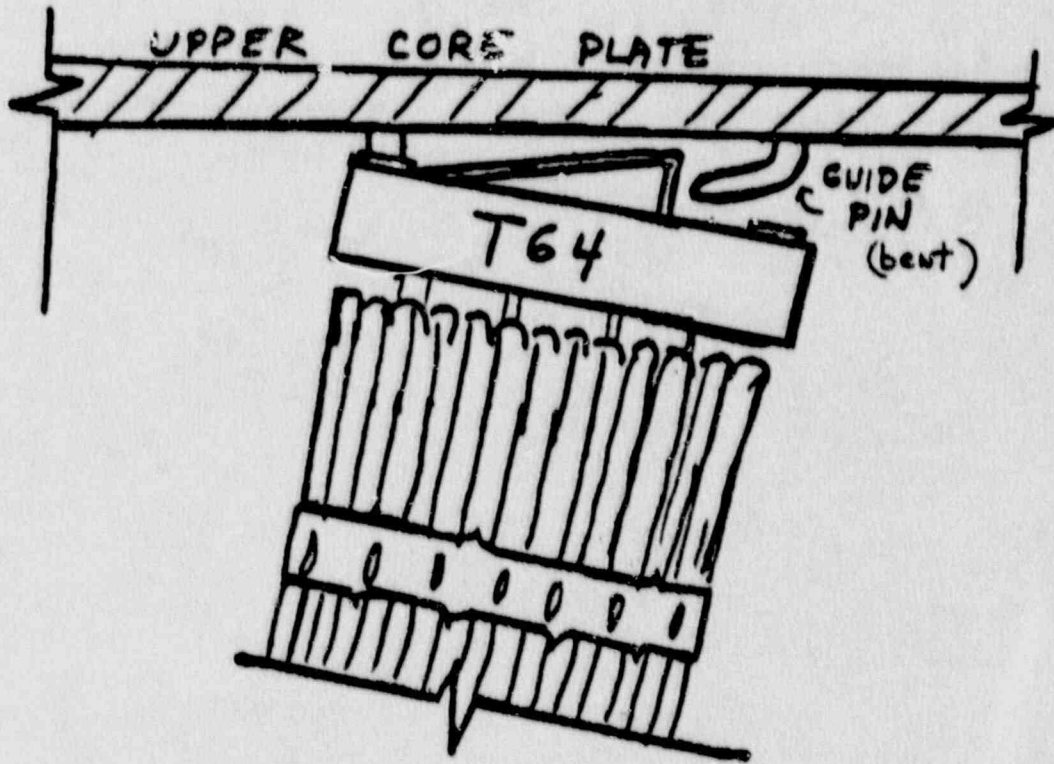
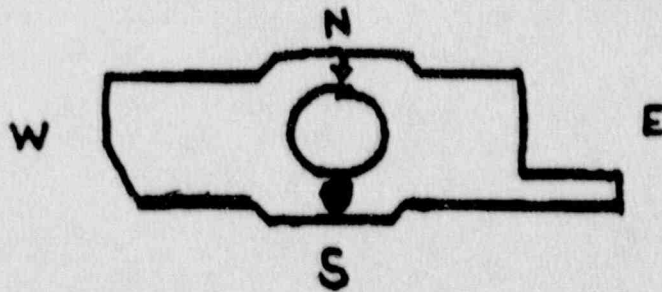
ASSEMBLY B-13

ON OCTOBER 4, 1990, THE LICENSEE DISCOVERED, WHILE LIFTING THE UPPER CORE INTERNALS, TWO FUEL ASSEMBLIES HAD BEEN INADVERTENTLY LIFTED FROM THE CORE AND REMAINED ATTACHED TO THE BOTTOM OF THE UPPER CORE INTERNALS.

- o ON OCTOBER 4, 1990, WHILE IN REFUELING (MODE 6), TWO FUEL BUNDLES WERE DISCOVERED HANGING FROM THE BOTTOM OF UPPER CORE PLATE DURING REMOVAL OF THE UPPER INTERNALS PACKAGE.
- o THE BOTTOM OF THE FUEL ASSEMBLIES ARE APPROXIMATELY 3'11" OVER THE TOP OF THE CORE AND THE UPPER INTERNALS HAVE BEEN DISPLACED 66" EAST FROM THE INSTALLED POSITION.
- o THE TWO ASSEMBLIES ARE B-13 (CONTAINS A BURNABLE POISON ASSEMBLY) AND A-5 (CONTAINS A THIMBLE PLUG ASSEMBLY).
- o THE CRANE (LOAD CELL) DID NOT DETECT THE ADDED WEIGHT TO THE UPPER INTERNALS (128,000 LBS) FROM THE TWO ASSEMBLIES (1500 LBS, EACH). THIS WAS DUE TO THE WEIGHT OF THE ASSEMBLIES WITHIN THE NOISE BAND FOR WEIGHT ACCURACY OF THE LOAD CELL.

- o USING A REMOTE VIDEO SUBMERSIBLE, THE LICENSEE DETERMINED THAT ONE-OF-TWO GUIDE PINS (ON BOTH ASSEMBLY) IS BENT (AND NOT TOUCHING THE ASSEMBLY), WITH THE OTHER GUIDE PIN WEDGED INTO THE ASSEMBLY, SUCH THAT THE ASSEMBLY IS COCKED AT ABOUT A 7 DEGREE ANGLE TO THE UPPER CORE PLATE.

- o THE LICENSEE'S FUTURE PLAN OF ACTION INCLUDES:
  1. PERFORMING A STATIC LIFT OF THE UPPER INTERNALS ANOTHER 8 FT.
  2. MANUALLY ROTATING THE UPPER INTERNALS SUCH THAT THE ASSEMBLIES WILL BE POSITIONED OUTSIDE OF THE VESSEL AND CAVITY SEAL.

3. MOVING THE UPPER INTERNALS TO THE DEEP-END OF THE REFUELING CAVITY AND LOWERING THE ASSEMBLIES INTO TWO FABRICATED STEEL BASKETS (16" DIAMETER PIPING) WITH HOLES DRILLED INTO THE BASKETS FOR WATER SEEPAGE. THE BASKETS WILL REST ON A TABLE CONSTRUCTED FOR THIS PURPOSE.

4. ATTEMPT TO FREE THE ASSEMBLIES.
- o A CONFIRMATORY ACTION LETTER (CAL) HAS BEEN ISSUED TO THE LICENSEE AND REQUESTS THE LICENSEE TO PROVIDE A PLAN OF ACTION AND NRC AGREEMENT BEFORE TAKING FURTHER ACTION.

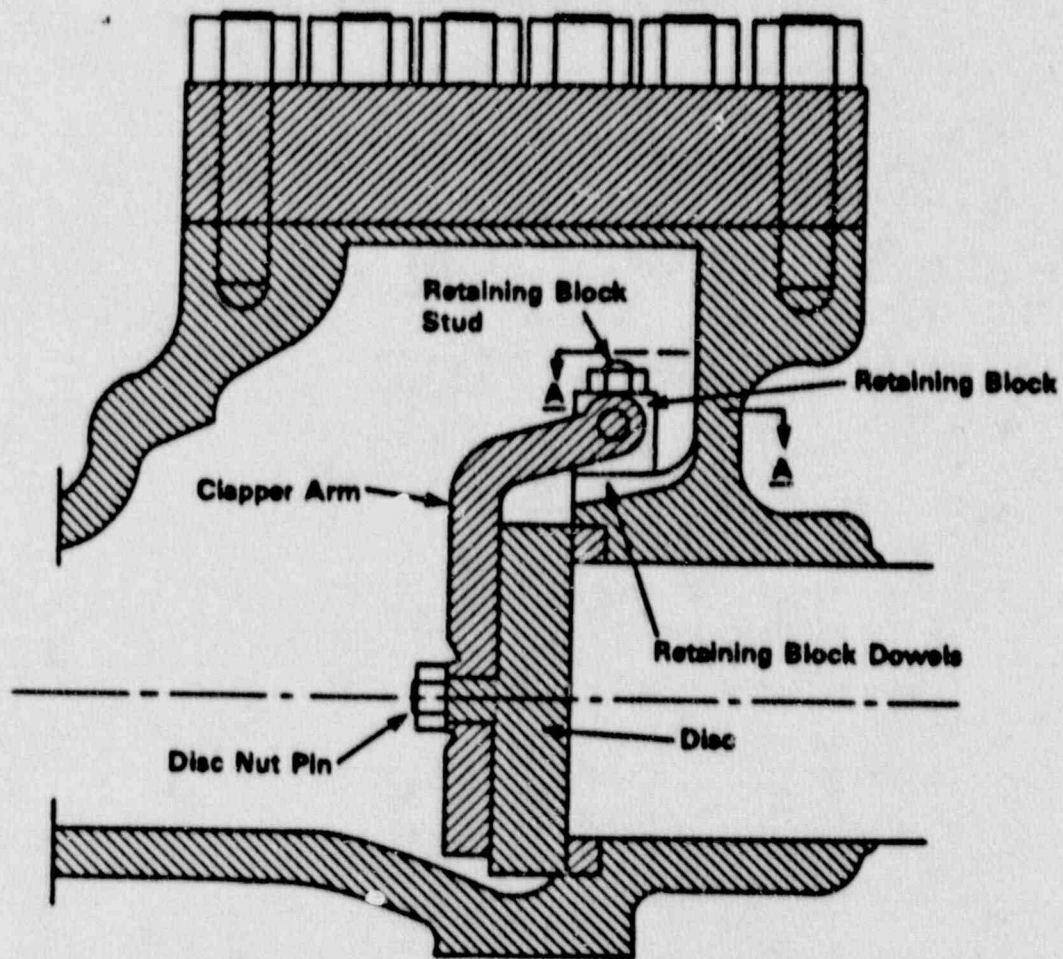
SEQUOYAH UNIT 1

THE LICENSEE FOR UNIT 1 DISCOVERED THAT 3 OF 4 MAIN STEAM LINE CHECK VALVES HAD DISC NUT PIN FAILURES WITH ONE OF THE VALVE DISCS LOCATED DOWNSTREAM OF THE VALVE BODY.

- o THE X-RAY SHOWED THAT THE CHECK VALVE DISC HAD SEPARATED.
- o FURTHER SURVEILLANCE BY THE LICENSEE DISCOVERED THAT 3 OF 4 CHECK VALVES HAD FAILED DISC PINS.

- o THE PINS WERE SHEARED WHERE THE VALVE DISC MEETS THE FLAPPER ARM.
- o ONE VALVE (UPON DISASSEMBLY) REVEALED THAT THE DISC HAD TRAVELLED SOME DISTANCE IN THE MAIN STEAM PIPING AFTER ITS DISC PIN FAILED.

- o THREE OF THE FOUR VALVES ON UNIT 1 HAD BEEN MODIFIED. THE MODIFIED VALVES FAILED. NO FAILURES INDICATED ON THE UN-MODIFIED VALVES.
- o THE MODIFICATION WAS TO PUT A RETAINING PIN THROUGH THE DISC NUT TO PREVENT THE NUT FROM LOOSENING.

- o AIT SENT TO THE SITE ON 10-09-90.
- o EAB WILL FOLLOW THIS EVENT TO DETERMINE GENERIC SIGNIFICANCE AND FURTHER ACTION.
