UNITED STATES
 NUCLEAR REGULATORY COMMISSION
 REGION III
 799 ROOSEVELT ROAD
 GLEN ELLYN, ILLINOIS 60137

IE Circular No. 78-18
November 6, 1978

UL FIRE TEST

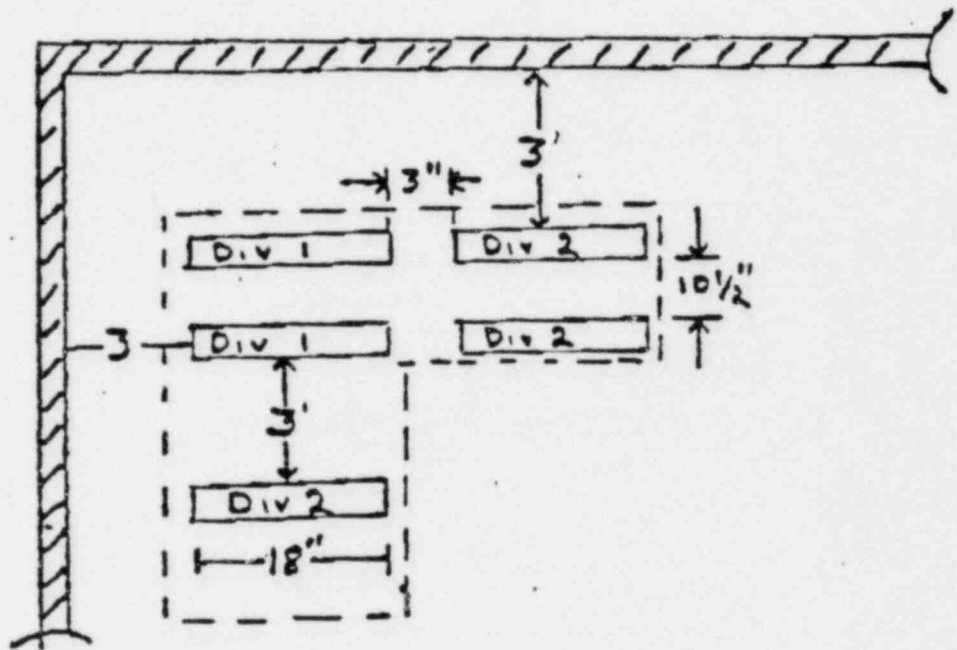
Figure 1

Preliminary information indicates that the flammable liquid or flames penetrated the protective barriers at the bottom of the vertical trays and caused fire damage to the polyvinyl chloride insulation on cables in four of the five trays.

The most probable cause of the fire damage in certain cable trays appears to be related to the absorption or seepage of heptane under the ceramic fiber blanket at the juncture with the floor. Once the heptane entered the interior regions of the cable tray, then ignition apparently occurred via the small opening at the floor or through a vapor/air path within the joints. There is some indication that some cable damage was caused by absorption of heptane on the inside of the barrier (wicking effect) and its ignition which heated a cable tray ladder rung, causing damage to a cable in contact with the rung. The ingress of the heptane into the ceramic fiber needs to be further evaluated since this appears to be the most significant failure mode.

--- approximate boundary
of pan for liquid
spill fire

1. To protect against spills of flammable liquids, barriers or curbs may be needed to prevent entry of the flammable liquid behind fire barriers. A wick effect may also need to be considered in the design of fire barriers.
2. Some small fires may not actuate sprinkler heads. To reduce this possibility in sprinkler systems to be installed, fast response sprinkler heads should be considered (less than approximately 3 minutes in the UL Standard 199 "Automatic Sprinklers for Fire Protection Service").
3. The location of the fire detection devices and the sprinkler heads relative to the fire and components being protected is of great importance. The path of the air movement in the area influences the actuation of such devices and should be considered in the system layout.

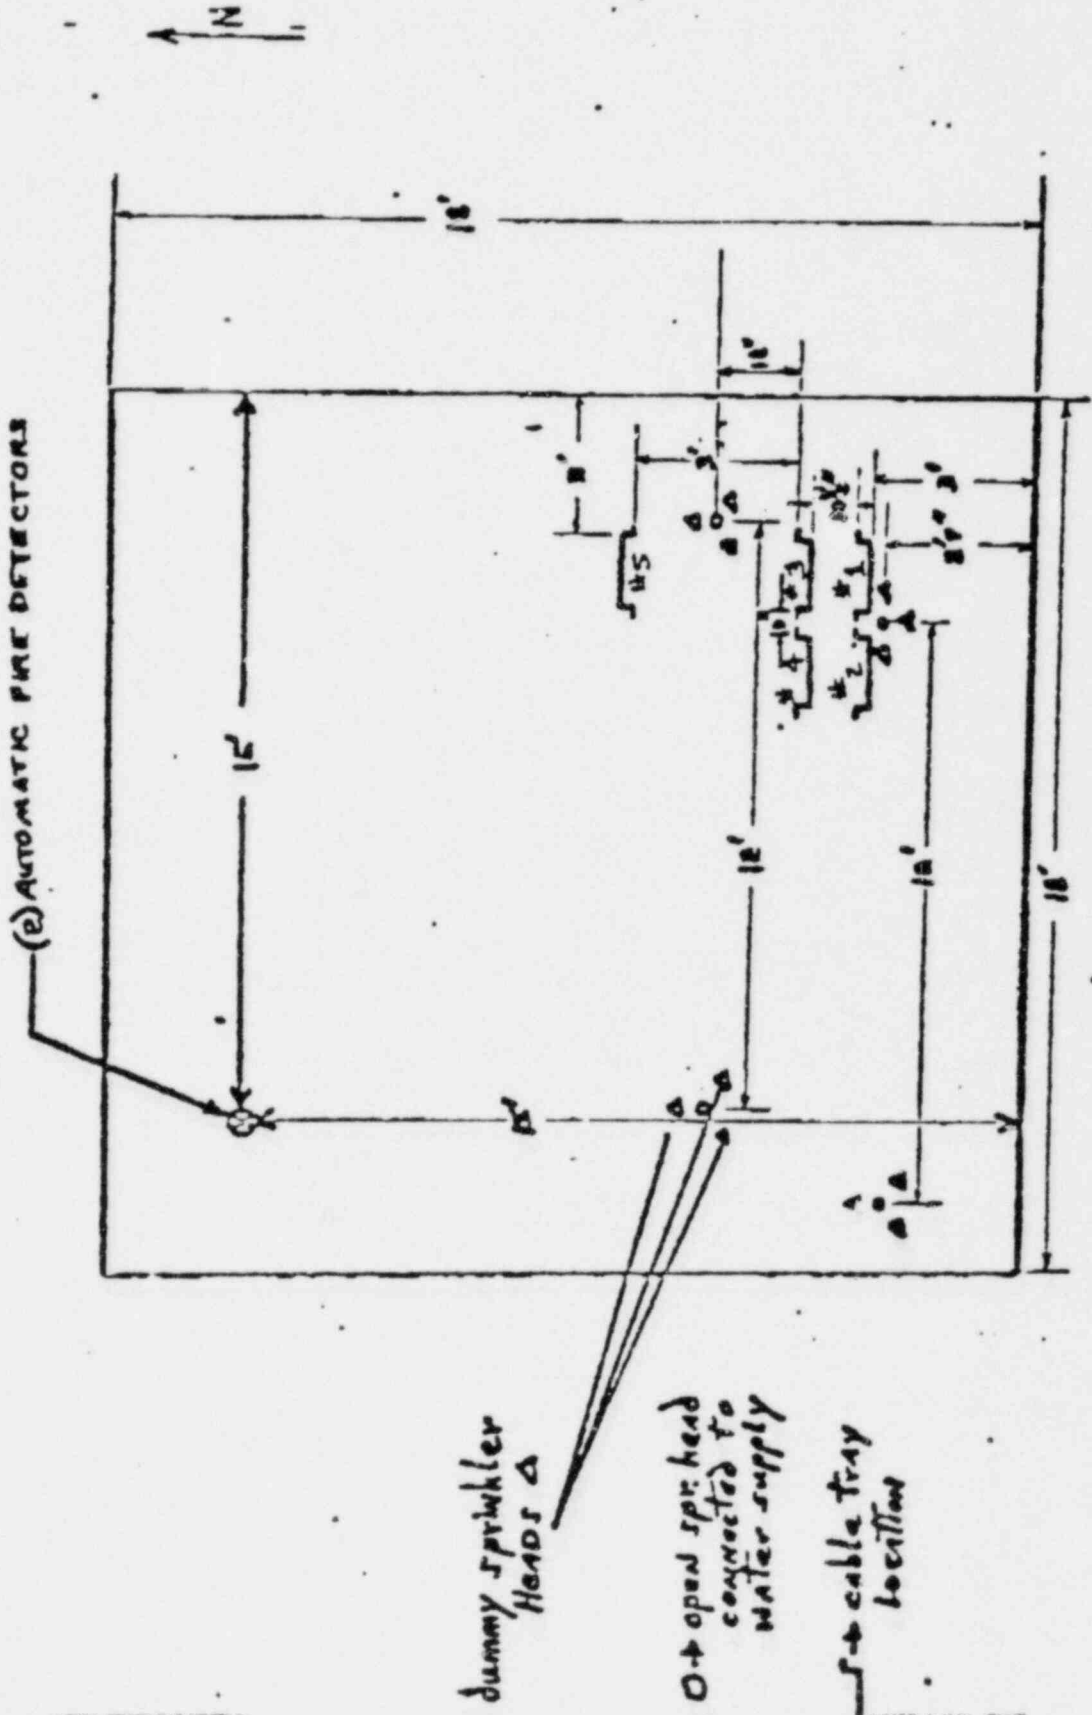
FIGURE 2
TOP VIEW GENERAL

Each sprinkler location in the test arrangement contained three nominally identical temperature sensing sprinkler heads with fusible links adjacent to an open sprinkler head which was connected to a manual water supply valve. The temperature sensing heads were wired to signal when their links fused. After all three temperature sensing heads at a given location activated, then the water supply for the open head was to be manually admitted. The sprinklers were of a type which actuate at the slow end of acceptance for reaction time. The test procedure required that all three temperature sensing heads had to activate before water would be turned on. In this way, it was expected to get some data on variability in the response time of identical sprinklers.

The test was started by igniting the two gallons of heptane that was poured into the floor pan. A fully developed fire occurred almost immediately. The ceiling smoke detector alarmed in about 15 seconds. In about 50-60 seconds, two of the three temperature sensing sprinklers located between the wall and cable trays 1 and 2 activated. The fire between cable trays 1, 2, 3, and 4 appeared most intense, apparently because of a chimney effect between the four trays. The flames between cable trays 3 and 5 did not appear to be so intense. The ceramic fiber blanket absorbed some of the heptane so that after the heptane in the pan burned, most of the flame seemed to come from the bottom outside surface of the ceramic fiber blanket. No additional temperature sensing sprinkler heads at any location activated; thus, the sprinkler water supply was not turned on for any of the three sprinkler locations. The apparent slow response of the third temperature sensing sprinkler is being investigated, since this was not intended to be a slow response sprinkler.
