U.S. NUCLEAR REGULATORY COMMISSION  
OFFICE OF INSPECTION AND ENFORCEMENT  
REGION III

IE Circular No. 78-18  
November 6, 1978

UL FIRE TEST

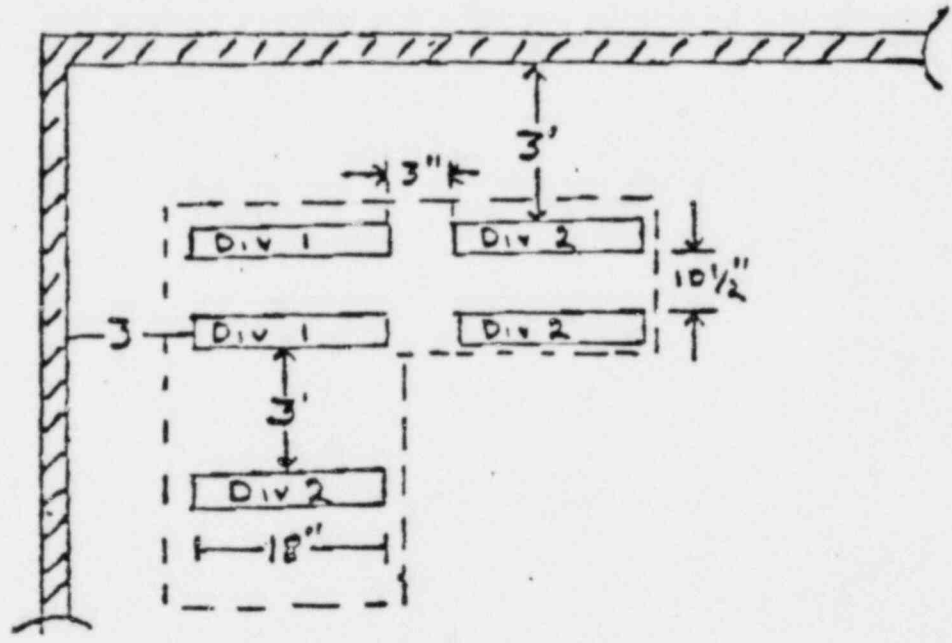
Figure 1

Preliminary information indicates that the flammable liquid or flames penetrated the protective barriers at the bottom of the vertical trays and caused fire damage to the polyvinyl chloride insulation on cables in four of the five trays.

The most probable cause of the fire damage in certain cable trays appears to be related to the absorption or seepage of heptane under the ceramic fiber blanket at the juncture with the floor. Once the heptane entered the interior regions of the cable tray, then ignition apparently occurred via the small opening at the floor or through a vapor/air path within the joints. There is some indication that some cable damage was caused by absorption of heptane on the inside of the barrier (wicking effect) and its ignition which heated a cable tray ladder rung, causing damage to a cable in contact with the rung. The ingress of the heptane into the ceramic fiber needs to be further evaluated since this appears to be the most significant failure mode.

--- approximate boundary  
of pan for liquid  
spill fire

Vertical Tray Corner Test

1. To protect against spills of flammable liquids, barriers or curbs may be needed to prevent entry of the flammable liquid behind fire barriers. A wick effect may also need to be considered in the design of fire barriers.
2. Some small fires may not actuate sprinkler heads. To reduce this possibility in sprinkler systems to be installed, fast response sprinkler heads should be considered (less than approximately 3 minutes in the UL Standard 199 "Automatic Sprinklers for Fire Protection Service").
3. The location of the fire detection devices and the sprinkler heads relative to the fire and components being protected is of great importance. The path of the air movement in the area influences the actuation of such devices and should be considered in the system layout.
