SUBJECT: IRS REPORTS

<i>Title - Titre</i>	
Effects of Fire Protection System Actuation on Safety-Related Equipment	
<i>Country - Pays</i>	<i>Date of Incident - Date de l'incident</i>
United States	Numerous
	<i>Type of Reactor - Type de réacteur</i>
	_____
<i>Plant - Centrale</i>	<i>Licensee - Détenteur du permis d'exploitation</i>
Numerous	_____
<i>Unit N° - Tranche n°</i>	<i>Manufacturer - Fabricant</i>
	_____
<i>Power - Puissance</i>	<i>First Commercial Operation -</i>
_____ MWe(net)	<i>Date de mise en service</i>
<i>Systems or Components Affected - Systèmes ou composants affectés</i>	
_____	
<i>Initial Plant Condition - Etat initial de la tranche</i>	
_____	
<i>Way in which Incident was Detected ?</i>	
<i>Comment l'incident a-t-il été détecté ?</i>	
_____	
<i>Radiation Exposure or Radioactivity Release -</i>	
<i>Exposition aux rayonnements ou libération de radioactivité</i>	
_____

<i>Title - Titre</i>	
Water in Diesel Generator Fuel Oil Storage Tanks	
<i>Country - Pays</i>	<i>Date of Incident - Date de l'incident</i>
United States	May 28, 1981
	<i>Type of Reactor - Type de réacteur</i>
	PWR
<i>Plant - Centrale</i>	<i>Licensee - Détenteur du permis d'exploitation</i>
Surry	Virg

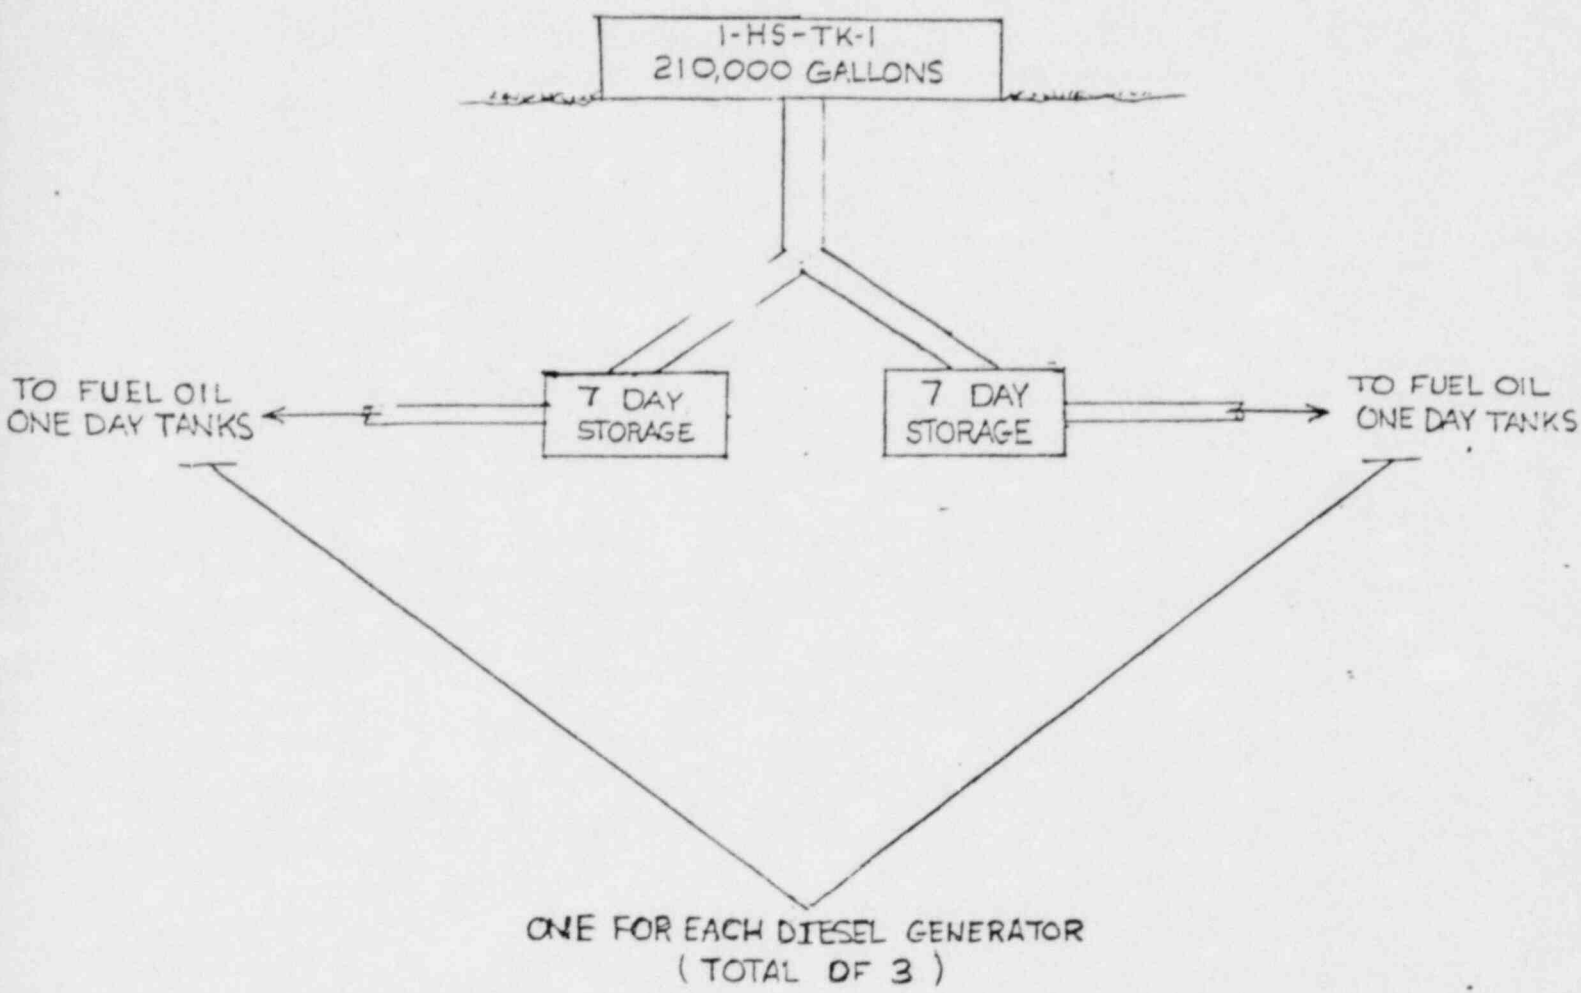
FIGURE 1

There are three diesel generators that serve both Units 1 and 2 at Surry. The generators are supplied with diesel fuel by the system shown in Figure 1. There is one above ground tank (1-HS-TK-1) which supplies fuel for two underground seven-day storage tanks. The underground tanks then supply the one-day storage tanks (each line of the underground tanks feeds all three one-day tanks). The one-day tanks then supply the diesel generators.

On May 28, 1981, a routine sample of one of the underground tanks revealed excess water. It was determined that water from the fire suppression system was inadvertently added to the above ground tank.

The fire suppression system employs a foam suppressant which is mixed with water. The water flows from a fire hydrant through a manual valve in two inch pipe through a foam induction nozzle to a sparger inside the fuel tank. The operation of the system requires the manual connection of the foam cannister to the nozzle and opening the manual valve and fire hydrant. The addition of water to the tank occurred when a hose was connected to the fire hydrant to test the reactor shield tank prior to its installation. Evidently, the manual valve was open, which provided a flow path to the fuel storage tank after the hydrant was opened. After the water had been added to the storage tank the tank was isolated and fuel oil was drained until the sample showed negligible amounts of water. However, the sample was not taken from the lowest elevation of the tank, which resulted in water accumulating in the underground and day tanks.

The cause of this event has been determined to be inadequate administrative controls for the fire suppression system.

Immediate action taken was to drain the water via the transfer suction strainer drains. Subsequently all tanks were sampled and the water content was within allowable limits.

1. Administrative controls to restrict use of fire hydrant to only fire protection.
2. Monthly surveillance procedures to test the diesel fuel oil above ground, underground, and day tanks for water. Additional surveillance testing is required if the fire hydrant has been opened.

3. The manual valve in the water supply piping is locked closed and tagged.
4. A drain line downstream of the foam induction nozzle is locked-open to indicate water leakage into the fire suppression system. Daily surveillance requirement on the drainline has been added to the operator's log. Corrective action has been specified when leakage is detected.
5. The surveillance procedure for the monthly test identifies the sample location by valve number corresponding to the lowest elevation in the tank.
