UNITED STATES  
NUCLEAR REGULATORY COMMISSION  
OFFICE OF INSPECTION AND ENFORCEMENT  
WASHINGTON, D. C. 20555

IE Circular 78-18  
Date: November 6, 1978  
Page 1 of 3

UNDERWRITERS LABORATORY FIRE TEST

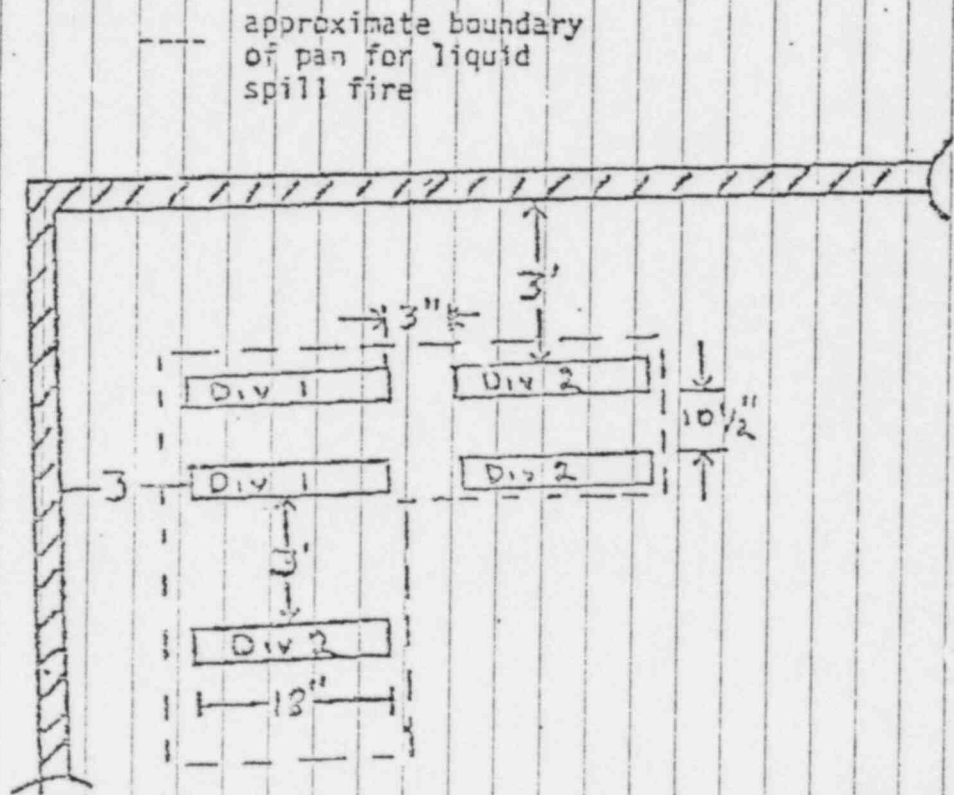
Figure 1

Preliminary information indicates that the flammable liquid or flames penetrated the protective barriers at the bottom of the vertical trays and caused fire damage to the polyvinyl chloride insulation on cables in four of the five trays.

The most probable cause of the fire damage in certain cable trays appears to be related to the absorption or seepage of heptane under the ceramic fiber blanket at the juncture with the floor. Once the heptane entered the interior regions of the cable tray, then ignition apparently occurred via the small opening at the floor or through a vapor/air path within the joints. There is some indication that some cable damage was caused by absorption of heptane on the inside of the barrier (wicking effect) and its ignition which heated a cable tray ladder rung, causing damage to a cable in contact with the rung. The ingress of the heptane into the ceramic fiber needs to be further evaluated since this appears to be the most significant failure mode.

Vertical Tray Corner Test

1. To protect against spills of flammable liquids, barriers or curbs may be needed to prevent entry of the flammable liquid behind fire barriers. A wick effect may also need to be considered in the design of fire barriers.
2. Some small fires may not actuate sprinkler heads. To reduce this possibility in sprinkler systems to be installed, fast response sprinkler heads should be considered (less than approximately 3 minutes in the UL Standard 199 "Automatic Sprinklers for Fire Protection Service").
3. The location of the fire detection devices and the sprinkler heads relative to the fire and components being protected is of great importance. The path of the air movement in the area influences the actuation of such devices and should be considered in the system layout.

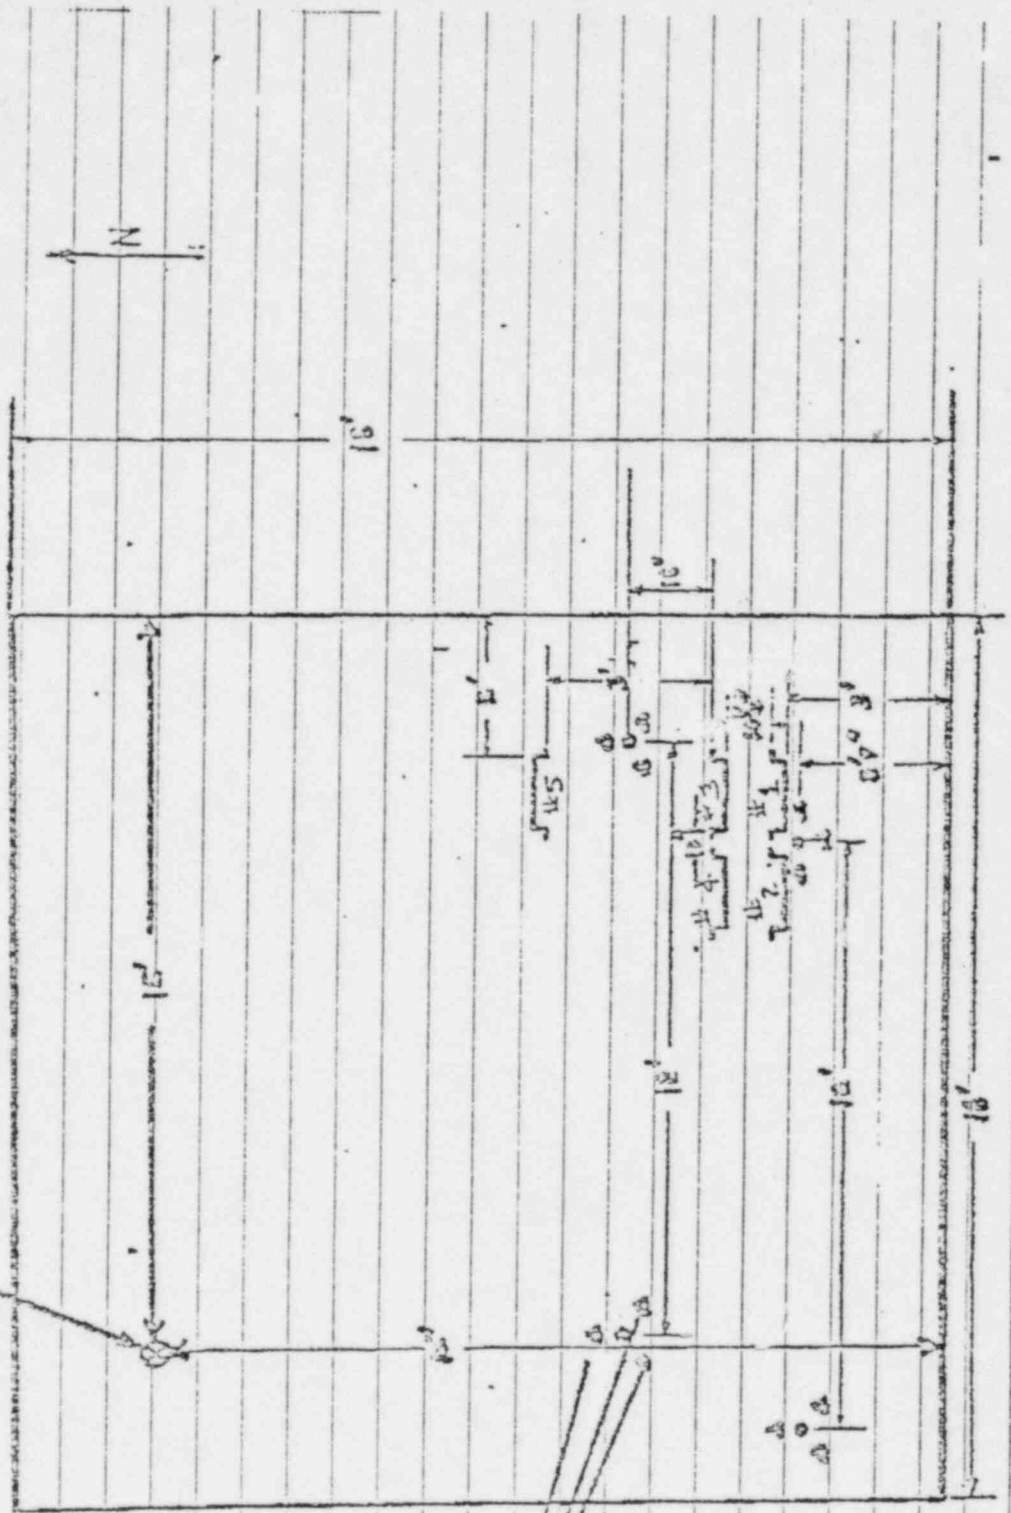
FIGURE 2  
TOP VIEW GENERAL

Each sprinkler location in the test arrangement contained three nominally identical temperature sensing sprinkler heads with fusible links adjacent to an open sprinkler head which was connected to a manual water supply valve. The temperature sensing heads were wired to signal when their links fused. After all three temperature sensing heads at a given location activated, then the water supply for the open head was to be manually admitted. The sprinklers were of a type which activate at the slow end of acceptance for reaction time. The test procedure required that all three temperature sensing heads had to activate before water would be turned on. In this way, it was expected to get some data on the variability in the response time of identical sprinkler heads.

The test was started by igniting the two gallons of heptane that were poured into the floor pan. A fully developed fire occurred almost immediately. The ceiling smoke detector alarmed in about 15 seconds. In about 50-60 seconds, two of the three temperature sensing sprinklers located between the wall and cable trays 1 and 2 activated. The fire between cable trays 1, 2, 3, and 4 appeared most intense, apparently because of a chimney effect between the four trays. The flames between cable trays 3 and 5 did not appear to be so intense. The ceramic fiber blanket absorbed some of the heptane so that after the heptane in the pan burned, most of the flame seemed to come from the bottom outside surface of the ceramic fiber blanket. No additional temperature sensing sprinkler heads at any location activated; thus, the sprinkler water supply was not turned on for any of the three sprinkler locations. The apparent slow response of the third temperature sensing sprinkler is being investigated, since this was not intended to be a slow response sprinkler.
