November 5, 1990

Subject: Docket No. 50-89: Reactor Facility License No. R-38; Reportable Occurrence

REG ROD CONNECTING ROD ASSEMBLY

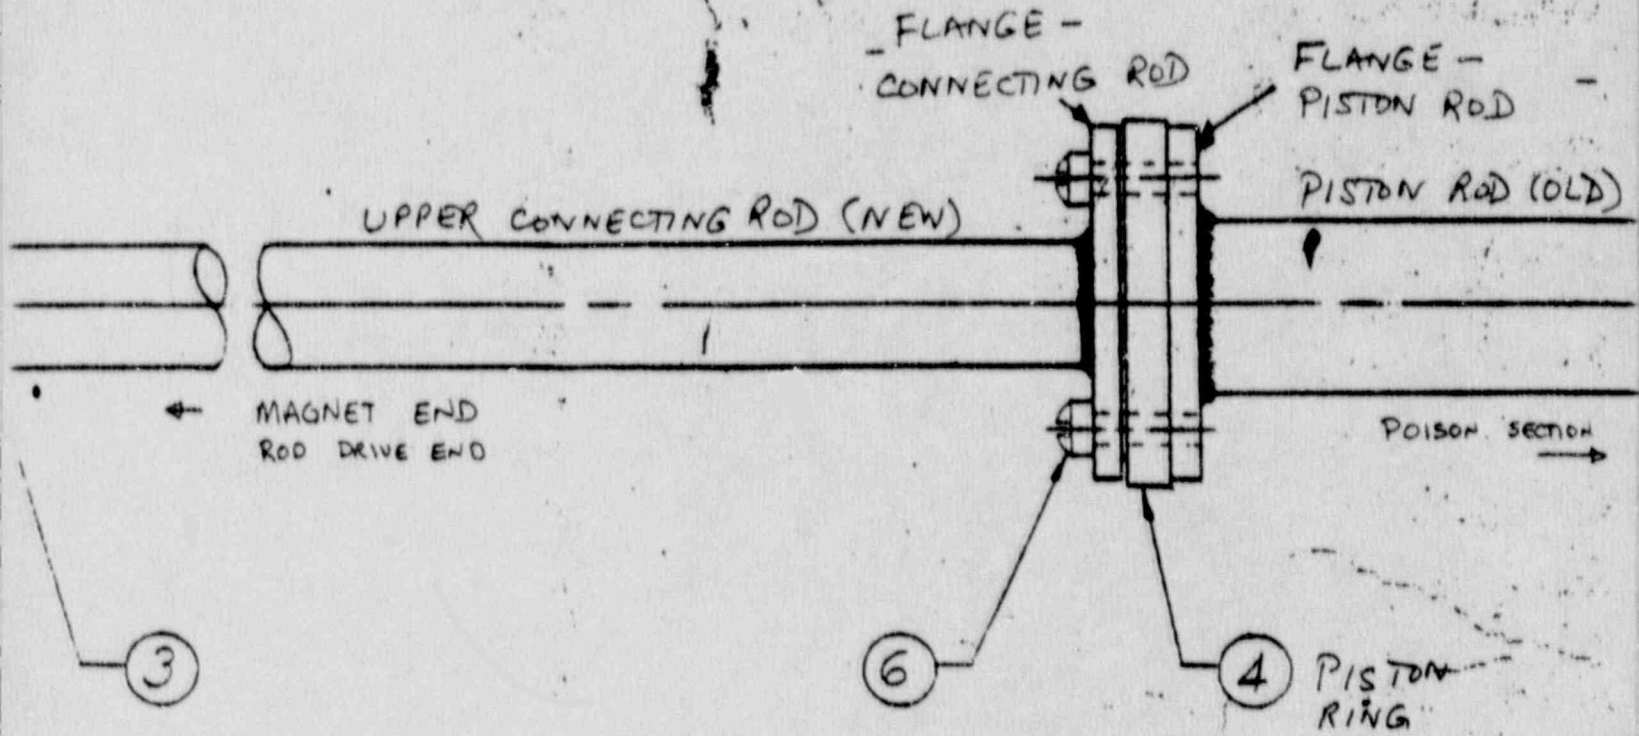
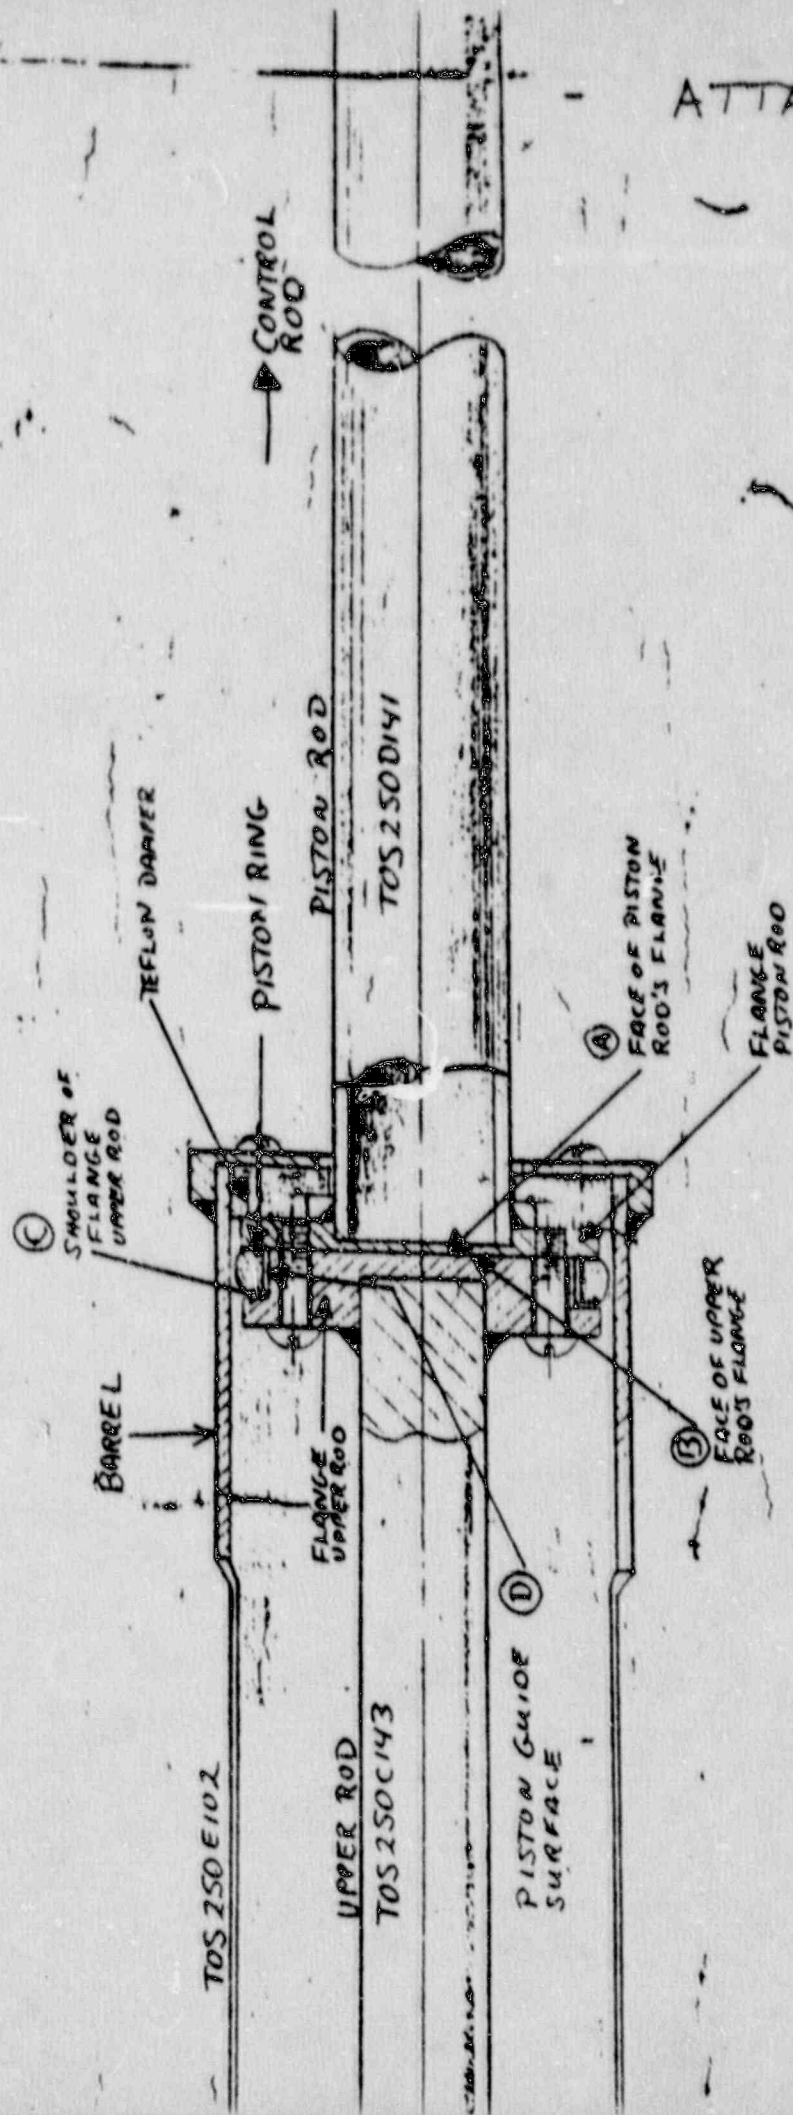
ATTACHMENT 1

Analysis and troubleshooting revealed that the problem was not in the magnet current interrupt switch, but in the control rod drive hardware. Part of the coupling assembly connecting the control rod to the drive mechanism was not properly aligned, which caused the rod drop times to be longer than expected. When the magnet current interrupt switch - which is not part of the scram loop on the reactor, but is used for momentary interruption of magnet current to drop individual rods - was used to drop the rod, the momentary interruption was inadequate to free the rod from the magnet, hence the rod did not drop. However, when the scram loop was opened by using the manual scram switch, magnet current was cut to the electromagnets, and the rod fell, although a fraction of a second (but noticeably) slower than other rods. Note however that the minimum scram time of two seconds or less continued to be met.

Upon removal and a careful evaluation of this assembly for the regulating rod, it was found that the old piston rod section had a noticeable bend ("wobble") in it when compared to the upper connecting rod. This wobble had a measured eccentricity of 1/4-inch (1/2-inch overall side to side motion). The cause of the wobble was found to be a slight misalignment at the flange section of the piston rod. This misalignment caused the lower connecting rod (piston rod) to slightly rub on the teflon washer located in the bottom of the barrel assembly, which slightly impeded the free motion of the rod.

The problem was corrected by machining the flange surfaces of both the piston and connecting rods to remove approximately 10 mils of metal from the surfaces. Doing this reduced the wobble to an eccentricity of about 10 mils (20 mils side to side motion), which is acceptable for proper control rod action.
