August 3, 1982

DOCKET 50-312
RANCHO SECO NUCLEAR GENERATING STATION UNIT NO. 1
AUXILIARY FEEDWATER HEADER REPAIR--ADDITIONAL INFORMATION

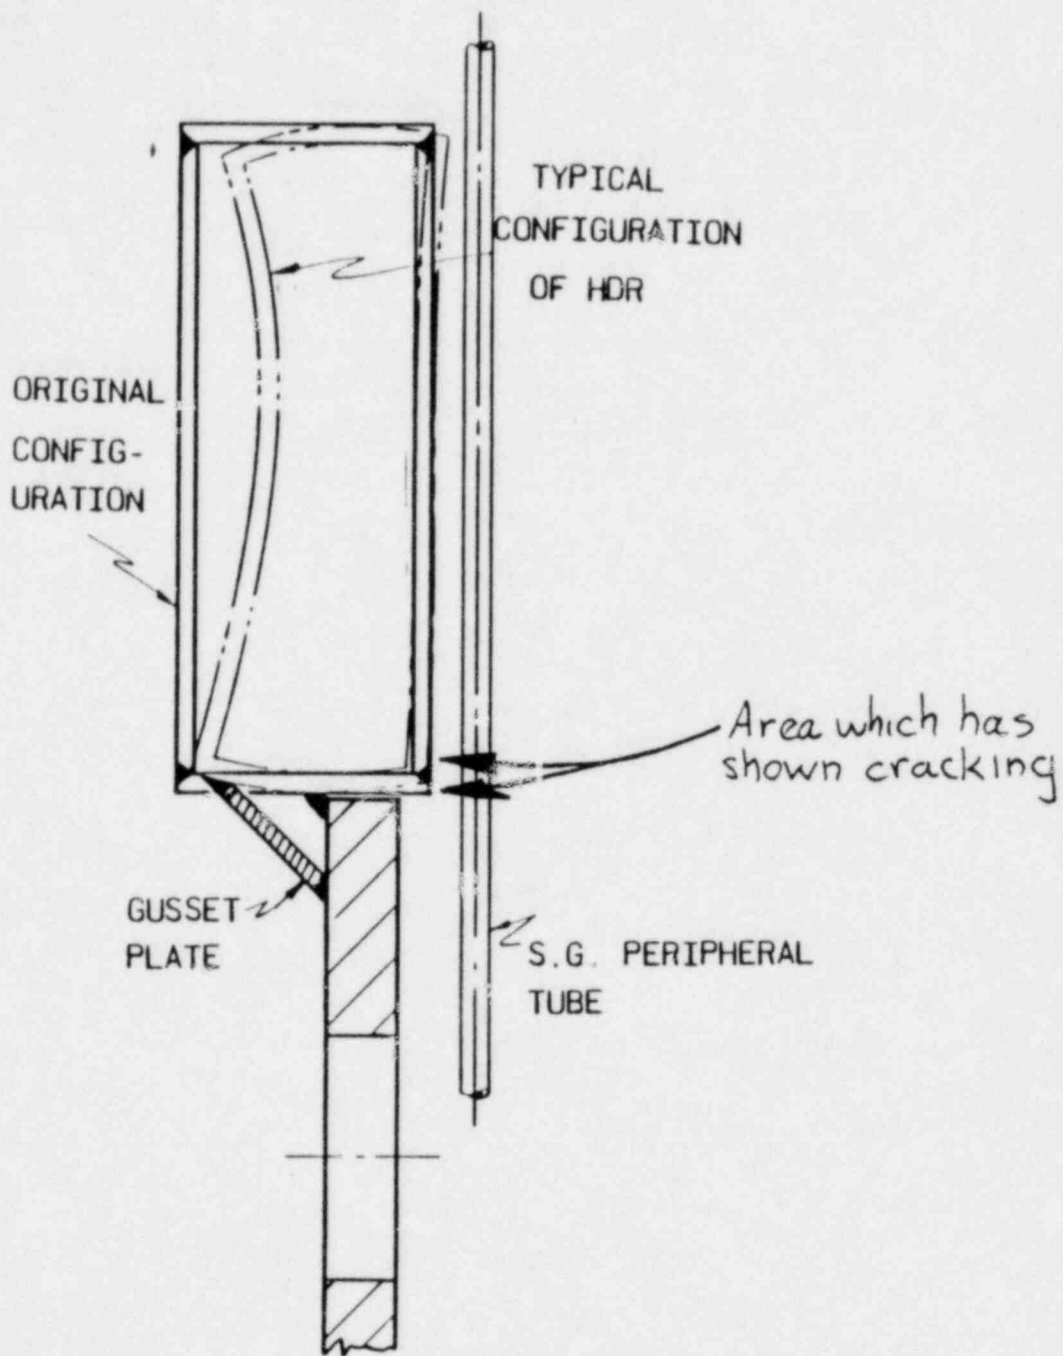
CROSS SECTION OF INTERNAL HEADER

During the course of an inspection, a crack was noted in the lower inside weld of the Internal Header in the "A" Steam Generator. The crack is approximately 20 inches long and is centered at one of the new Auxiliary Feedwater Penetrations. The crack runs along the lower inside weld which joins the inner plate to the bottom of the Internal Header.

Additional inspections have been performed through all of the new Steam Generator Auxiliary Feedwater Penetrations in both Steam Generators. These inspections have specifically looked for cracking in the upper and lower inside welds in the Internal Header. One additional crack was found. This crack was in the lower inside weld in the "B" Steam Generator and was found to extend for approximately 15 inches. The consequences of this imperfection are bounded by the analysis done on the 20-inch crack in the "A" Steam Generator.

The inspections which would have revealed cracking in the Internal Header welds are documented on the attached drawings. In addition, the specific Penetrations which have shown cracking are delineated. An additional sketch shows the weld area which has shown cracking.

Babcock and Wilcox has evaluated this flaw and has found it to be acceptable based on calculations done previously. In addition, B&W will perform an analysis of this flawed Header using a finite element analysis model to assure that the Header will be capable of withstanding any anticipated loads. This analysis will assume the highest anticipated loads would result from a steam line break.
