BAW-1732  
July 1, 1982

EVALUATION, REPAIR AND REPLACEMENT  
OF  
DAMAGED INTERNAL AUXILIARY FEEDWATER HEADER  
AT  
DAVIS BESSE 1, OCONEE 3 AND RANCHO SECO

50-346  
50-312  
50-287

**Babcock & Wilcox**

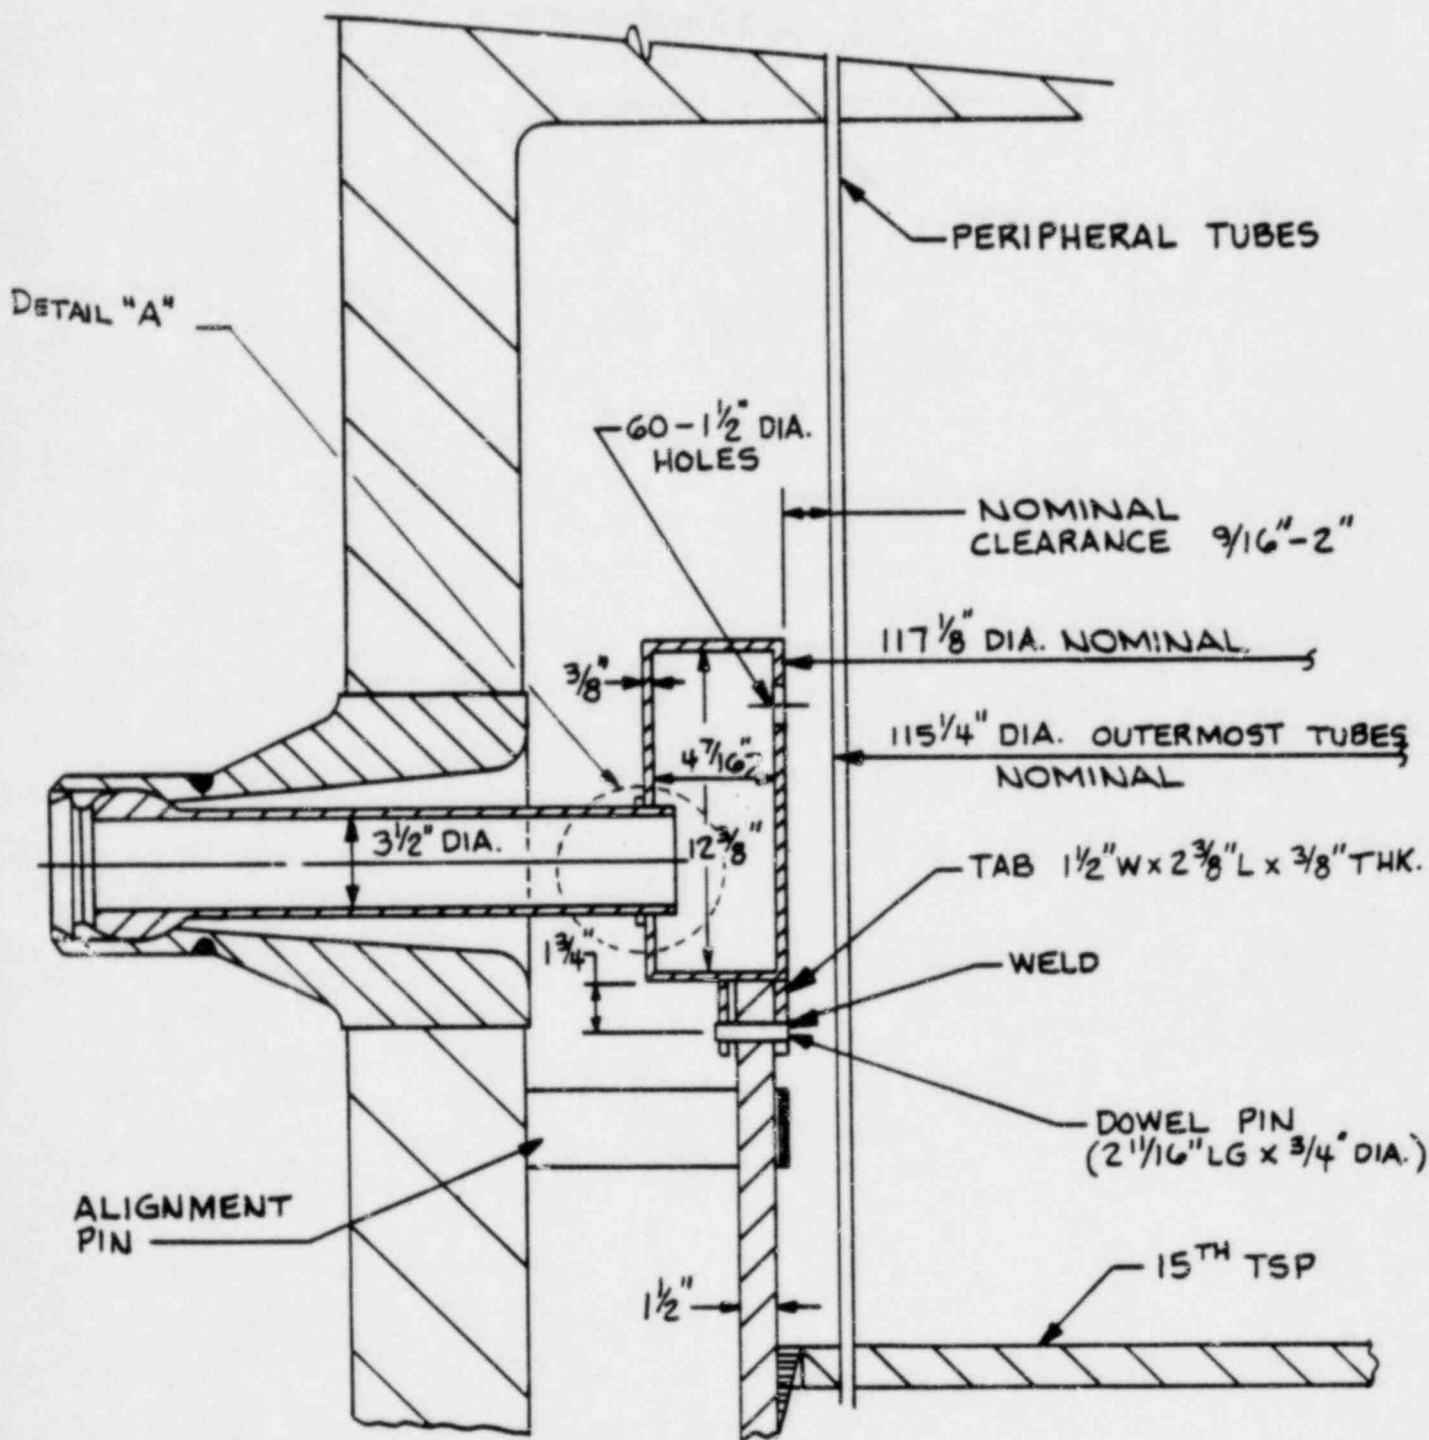
Figure 1-2  
 LONGITUDINAL SECTION OF INTERNAL  
 AFW HEADER AT DOWEL PIN

It should be noted that although Figure 1-2 indicates a possible nominal clearance of 9/16" to 2" in the original header design, there was no minimum clearance criteria defined. No minimum dimension was specified.

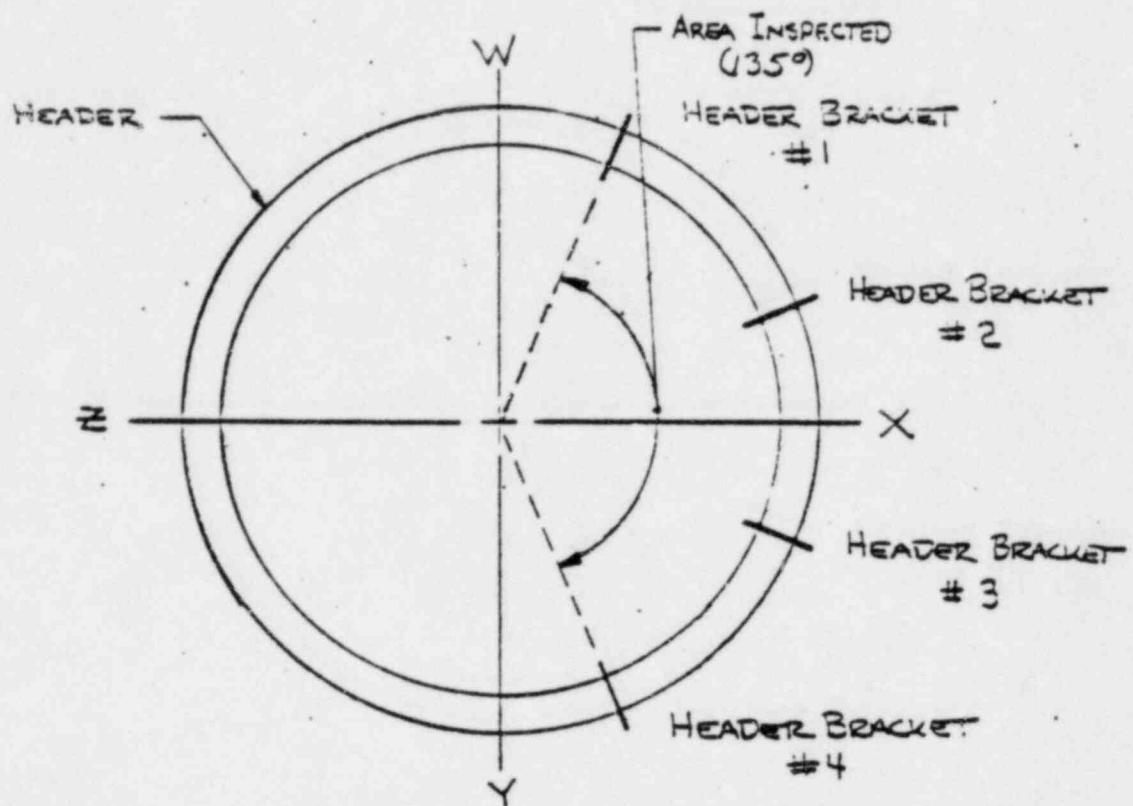
Fig. 2-1

With one exception, the inspection results from all three plants were generally similar. The outer vertical wall of the header was distorted inward toward the center of the generator, the support brackets were bent or damaged and the dowel pins were either out of position or missing. The exception was the presence of holes in the parent metal at the top and bottom plates of the headers at Oconee 3. Investigation of the holes in the Oconee 3 headers is continuing.

Clearances between the inner wall and inner brackets and peripheral tubes have been inferred at Davis Besse and Rancho Seco to be minimal. It is postulated that the distortion of the outer vertical wall of the header has led to some inward bowing of the inner vertical wall and movement of the top and bottom corners of the inside of the header closer to the peripheral tubes. This bowing was checked by feeling the inner wall at Davis Besse 1 and SMUD after machining the access holes. This movement along with distortion of the inner brackets could also account for the apparent reduction of inner bracket to peripheral tube clearance. The distortion of the header inner wall is indicated in Figure 2-1, 4-1, and 4-2.

A visual inspection of the internal headers, followed by a 360° remote video inspection, showed that the outer wall (shellside) of the header is distorted inward (concave) as much as 4 1/2". In addition, the inner vertical wall was noted to be bent inward in some locations. It was also noted that certain header support brackets were bent, the bottom ligament torn out, or were broken off and that there was evidence of wear and/or distress on dowel pins and brackets. Dowel pins were found to be not in place at the majority of the eight bracket locations in each of the steam generators (See Fig. 2-1). All brackets and all but one dowel pin have been located and retrieved. The missing dowel pin is not in the tube bundle or on the 15th tube.

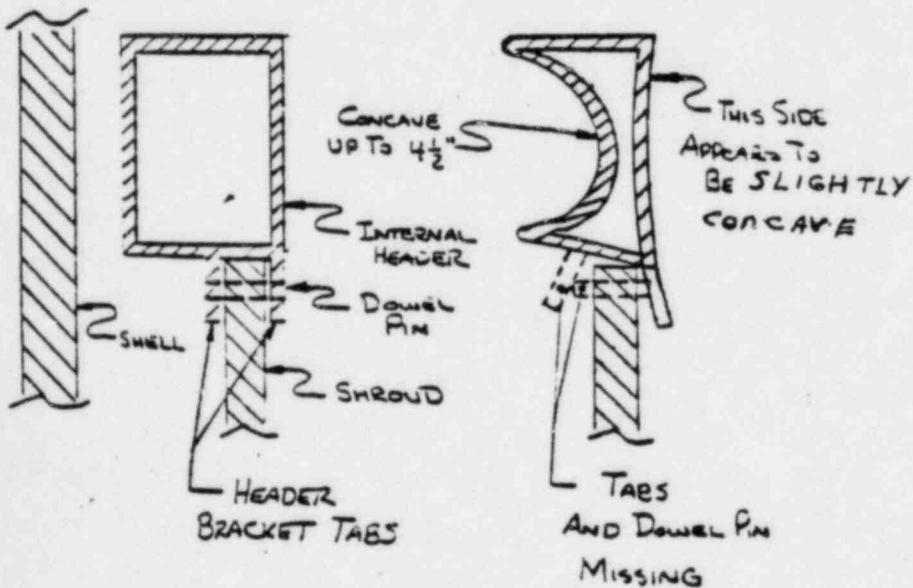
"AS MANUFACTURED"  
CONFIGURATION

WORST CASE  
CONFIGURATION

TYPICAL DAMAGE FOUND  
DURING INITIAL VISUAL INSPECTIONS
