MISSISSIPPI POWER & LIGHT COMPANY

NUCLEAR PRODUCTION DEPARTMENT

SUBJECT: Grand Gulf Nuclear Station
Units 1 and 2
Docket Nos. 50-416 and 50-417
License No. NPF-13
File 0260/0272/L-860.0
Reference: AECM-82/263
PMP Water Level Analysis,
Operating License Condition
2.C (5); SSER-2 1.11 (46)
AECM-82/440

EFFECTS OF PMP WATER LEVEL ON GGNS

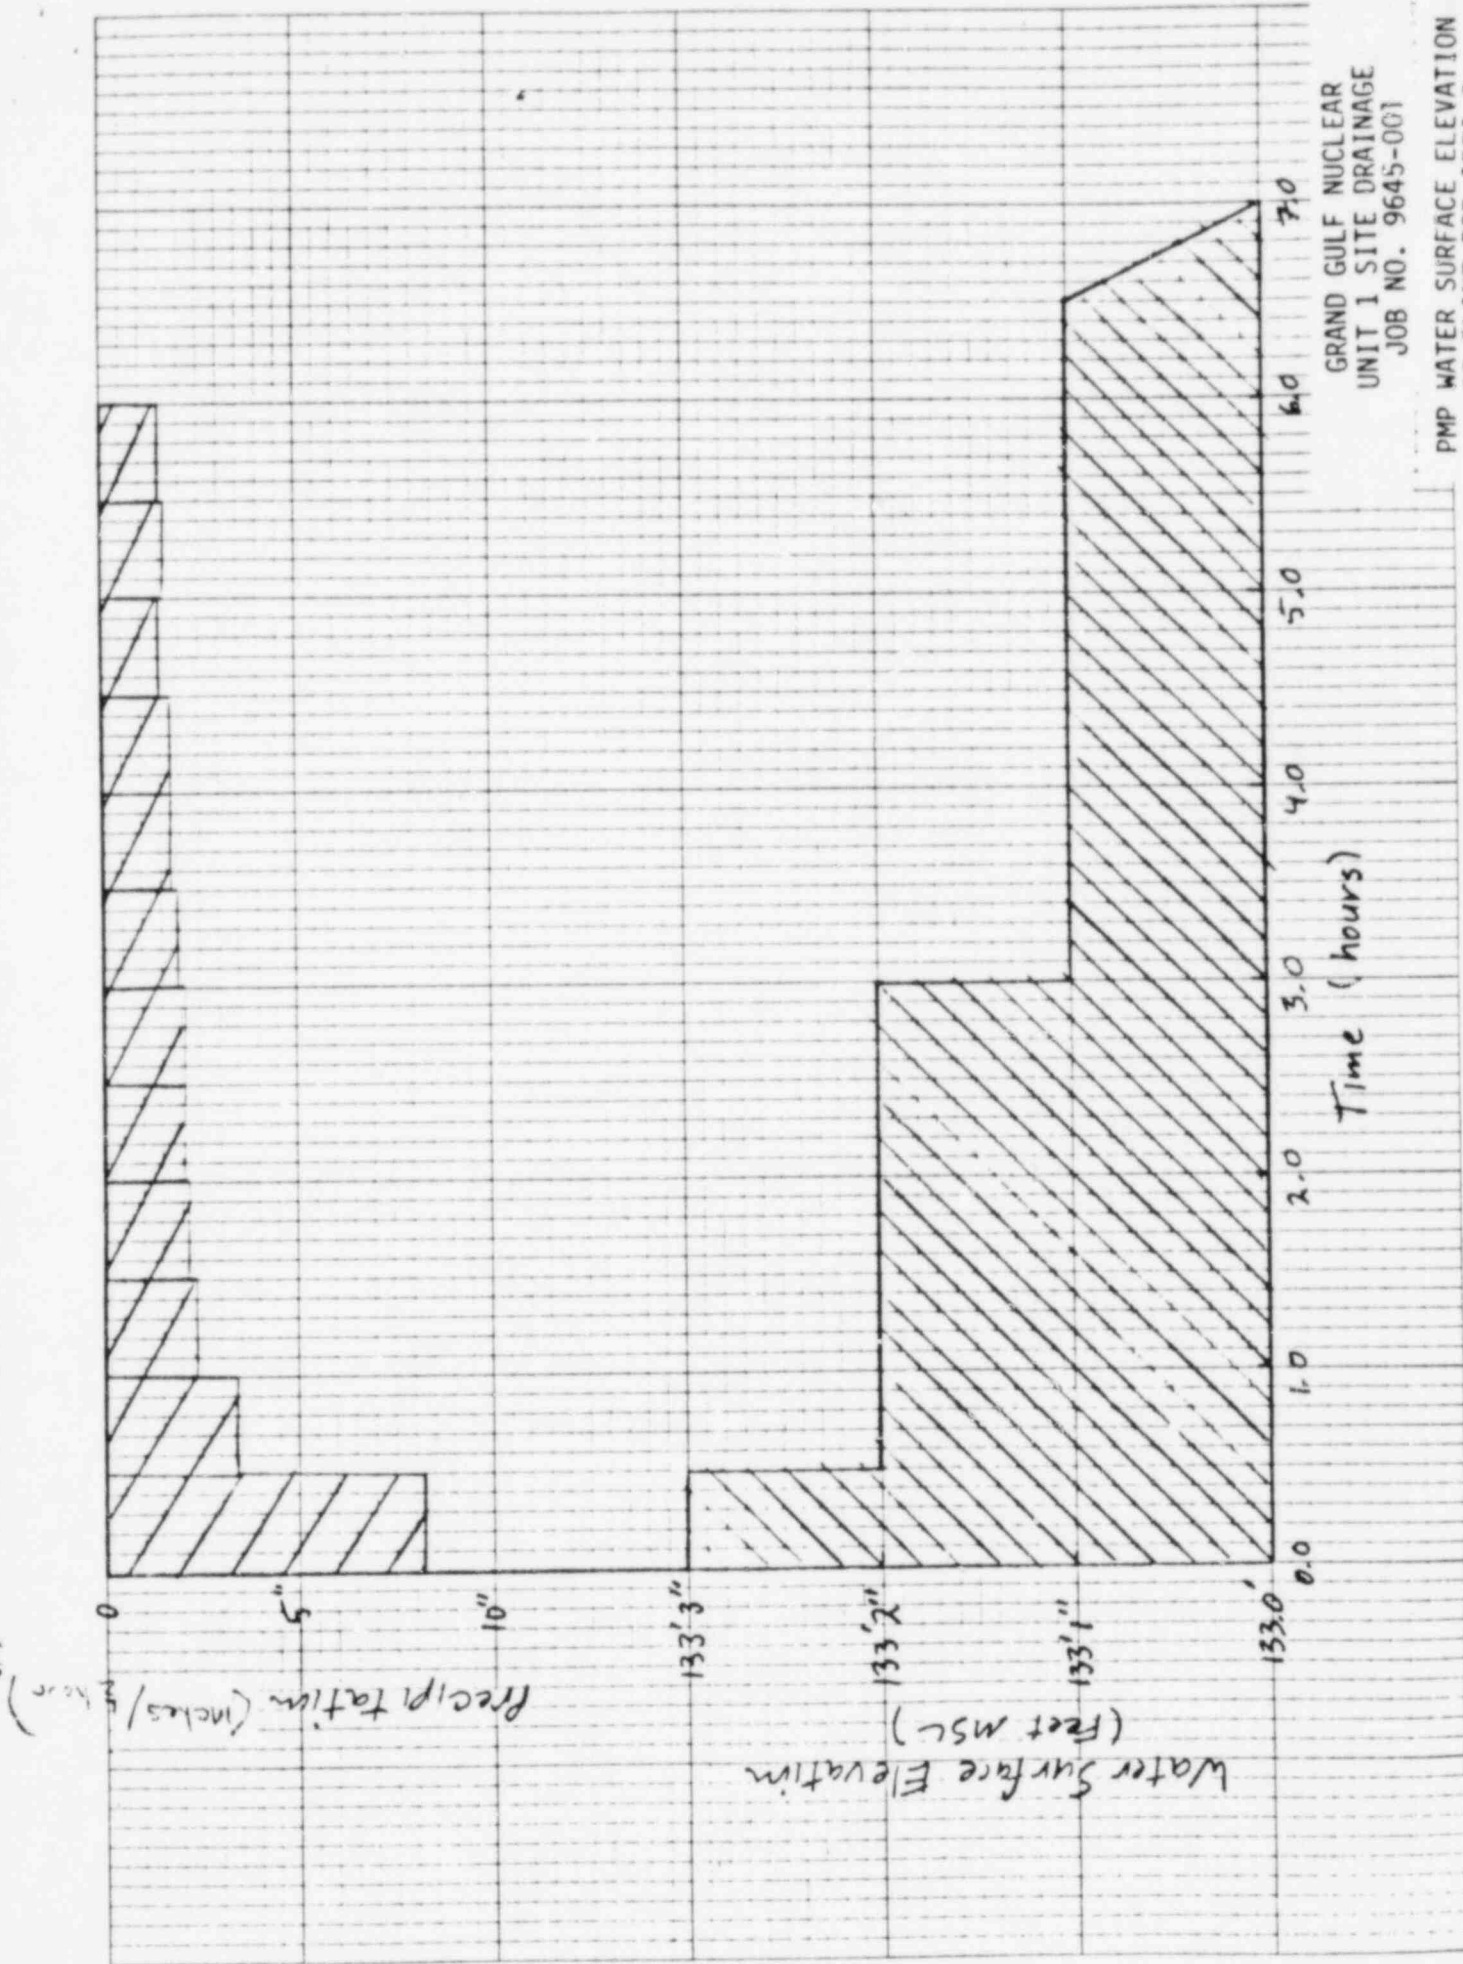
FIGURE A

With all doors in a closed position, water leakage rates were calculated using a time-step function in which floodwater heights against the doors varied with time. These time functions are shown in Figures A and B and are based on inflow from the 6-hour PMP design storm and outflow over the roads and railroad. Calculations show that water surface elevations above 133'-0" would exist for 7 hours.

Figure A (Drainage Area C) was used for the radwaste building and doors on the East side of the Turbine Building. Figure B (Drainage Area L) was used for the control, auxiliary, standby service water basin building, diesel generator, and water treatment buildings and door 1T326 in the turbine building. Drainage areas for GGNS are shown in FSAR Figure 2.4-7a.

PMP WATER SURFACE ELEVATION
AT PLANT FOR AREA G
(EAST AREA)

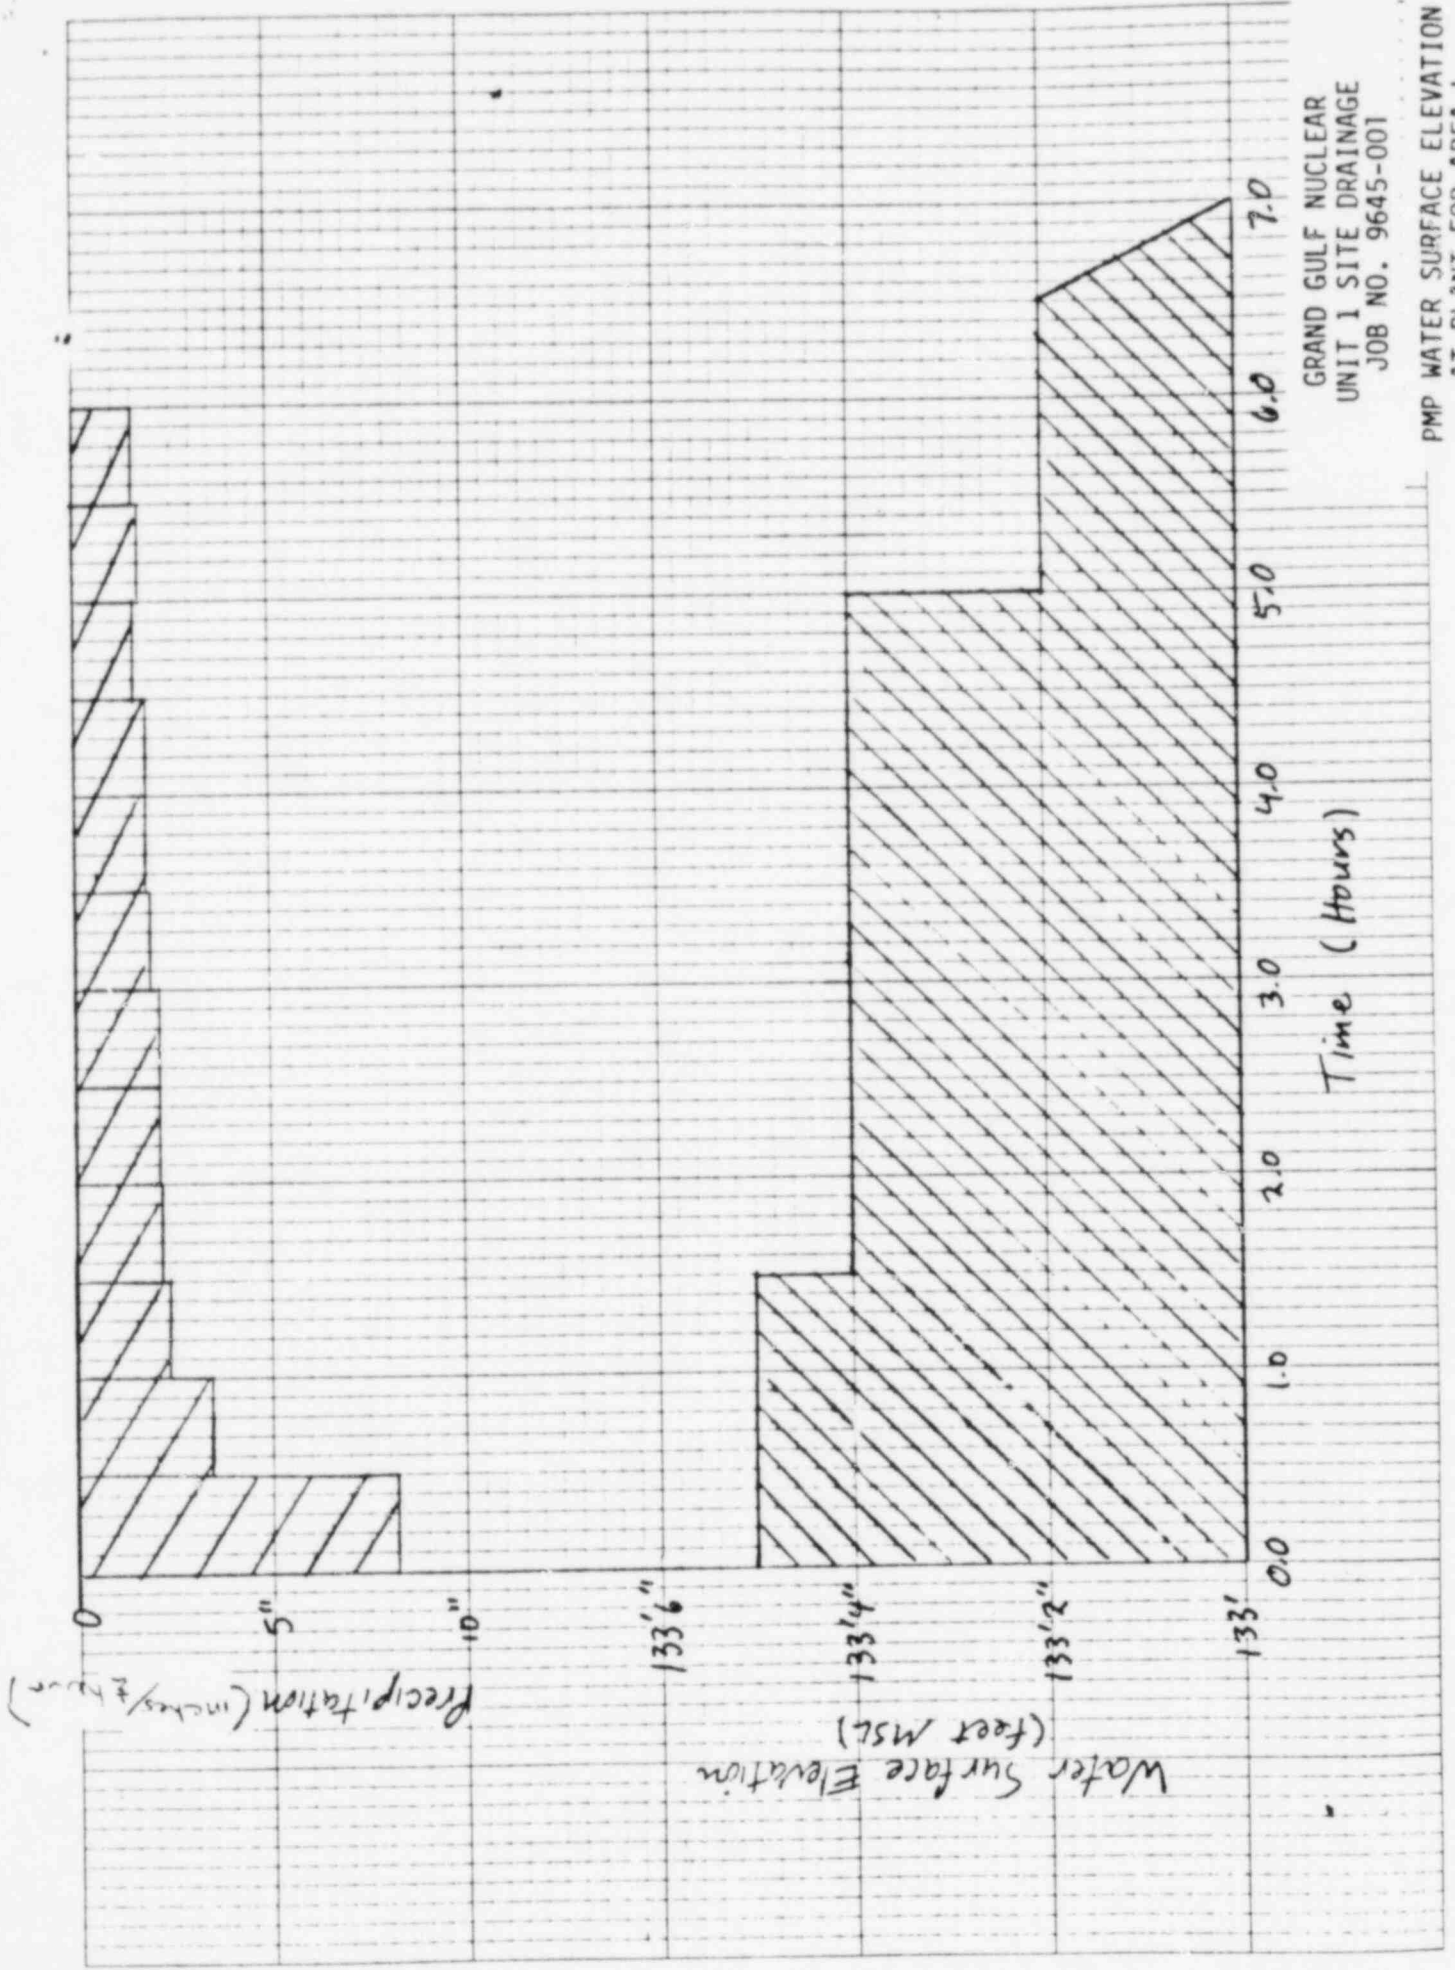
FIGURE B

PMP WATER SURFACE ELEVATION
AT PLANT FOR AREA L
(AREA WEST)

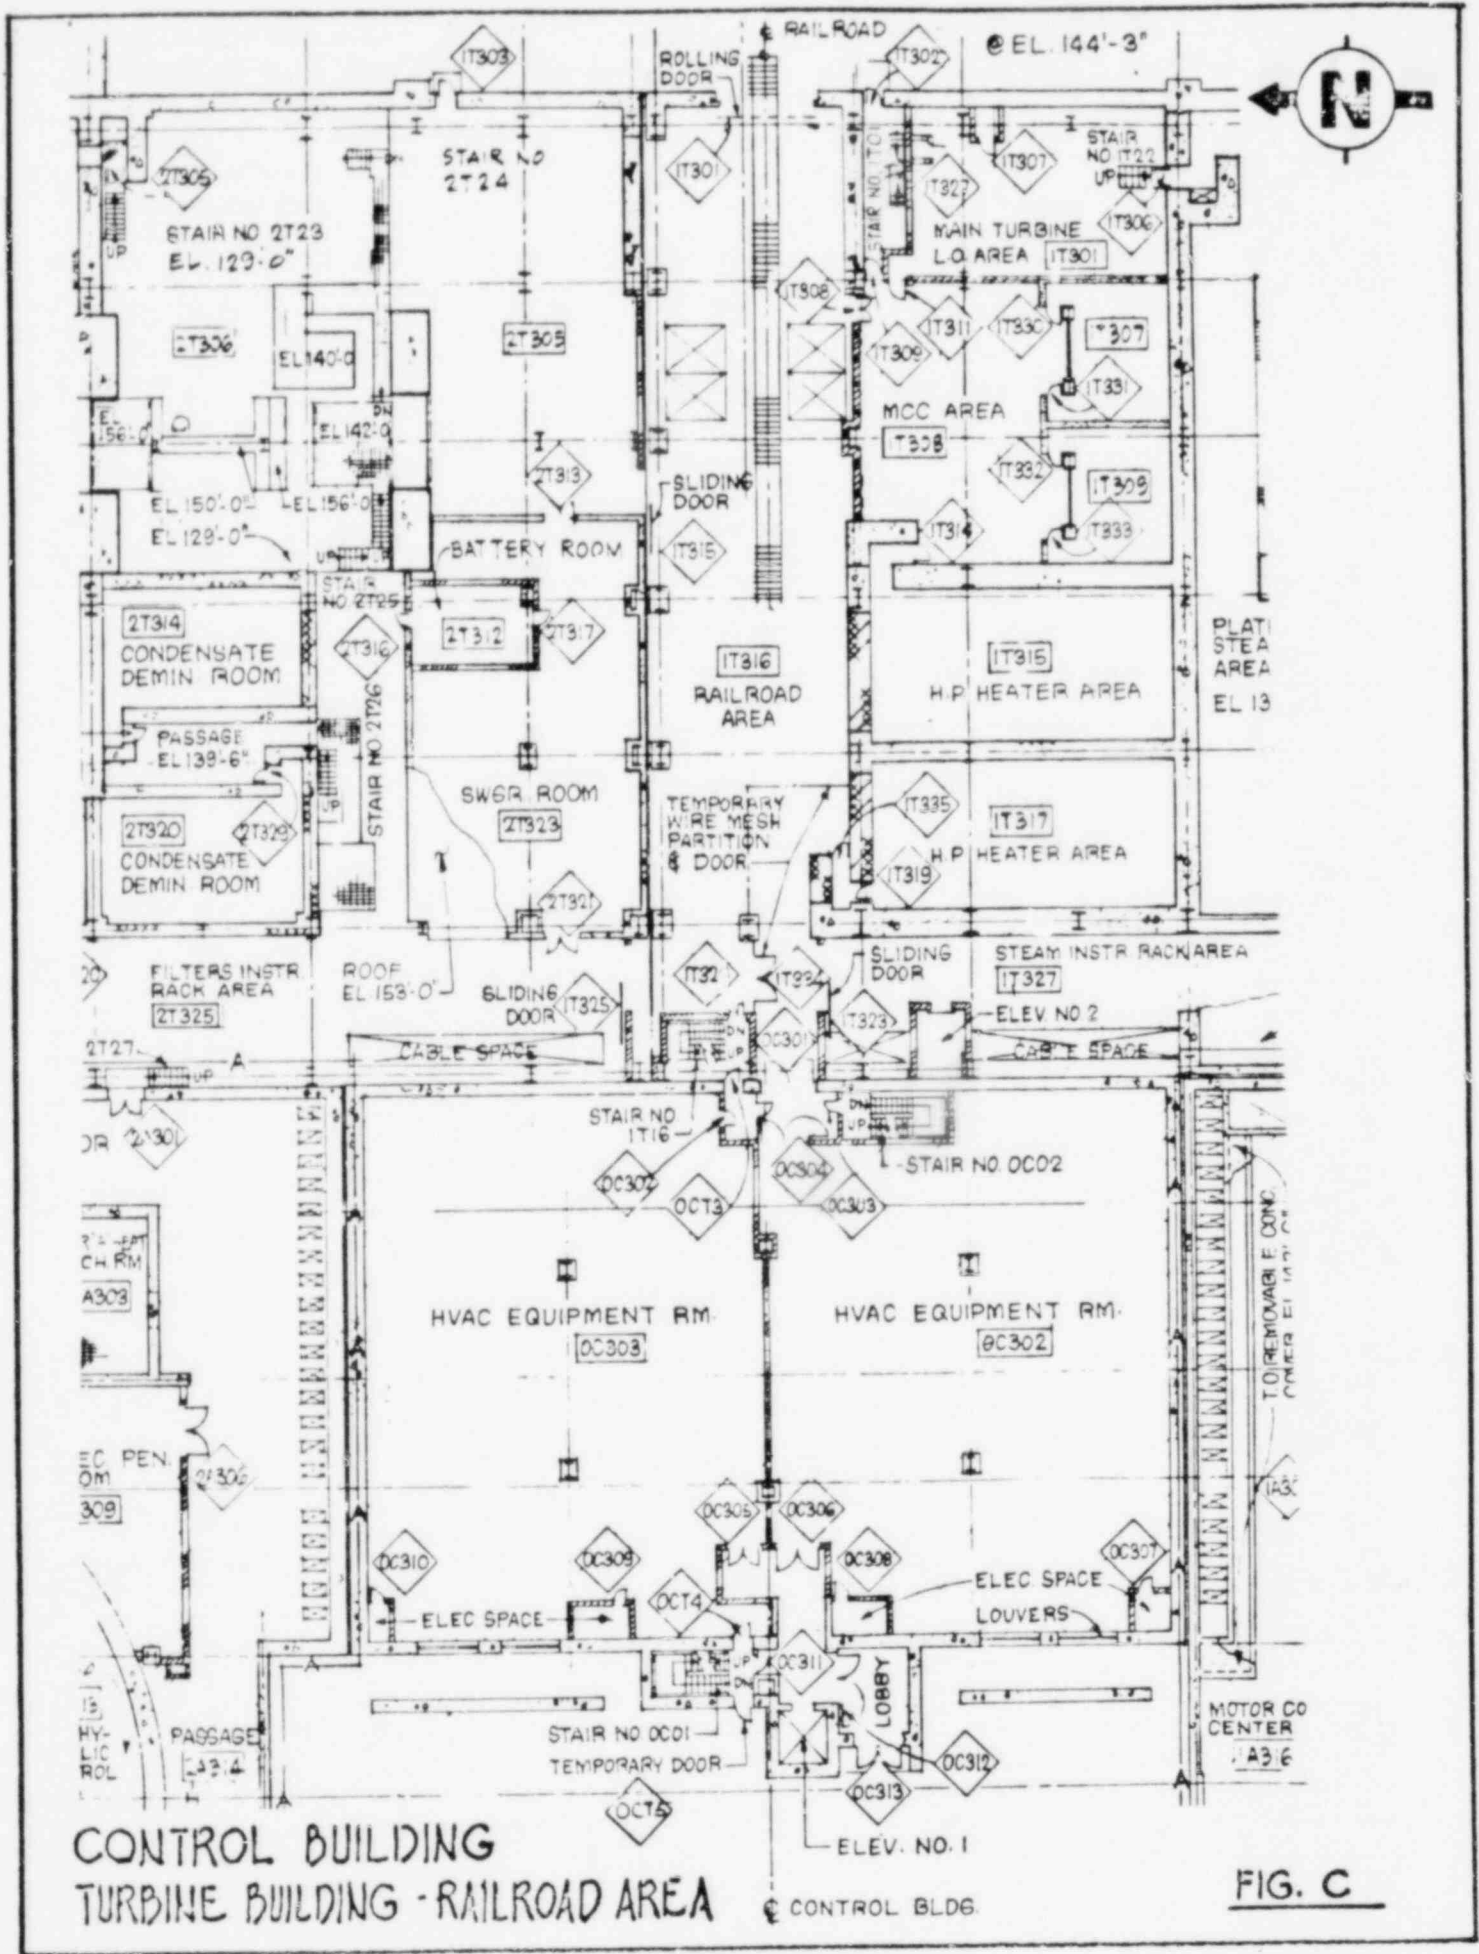
The control building has two doors in the west wall that could allow water to enter the building. These doors are OCT5 and OC313 (see Figure C). The combined maximum flow rate entering these doors is 81.2 gpm, and the total amount of water entering the building over the projected seven hours that water will be above Elevation 133'-0", is approximately 27,000 gallons.

Water entering through these doors could flow down the center hallway to HVAC equipment rooms OC302 and/or OC303, flow down the stairwell OC01, or flow down the elevator shaft.

Since all floor penetration seals in the Elevation 133'-0" floor are not leak tight, water entering the HVAC equipment rooms would leak through the penetrations to the Elevation 111'-0" floor where electrical switchgear necessary for safe plant operation are located. Water flowing down stairwell OC01 could flow out onto the Elevation 111'-0" floor, further exposing the same switchgear to an unsafe condition. For these reasons, floodwater must be prevented from flowing onto the floor areas at Elevations 133'-0" and 111'-0". This can be accomplished by such modifications as installing concrete curbs near doors OC313 and OCT5 entrances to prevent water from entering the building, by installing grout ridges across the floor at doorways or hallways which pass through the concrete wall opening, or by providing doors with a watertight design.

The grout ridge option would confine water to the stairwell areas and channel the flow to floor elevation 93'-0" where safety-related equipment would not be affected. The maximum floodwater depth passing from door OC313 through doors OC312 and OC311 and down the stairwell is approximately 3/8-inch. A one-inch ridge height would be sufficient to divert such a flow, while leaving a margin to accommodate flow effects such as sloshing or rippling.

Water leaking into the auxiliary, turbine, radwaste, and water treatment buildings would not affect the safe operation of the plant, and no modifications would be required to protect these buildings. Water leaking into the control building could affect safety-related equipment, and therefore, modifications such as water tight doors, door seals, or curbs at the exterior doorways or flow diverting ridges in selected areas of the Elevation 133'-0" and Elevation 111'-0" floors would be required to assure safe plant operation.

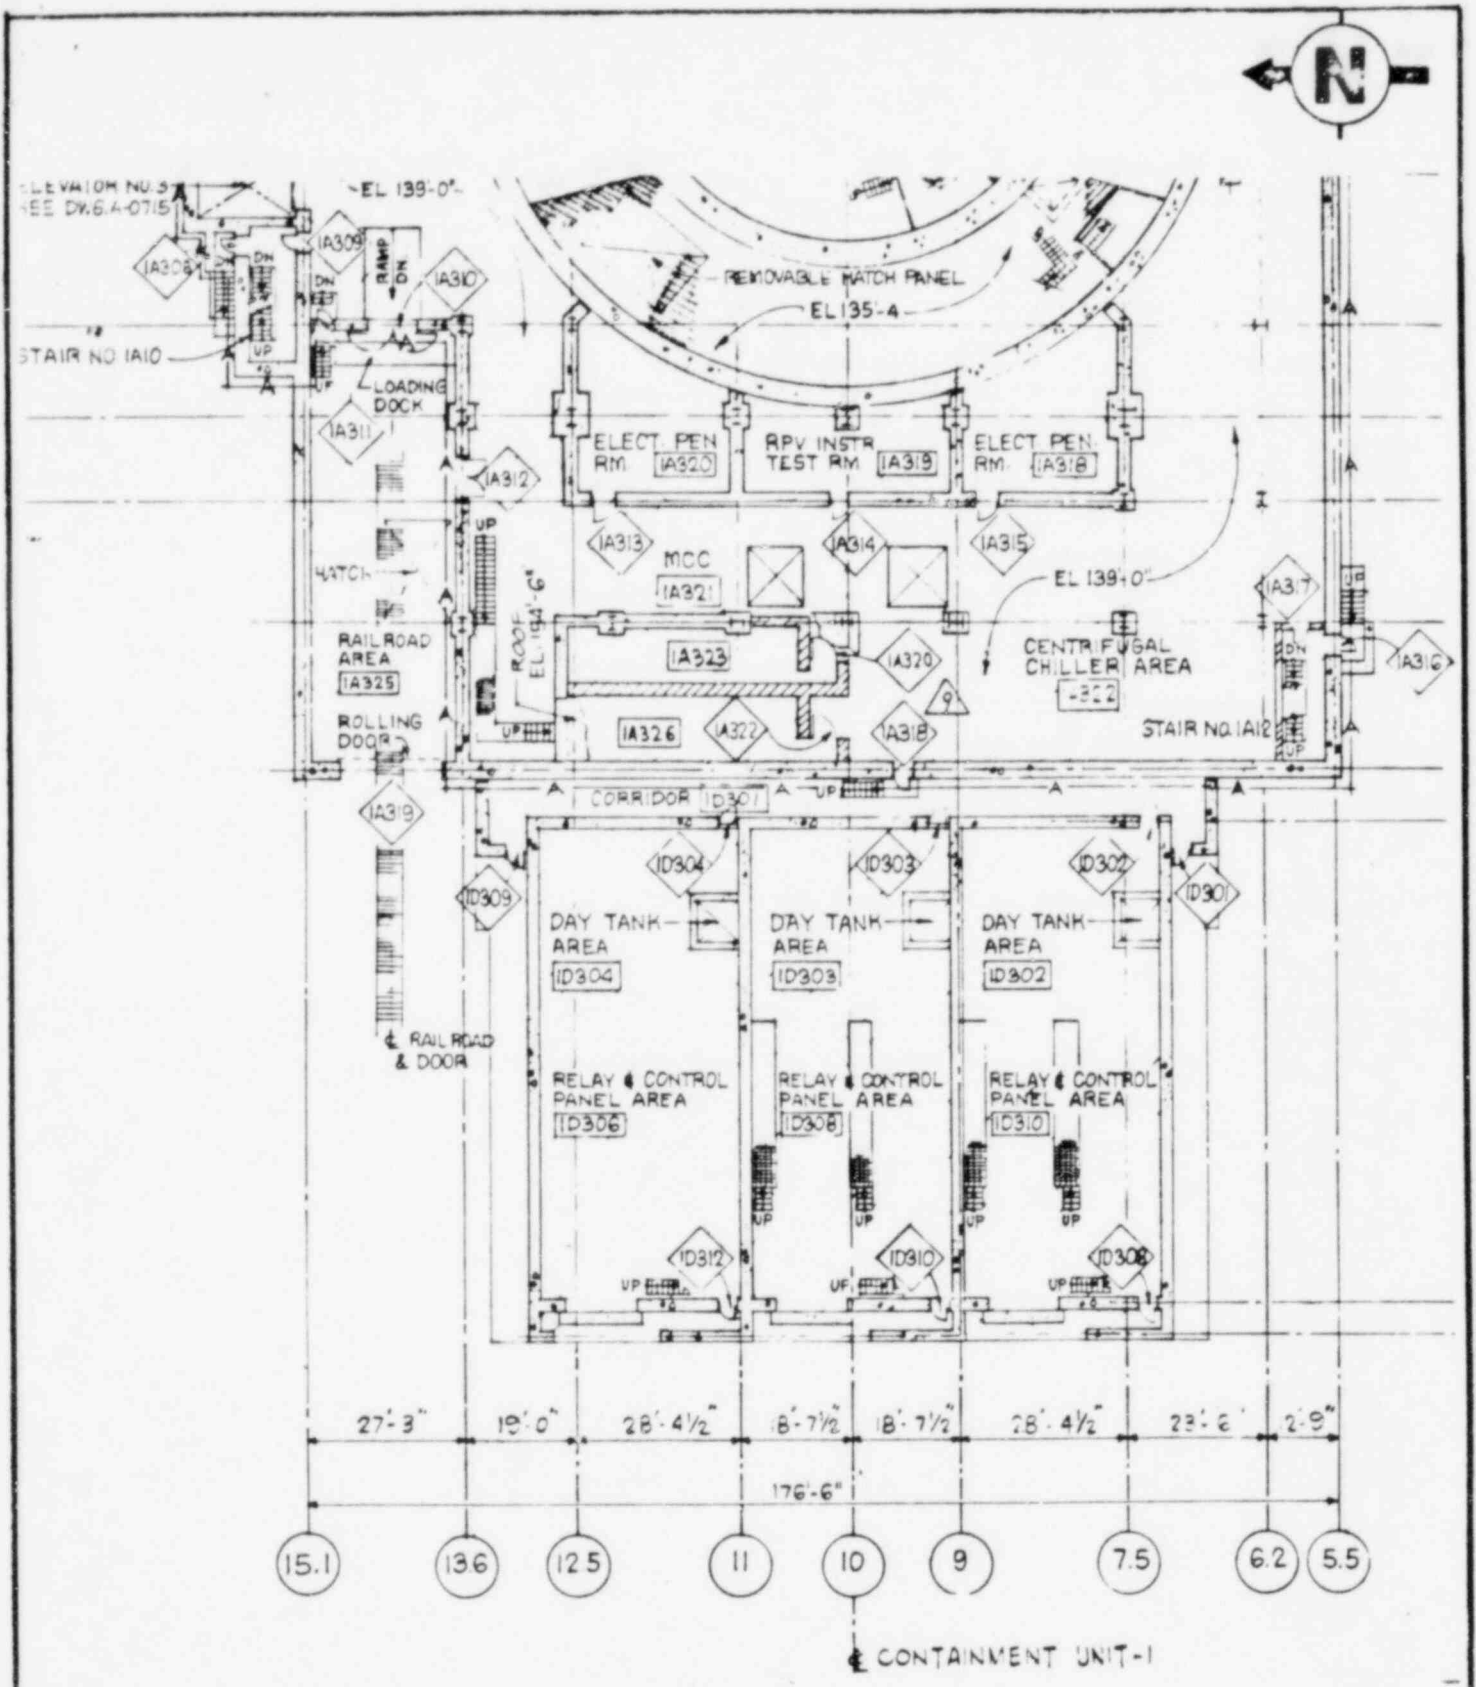
FIG. D

The auxiliary building has only one door where water could leak into the building. This is the railroad door IA319 shown on Figure D. The door sill has a compressible rubber weather strip attached to it. When the door is mechanically locked closed, a seal against the smooth concrete floor is formed, and negligible amounts of water will enter the building through this gap. However, there are channels in the concrete slab underneath the door for the railroad tracks. The calculated flow rate from leakage through the sides of the door frame and through the track channels is a maximum of 55.6 gpm, and the total accumulation is approximately 19,400 gallons. If the track channels are plugged, the maximum leakage rate is 3.3 gpm, and the total accumulation is 861 gallons. All rolling doors are constructed of interlocking flat steel slats. Negligible amounts of water will leak through these slats from windblown rain or water standing against the rolling door.

Water leaking through door IA319 will be confined to the railroad bay. This is because all other openings are at or above Elevation 139'-0", and the equipment hatch in the railroad bay floor slab has a water proofed seal around it. All drains in the floor slab are plugged, except for four 2-inch-diameter drains. These four drains would eventually drain the bay area, but the rate would not be sufficient to prevent water from ponding to a maximum depth of five inches.

The diesel generator building has five doors that would allow water to leak inside the building. These doors are 1D301, 1D308, 1D309, 1D310, and 1D312 and are shown in Figure D. These five doors have a combined maximum leakage rate of 118.4 gpm, and a total volume of approximately 38,700 gallons would enter the building. All floor drains have sufficient capacity to handle the maximum leakage rate. All water entering the building would be confined to enter the Elevation 133'-0" floor drain system, since there are no lower elevations in the diesel generator building. The floor drain system empties into three sumps, each with a capacity of 2,025 gallons. Each sump has a pump rated at 75 gpm to pump the collected water into the plant's main storm drainage system. If the pumps are inoperable, or in the likely event during the PMP the main storm drainage system is flooded, then the sumps will overflow and water will pond as high as Elevation 133'-5". Since there is safety-related electrical equipment located near the floor, an unsafe condition would exist.

DIESEL GENERATOR BUILDING
 AUXILIARY BUILDING - RAILROAD AREA

Permanent modifications to the diesel generator building will be limited to those considerations which prevent water from entering the building itself. Such modifications could include providing curbs at or near the entrances, water tight doors, door seals, waterproofing for individual components, or a combination of these options.

Water leaking into the diesel generator building could affect safety-related equipment; and, therefore, modifications such as curbs or watertight doors would be required at all entrances to this building to assure safe plant operation. A total of five door entrances would require modifications to stop water leakage. The standby service water basin building would require modifications such as watertight toeplates or curbs surrounding all safety-related, floor mounted electric equipment to assure safe plant operation.

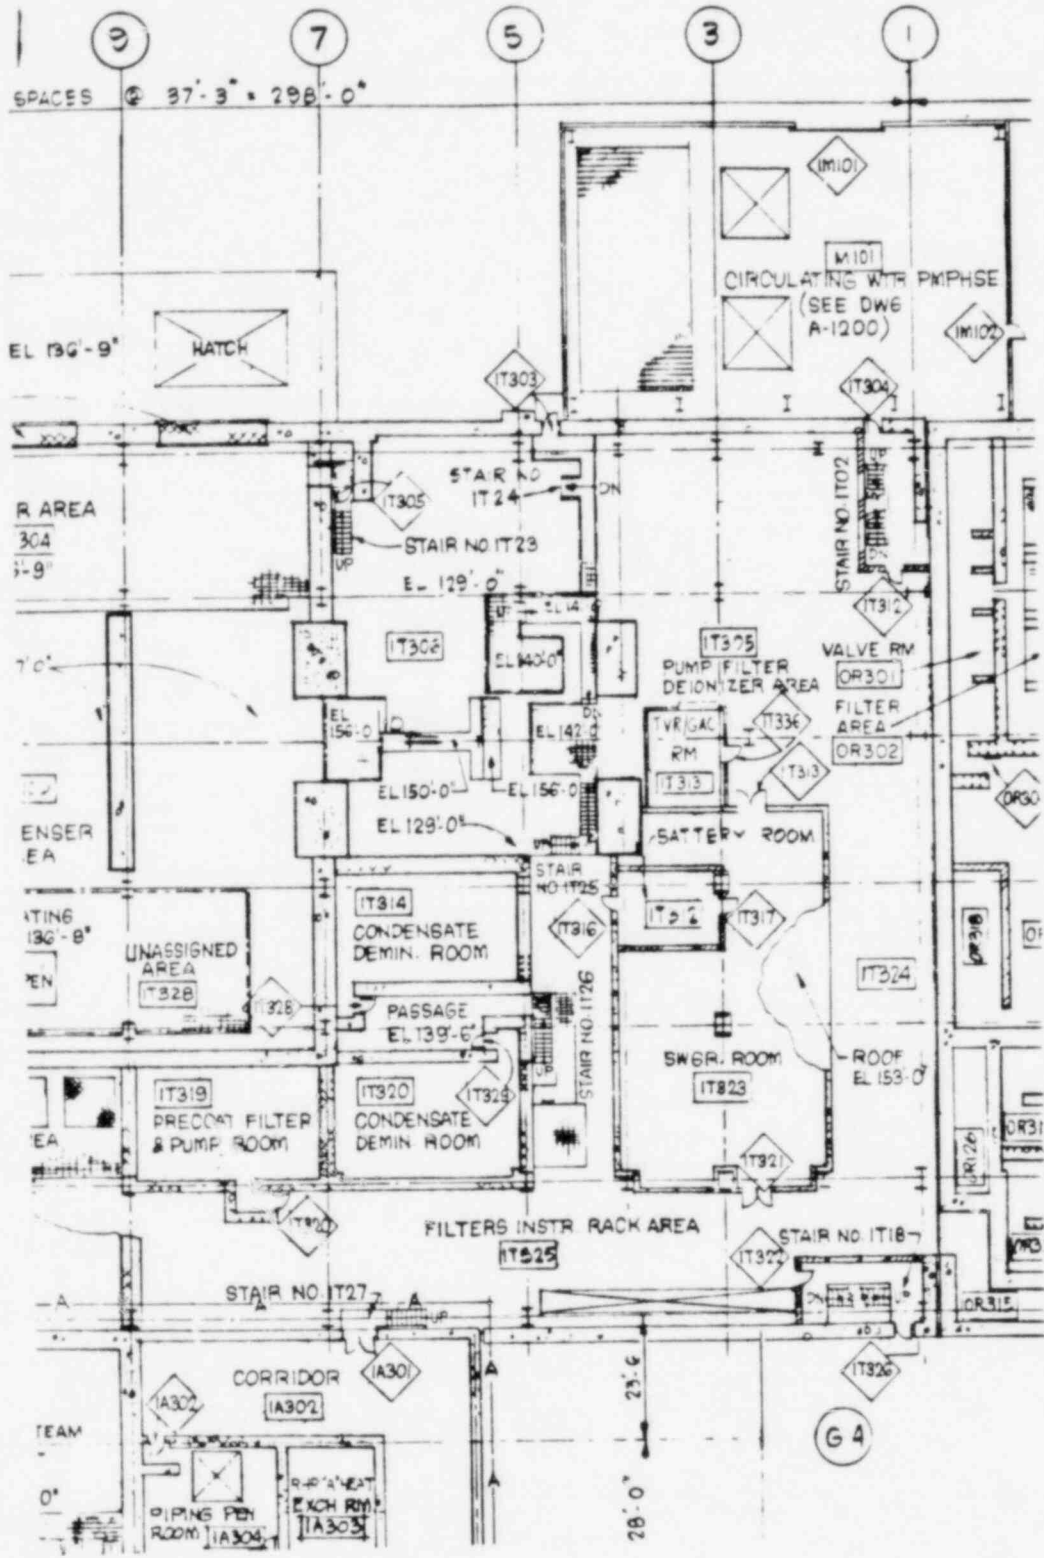
FIG. E

The turbine building has five doors that could allow water to leak into the building. These doors are numbered 1T301, 1T302, 1T303, 1T304, and 1T326 and are shown on Figures C and E. Door 1T301 is a rolling door located at the railroad bay opening, and the same assumptions used in calculating the leakage flows for auxiliary building door IA319 were used for 1T301. Assuming that the track channels are not plugged, then the maximum leakage rate through

At door 1T302, it is calculated that the maximum leakage rate will be 17.6 gpm, and the total accumulation will be approximately 4,450 gallons. Water leaking through this door will either flow down stairwell 1T01 to lower elevations or will flow to rooms with floor drains which have the capacity to handle the maximum flow rate. Water flowing down the stairwell or flowing down to lower elevations through floor penetrations will not be a concern, since no safety-related equipment in the turbine building is affected.

Door 1T303 has a maximum leakage rate of 19.0 gpm, which allows approximately 4,770 gallons to enter the turbine building. Door 1T304 has a maximum leakage rate of 17.3 gpm and allows approximately 4,360 gallons to enter the building. Door 1T326 has a maximum leakage rate of 25.5 gpm and allows approximately 8,470 gallons to leak into the turbine building. Water leaking through these three doors will flow down stairwells to lower elevations, flow down floor penetrations to lower elevations, or enter the floor drain system. There is no safety-related equipment that can be affected by water which leaks through these doors have the capacity to handle the maximum leakage rates which would minimize water damage to equipment in these areas.

TURBINE BUILDING - SOUTH

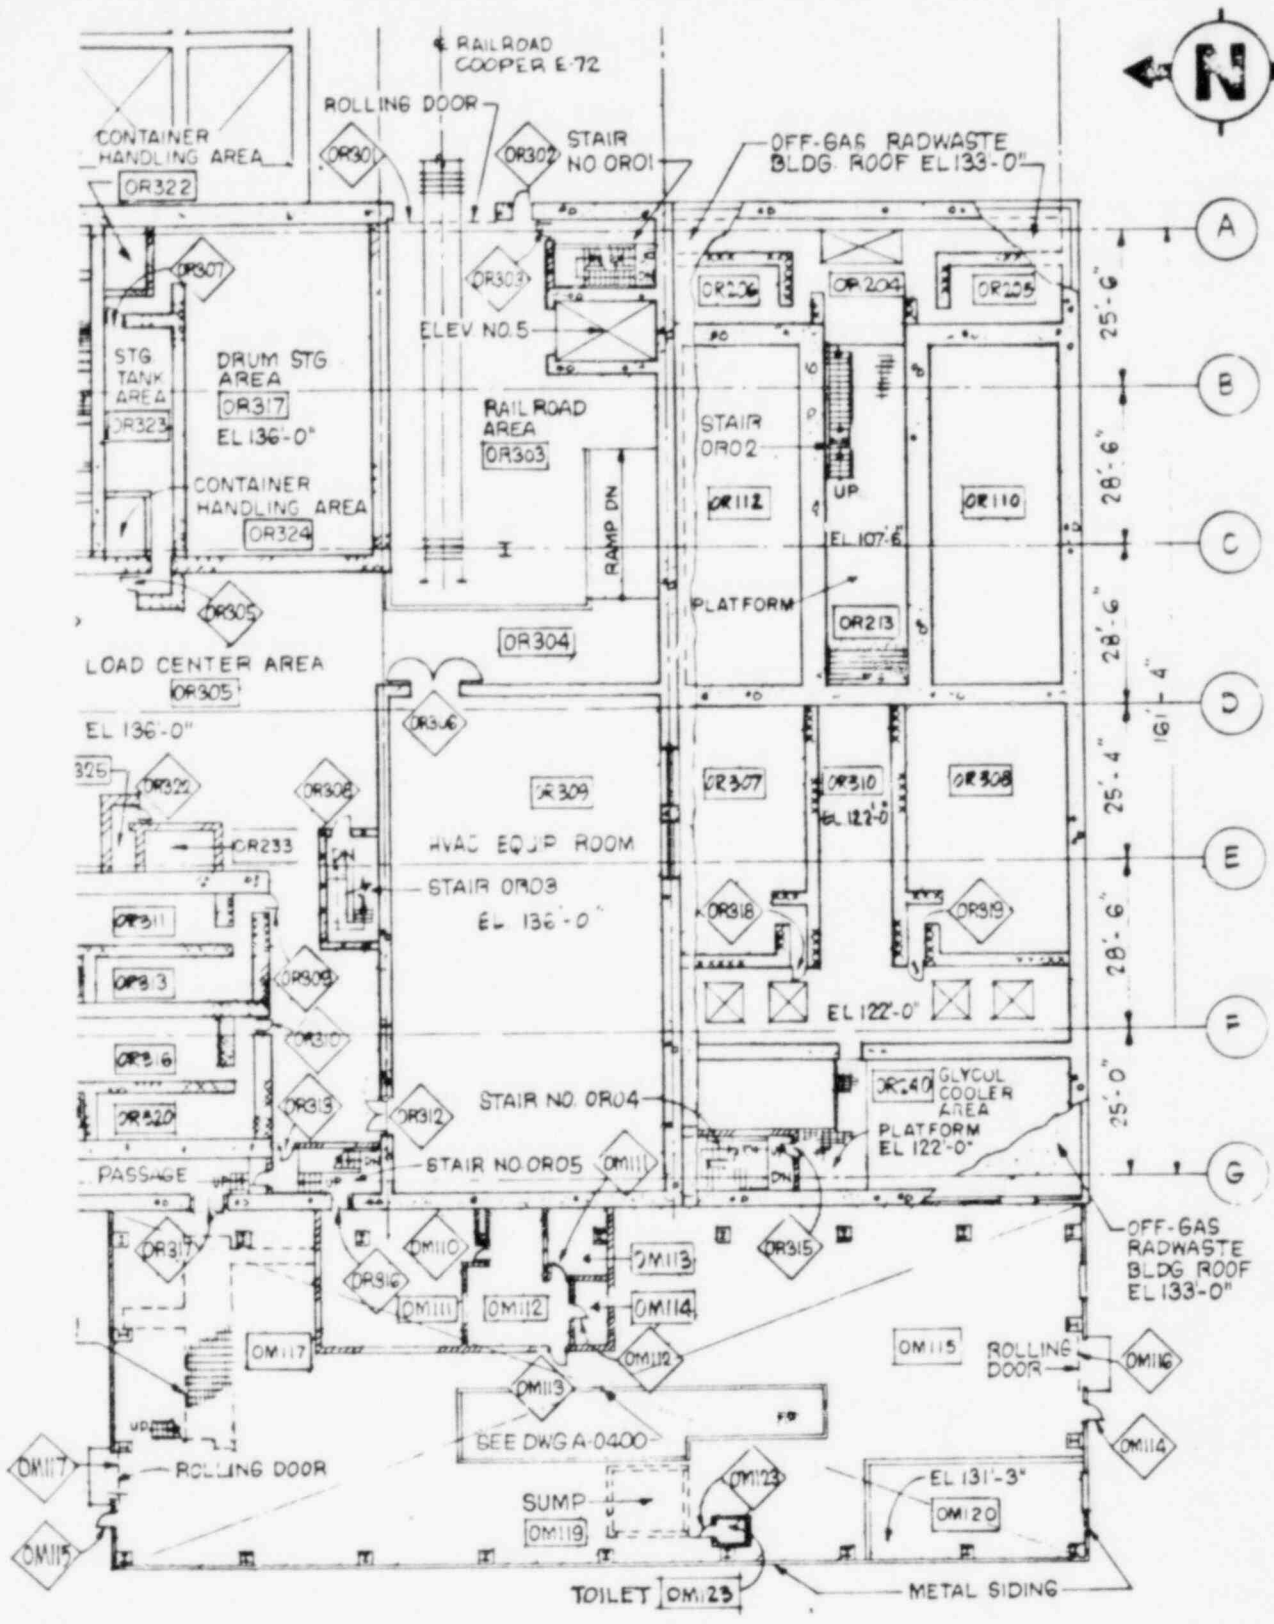
FIG. F

The radwaste building has two doors in the East wall that could allow water to leak through them. These doors are numbered OR301 and OR302 and are shown on Figure F. Door OR301 is a rolling door railroad entrance. The same assumptions used to determine flows through auxiliary building door 1A319 were used for door OR301. Assuming the track channels are not plugged, the maximum leakage rate for door OR301 is 43.2 gpm, and the total volume of water that would enter through the door is approximately 13,422 gallons. If the track channels are plugged, these quantities would be reduced to 1.5 gpm and 231 gallons. Door OR302 would allow a maximum leakage rate of 18.5 gpm and a total volume of 4.665 gallons to leak through the door.

Water entering these doors would either be confined to the railroad bay and would enter the floor drain system or would flow to lower elevations by entering stairwell OR01, the elevator shaft, or floor penetrations. No safety-related equipment is located in the radwaste building; thus, water leakage is of no concern. All drains in the radwaste building have sufficient capacity to handle the maximum leakage rates calculated for the two doors with or without plugging the track channels, thereby minimizing water damage to equipment.

The water treatment building has four doors that could allow water to leak inside the building. These doors are numbered OM114, OM115, OM116, and OM117 and are shown on Figure F. OM116 and OM117 are rolling doors, and the same assumptions used to calculate the flows for auxiliary building door 1A319 were used for OM116 and OM117. However, these two doors are not railroad entrances, and thus no track channels exist. The combined maximum leakage rate for the four doors is 61.8 gpm, and the total volume of water that would enter the building is approximately 19,800 gallons. Water entering the floor drain system at the base slab Elevation 133'-0" empties into either the chemical drain sump or the oily water drain sump. Assuming the sump pumps are inoperable or that the main storm drainage system is full, the sumps will overflow. Assuming that this overflow enters the turbine or radwaste buildings through doors OR316 and OR317, the additional amount of water will not cause any safety-related equipment to be affected, and an additional 75 gpm to the liquid radwaste system will not change any of the postulated effects previously mentioned.

WATER TREATMENT BUILDING
 RADWASTE BUILDING - RAILROAD AREA

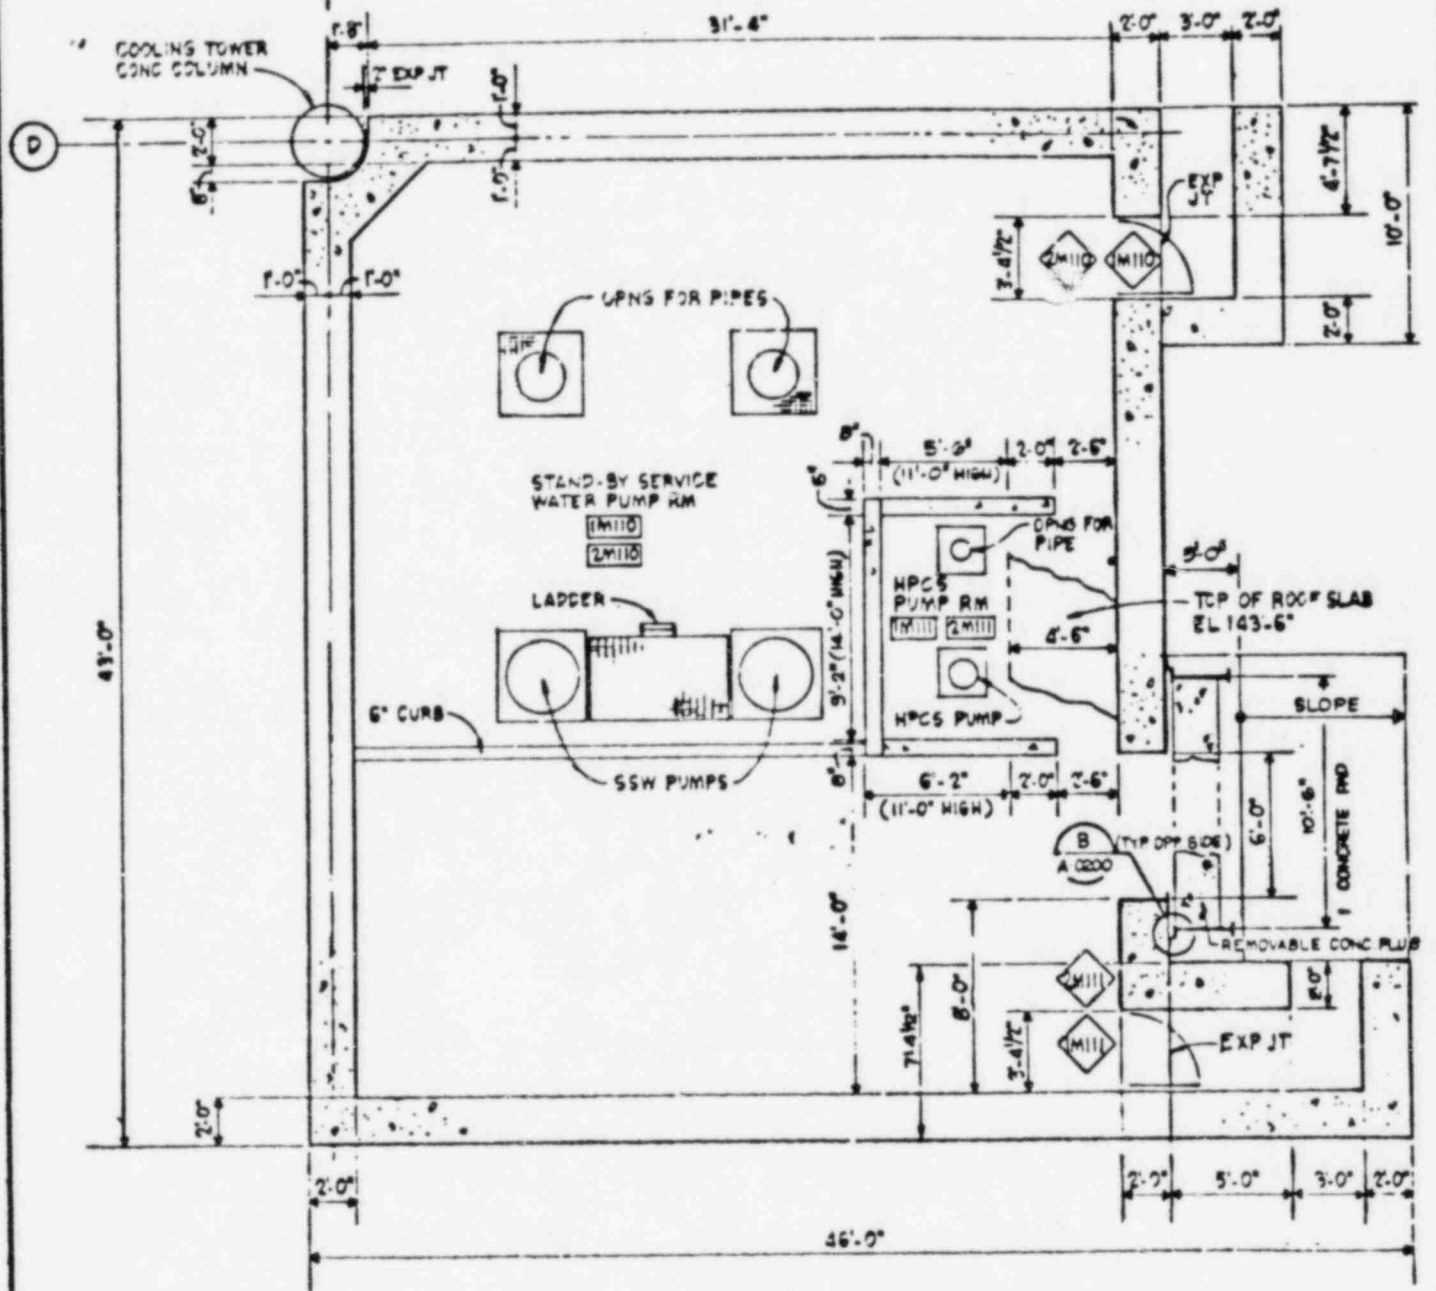
FIG. G

The standby service water basin has six doors which allow water to enter the pump house and the valve rooms. These doors are numbered 1M110, 1M111, 1M112, 2M110, 2M111, and 2M112 and are shown on Figures G and H. These doors permit a maximum leakage rate of 80.9 gpm for Basin A (Unit 1) and 81.9 gpm for Basin B (Unit 2), and the total volume of water entering the basin structure is approximately 27,000 gallons for each basin.

The flow calculations are all conservative, since the 133'-5" height of floodwater was assumed. The basin is not located in Drainage Area L, and the floodwater is not expected to reach this elevation, due to more favorable drainage conditions around the basin. There is no floor drain system for these buildings, and water entering these building would flow down blockouts and unsleeved penetrations in the floor slab to the water basin below.

Additional water from direct rainfall would enter the basins through the cooling fan towers and through backflow from the overflow drains. The cumulative effect of these three flows would cause the basins to overflow and water in the pump houses and valve rooms to reach elevations of 133'-6". This would affect electrical safety-related equipment, creating unsafe conditions.

STAND BY SERVICE WATER
 PUMP HOUSE

Therefore, to protect safety-related equipment, modifications such as an 8-inch waterproofed toeplate or curb to be placed around all safety-related equipment is being considered. A toeplate would be an angle anchored to the concrete slab and caulked to provide a watertight seal. Both options would provide unobstructed access to all doors and could easily be removed if temporary access to the affected equipment was required.
