October 30, 1990

License No. 48-12016-01
Docket No. 030-06763

Seaman Nuclear Corporation
Radiation Safety Program Review
October 1990

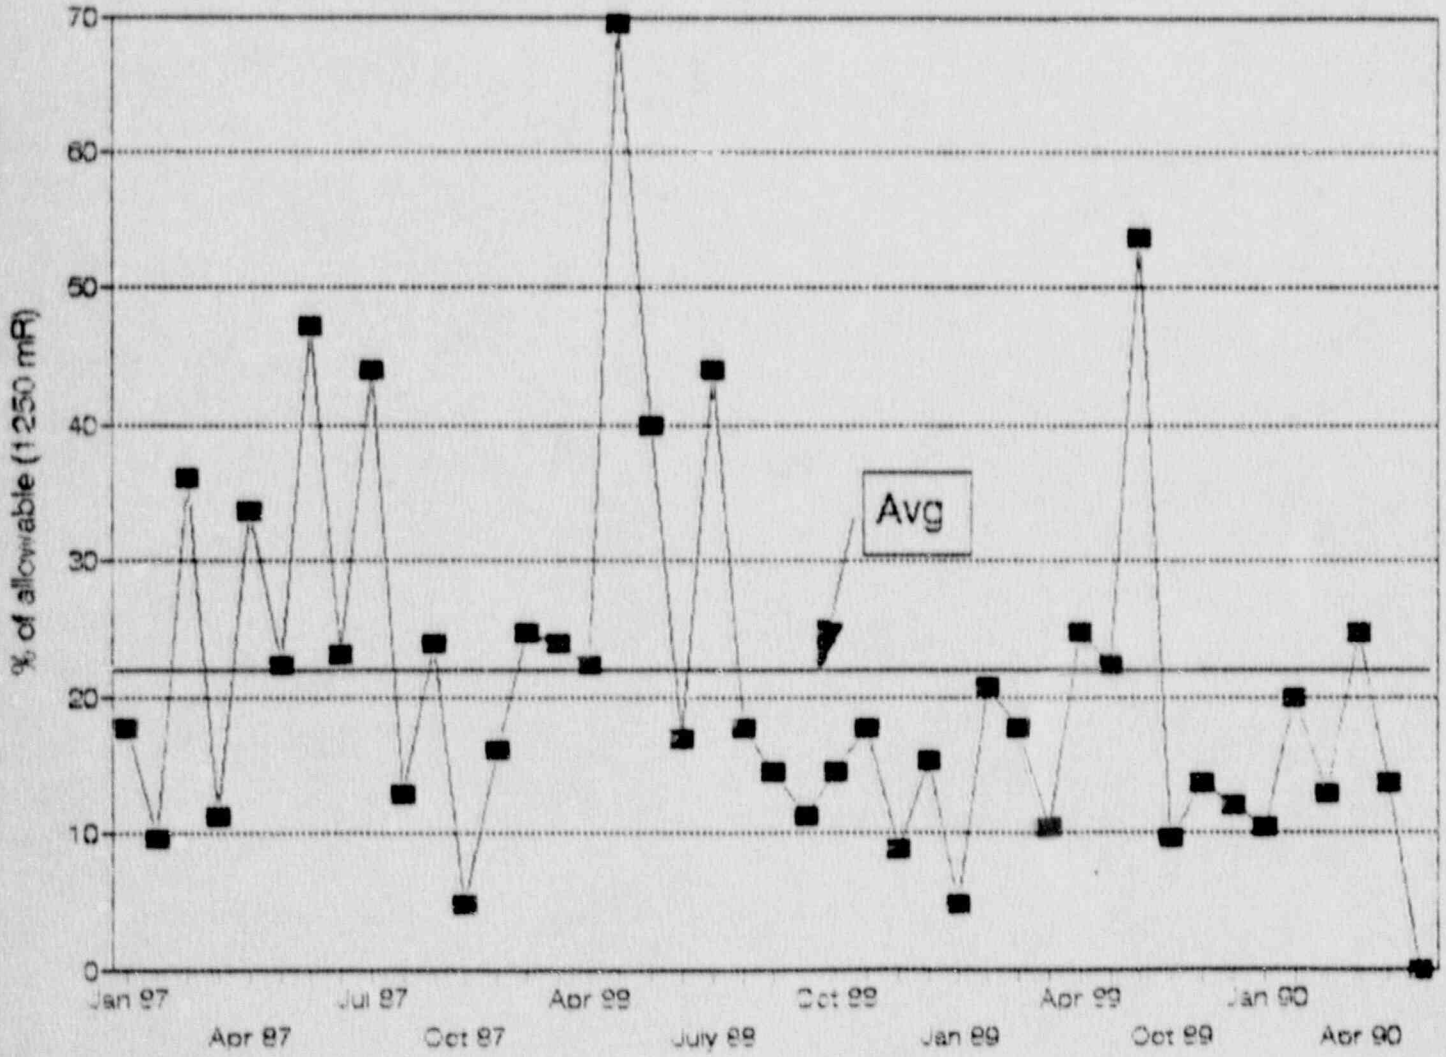
Technicians Trend Analysis

Actual worker exposures have been significantly reduced over the last several years. Gamma and neutron exposures are monitored monthly by whole body and ring dosimeters. Pocket dosimeters are also utilized. The result of the personnel monitoring is summarized graphically on attached Technicians Trend Analysis. This graph illustrates the downward trend in employee exposures over the last three years. This graph was shown to Messrs. Gibbons and King of the NRC during an inspection. The horizontal axis lists the exposures of each technician, grouped by calendar quarter. You will notice that each quarter has 3 or 4 technicians. Several points for each quarter correspond with the quarterly exposure of several technicians. The two highest readings result from two individuals, noted for their carelessness in their work habits. They are no longer employed by us.

To summarize the dosimetry results, it was found that: (a) Whole body gamma exposures to technicians have been reduced from approximately 24% of allowable to 14% over the last 3 years. A 41% percent reduction. (b) Extremity exposures are generally 2 to 3% of allowable, with the highest exposure 6.9%. They also correlate predictably with whole body readings. (c) No measurable neutron exposures have occurred since 1985.

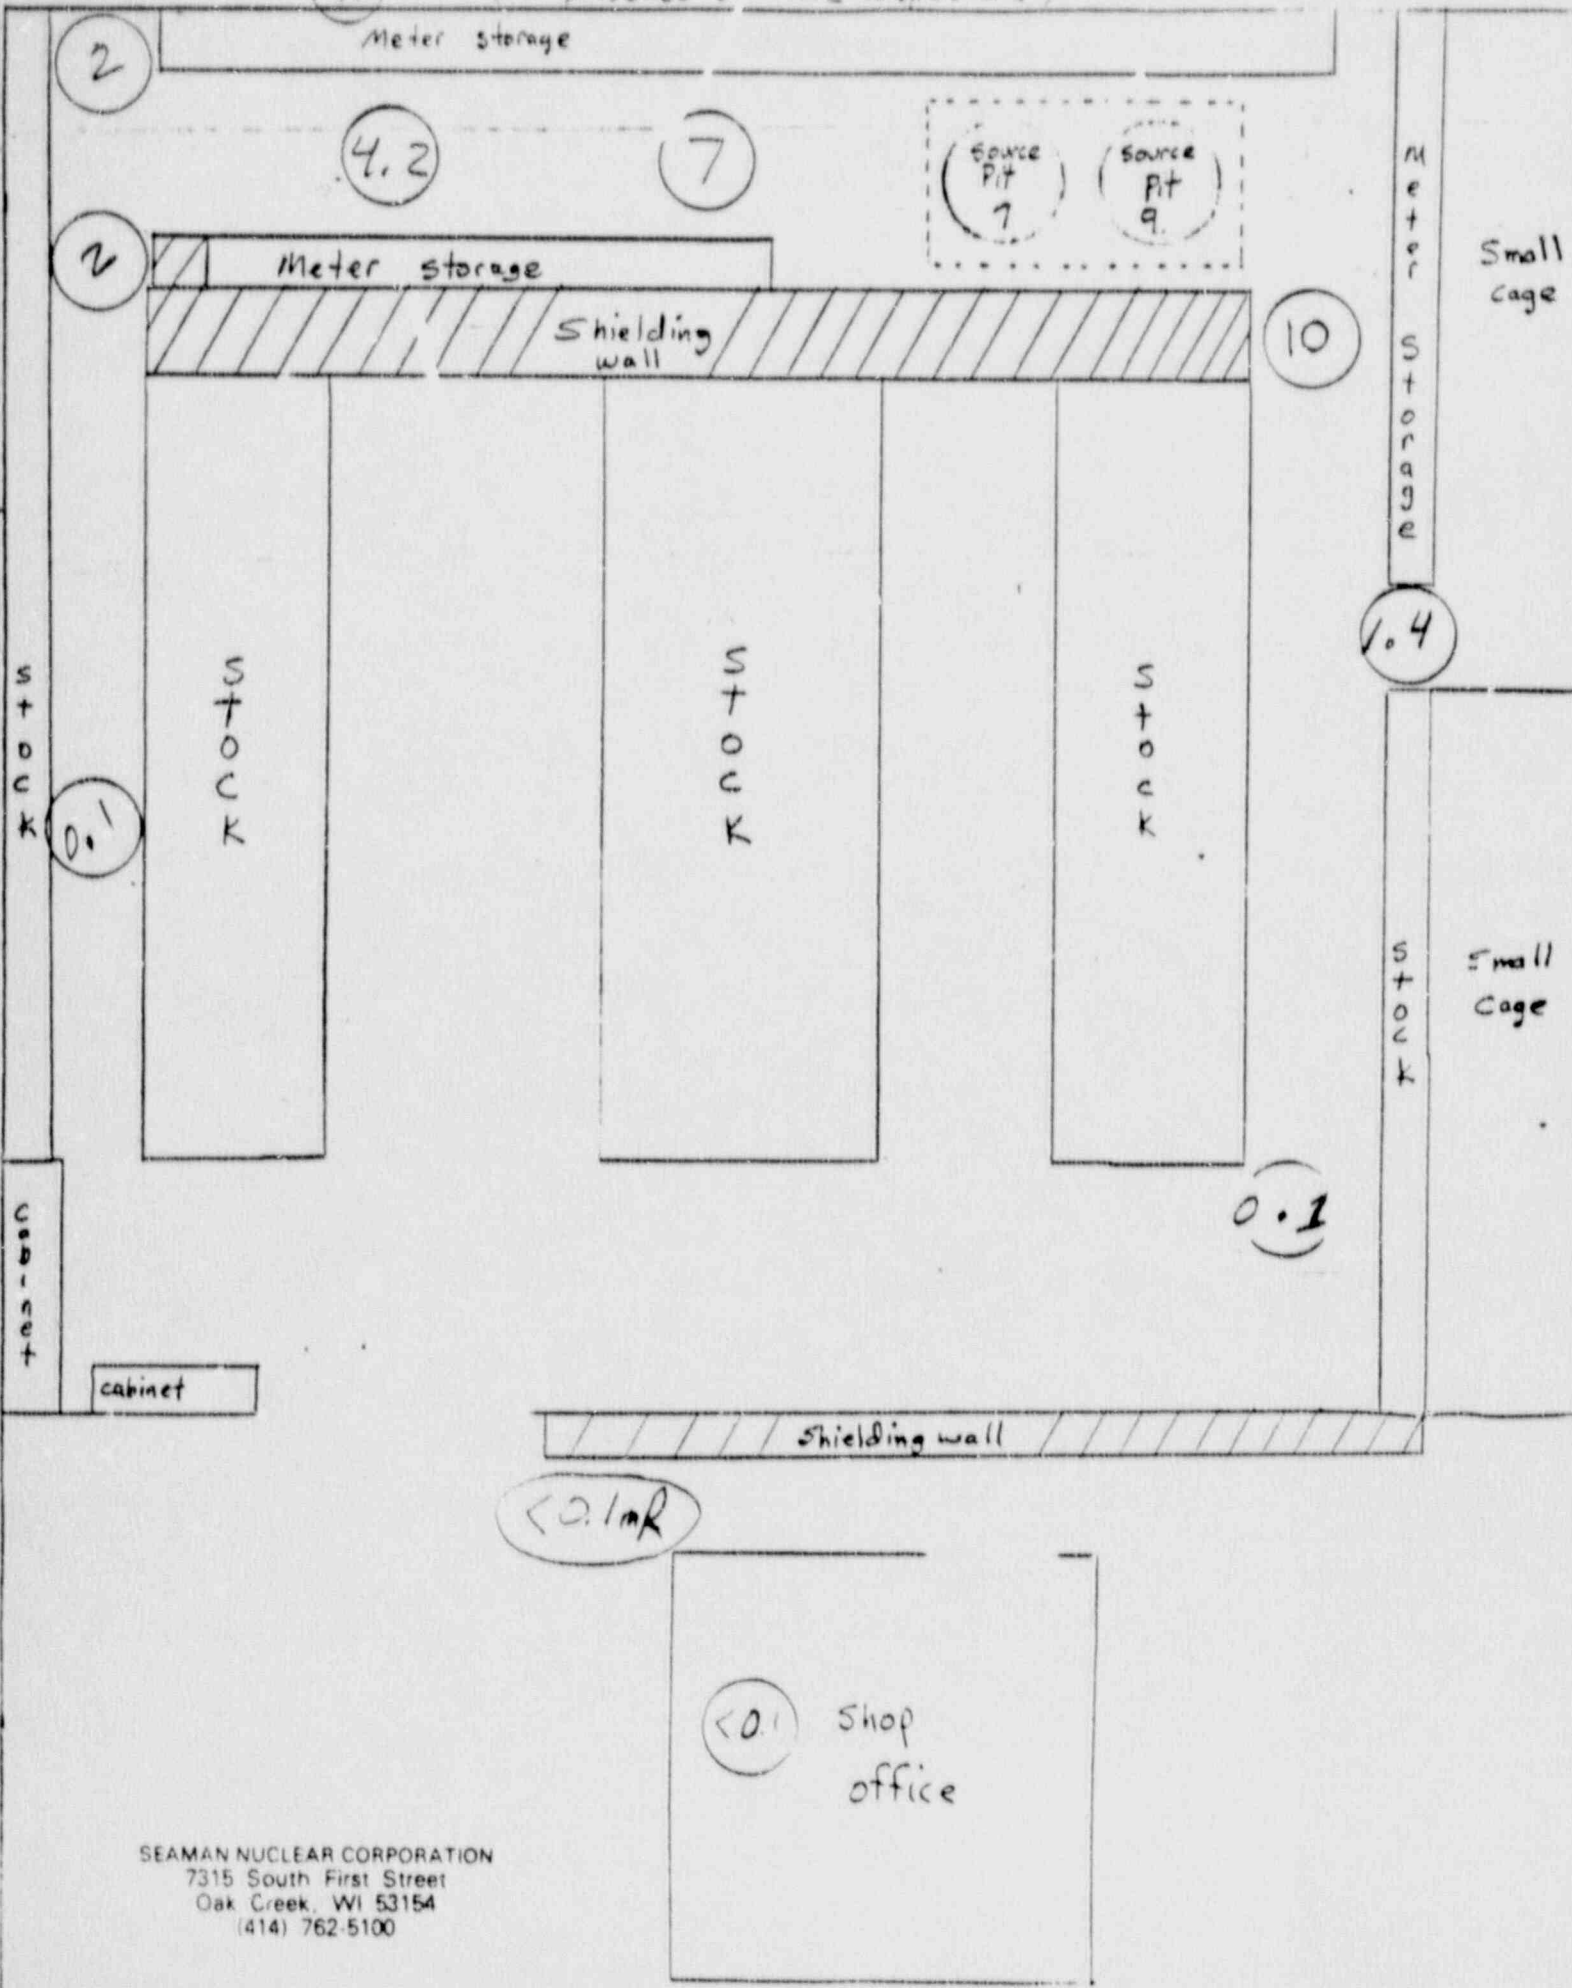
Inventory Area Survey

In February 1990, solid concrete block walls were erected in the source and meter storage area to reduce radiation levels. This shielding is illustrated on attached inventory area survey. This survey was conducted in the presence of NRC inspector, Messrs. Gibbons and King.

The main shielding wall is 24 inches thick, other walls are 16 inches. Since the wall was constructed, the following reductions in radiation levels have been observed: In the inventory isles, behind the shielding wall, the radiation level has been reduced to less than 1/10 of former levels. In the meter storage area the level has been reduced to approximately 1/2 or less due to (a) shielding between some storage shelving, (b) wider isle width to increase distance between worker and meters and (c) more efficient identification system for meters to reduce search time.
