Evaluation of Events Involving Decay Heat Removal Systems in Nuclear Power Plants

Prepared by J. A. Haried

Oak Ridge National Laboratory

Prepared for
U.S. Nuclear Regulatory
Commission

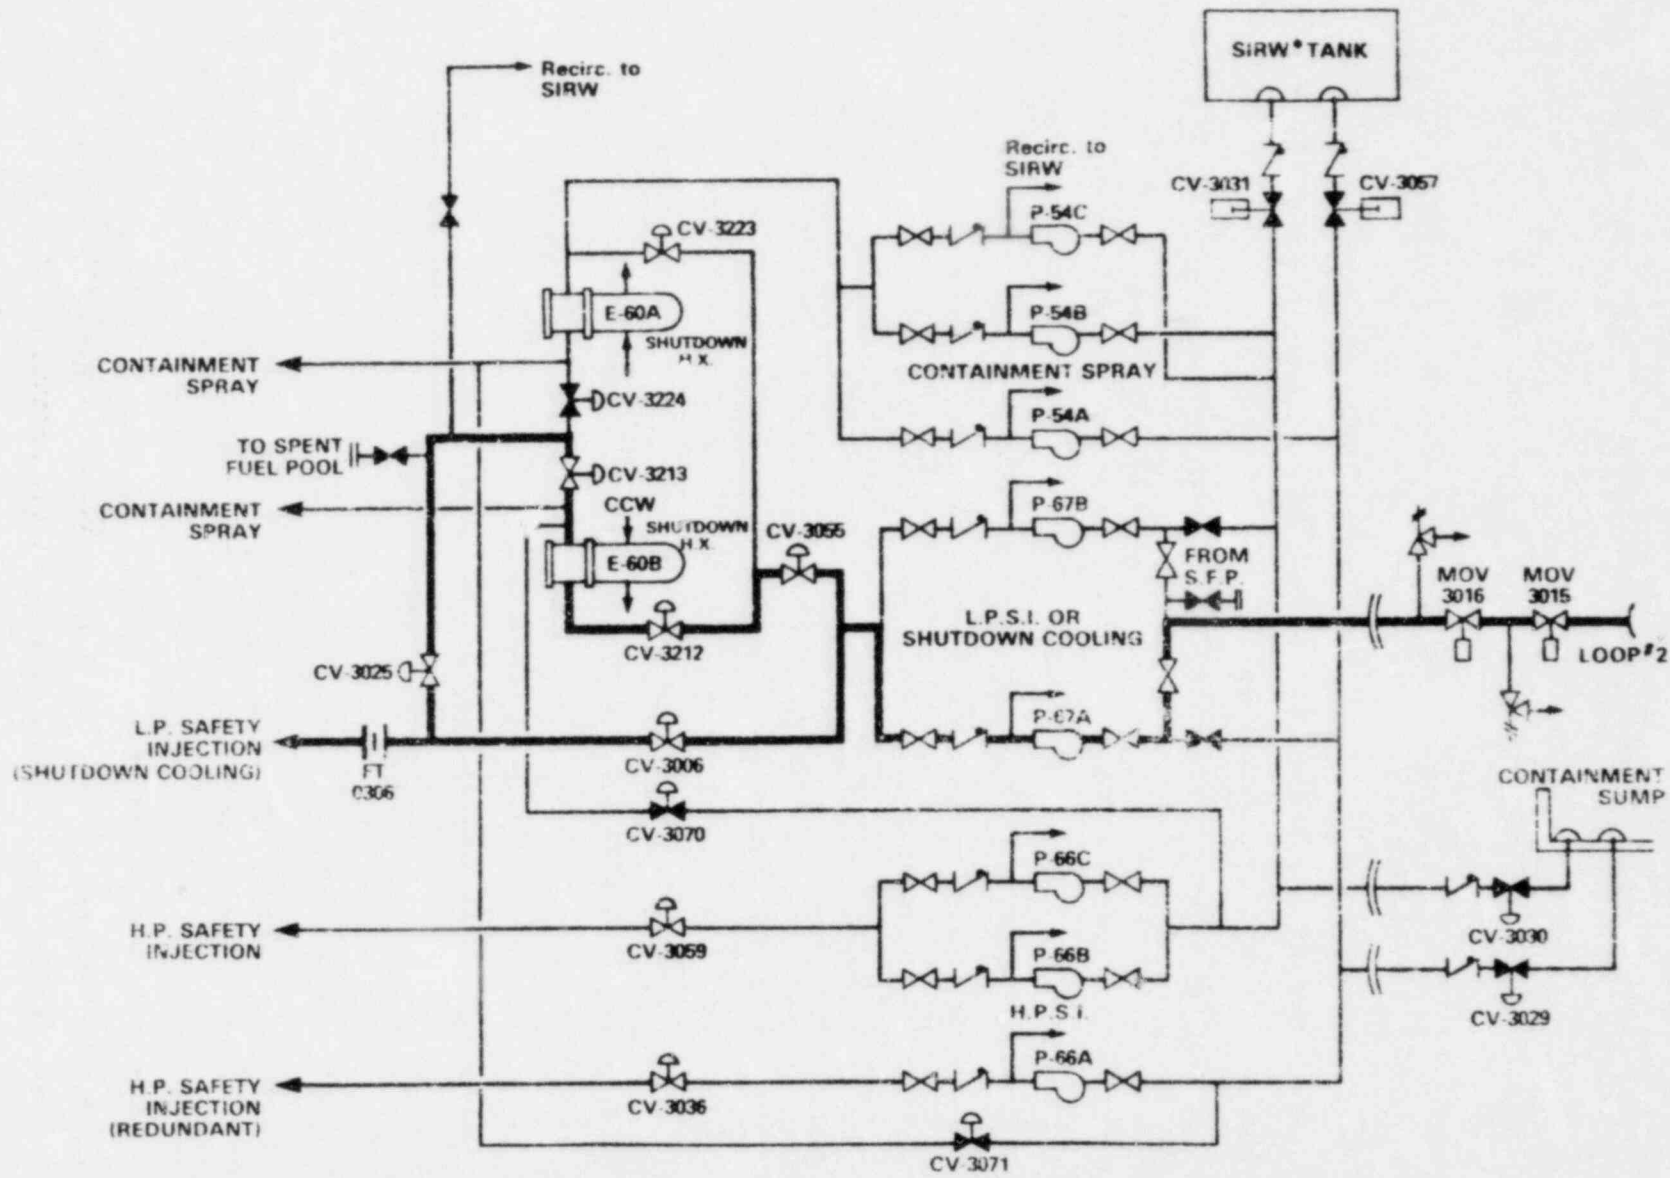
Fig. B.1. Palisades shutdown cooling systems.

1. A single failure can cause loss of shutdown cooling even if both trains of RHR are operable.
2. Moisture buildup in air lines can cause failure of one or more air-operated valves, particularly during periods of high air demand.

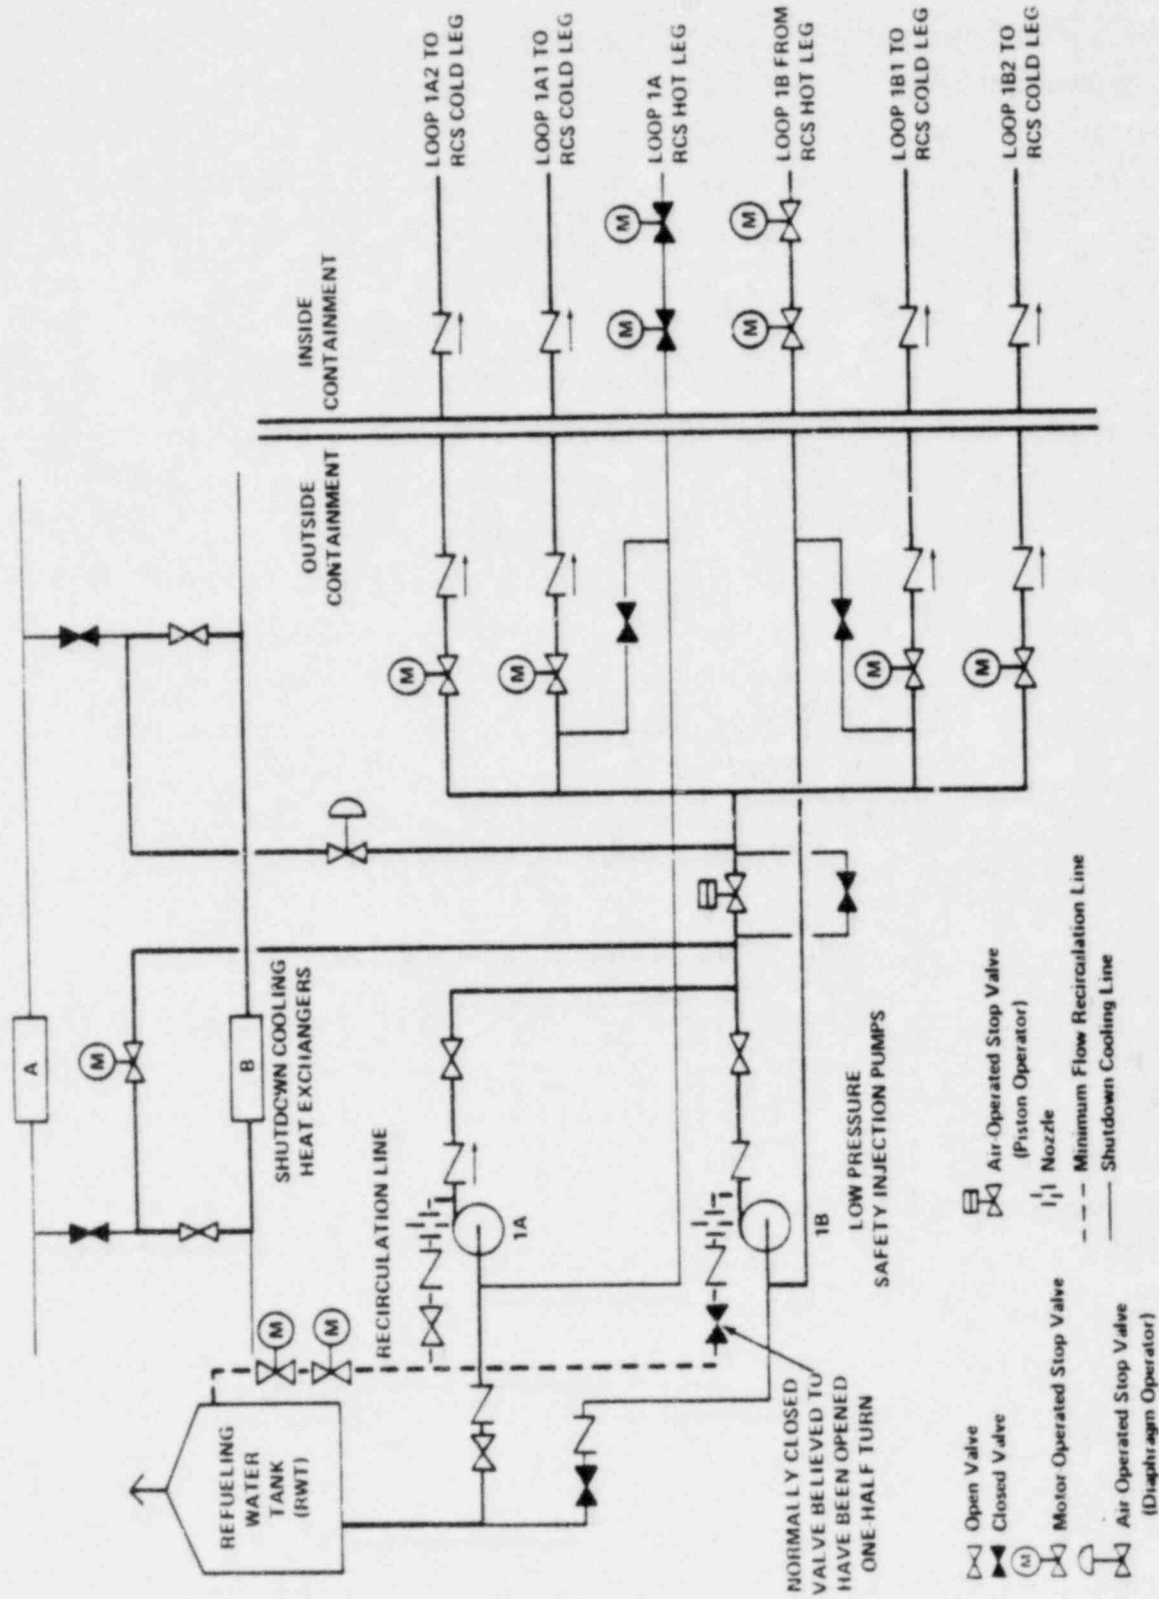
Fig. D.2. Shutdown cooling at St. Lucie.

During the 90 min that the LPSI pump 1A was operating in the injection mode, the RWST gained about 17 m³. A path from the RCS to the RWST existed through the LPSI pump 1B minimum flow recirculation line

(Fig. D.2). After the shutdown cooling system had been warmed, the pump 1B minimum flow manual isolation valve was closed; however, on a check subsequent to the discovery of an increasing RWST level, the valve was found to be one-half turn open, allowing the flow of water back to the RWST. Also, about 90 min after starting, pump 1A was stopped and its recirculation line was isolated. The LPCI pump 1A discharge check valve was a second suspected leakage path through the 1A minimum flow line to the RWST.

Actions recommended in the NRC's IE Circular include: (1) informing all facility-licensed personnel of the possibility of a steam-void formation in the reactor vessel head during natural-convection cooling, even when a high subcooling margin exists in the reactor coolant loops; (2) reviewing and revising procedures for using natural convection for shutdown cooling and cautioning operators against the conditions that occurred, including appropriate recovery action should they occur again; (3) establishing natural-convection cooldown and depressurization rates that will preclude steam-void formation and ensure adequate core cooling; (4) evaluating the design of CCW systems to determine their vulnerability to single failures that could cause loss of RCP cooling, simultaneous common-mode failure of all RCP seals, and reactor-coolant-system leaks through failed seals at multiple locations; and (5) using a temperature-monitoring system for the metal of the reactor vessel head to aid the operator in preventing the formation of a steam void in the reactor head during natural-convection cooling.
