NOTICE OF VIOLATION
AND
PROPOSED IMPOSITION OF CIVIL PENALTIES

Illinois Power Company
Clinton Power Station

Docket No. 50-461
License No. NPF-62
EA 90-108

Areas Inspected: Special, announced team inspection of a licensee identified reportable event of inadequate design flow through components using the Shutdown Service Water (SX) System for cooling water, and actions associated with Generic Letter (GL) 89-13, "Service Water System Problems Affecting Safety-Related Equipment".

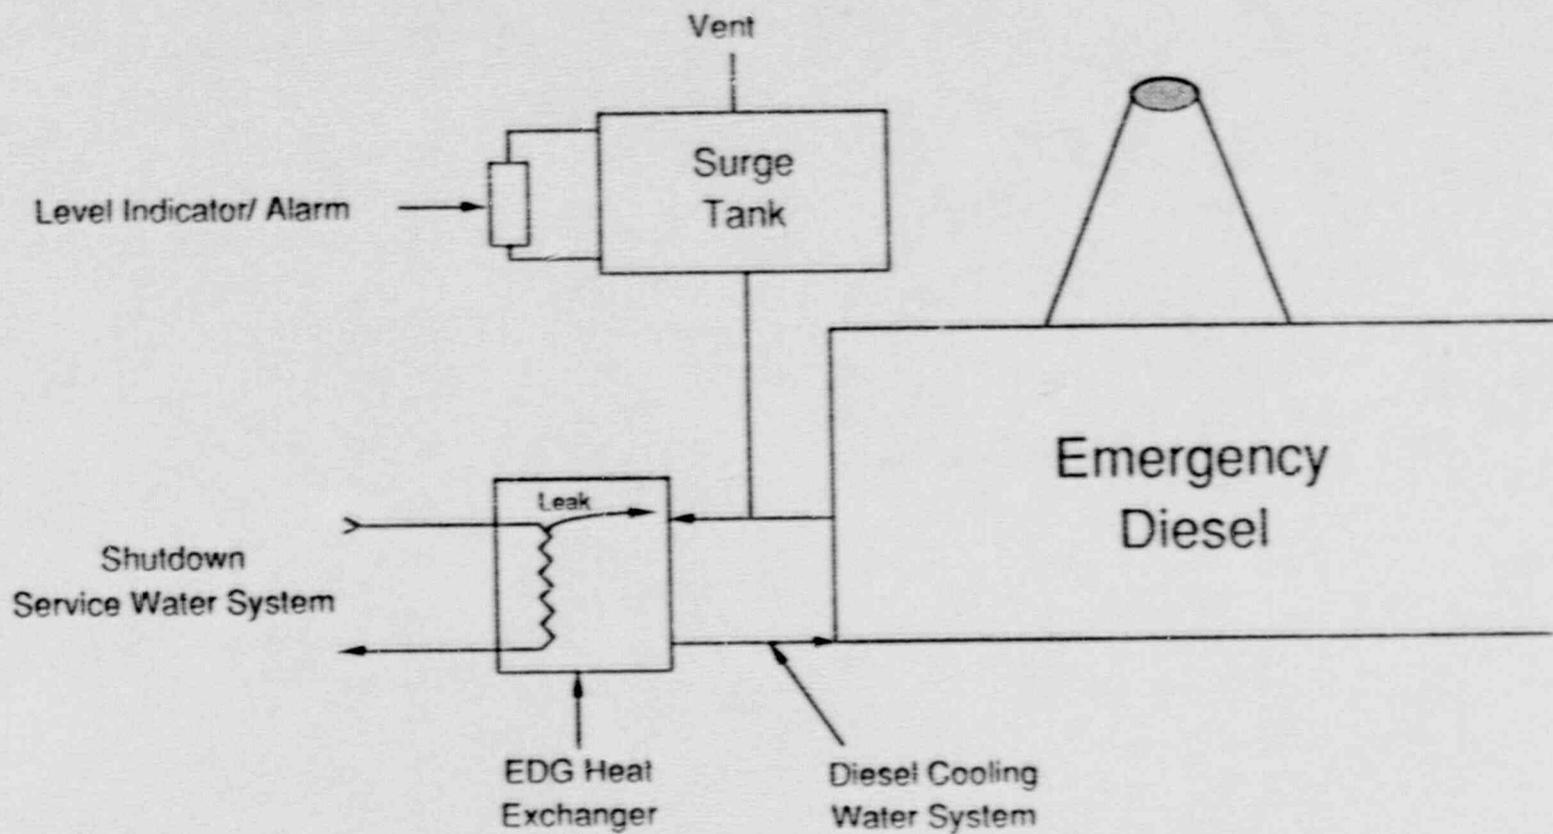
FIGURE 1. Emergency Diesel - SX System Interface

In late December 1989, after approximately three years of commercial operation, a Division I emergency diesel expansion tank high level was observed. The high level was caused by apparent in-leakage from the SX system (having a line pressure of approximately 100 psig) to the emergency diesel generator (EDG) engine closed cooling water system (slightly above atmospheric pressure), reference Enclosure 2. The Division I EDG was declared inoperable and, during the subsequent Limiting Condition for Operation (LCO) of 72 hours, the licensee examined the suspect HX and found through wall pitting in one tube of the dual HX units. The defective tube was replaced with a new tube of like material (90/10 Cu/Ni), the HX was tested, and the EDG was returned to service.

Approximately one week later, a similar tube failure occurred. The HX was repaired, eddy current tested and approximately half of the tubes were cleaned, within a 72 hour LCO. A third failure took place on January 15, 1990, at which time the licensee completely retubed and hydrostatically tested both Division I EDG HX units. A consultant associated with the Electric Power Research Institute (EPRI) was called in to examine the degraded HXs and identified the degradation mechanism as local Microbiologically Induced Corrosion (MIC) accelerated by the thermal and stagnation environment present in the EDG HX tubes.

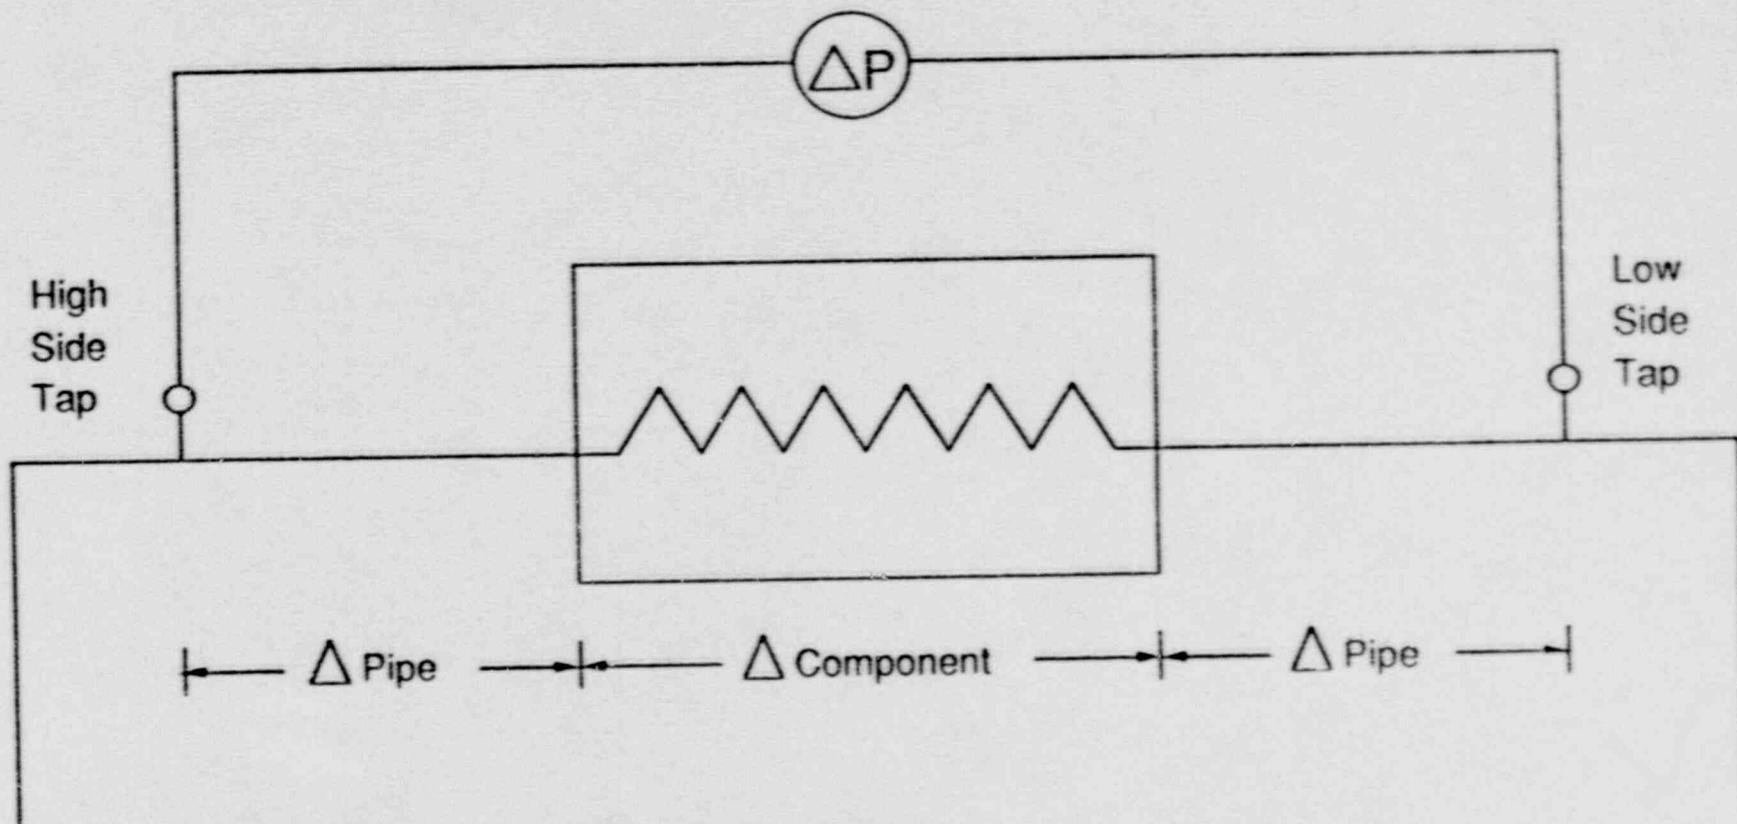
FIGURE 4. Component Differential Pressure Drops

It was noted during the review that the acceptable flow rate values supplied by engineering made no additional allowances for any pressure drops between the taps for differential pressure measuring devices and the cooling coils. The vendor supplied pressure drop data was accountable only for the pressure drop across the coil. The actual locations of the instrumentation used during the preoperational tests could not be established, but assumptions were made of the possible pressure tap locations and additional line losses should have been accounted for. (Reference: Enclosure 4)

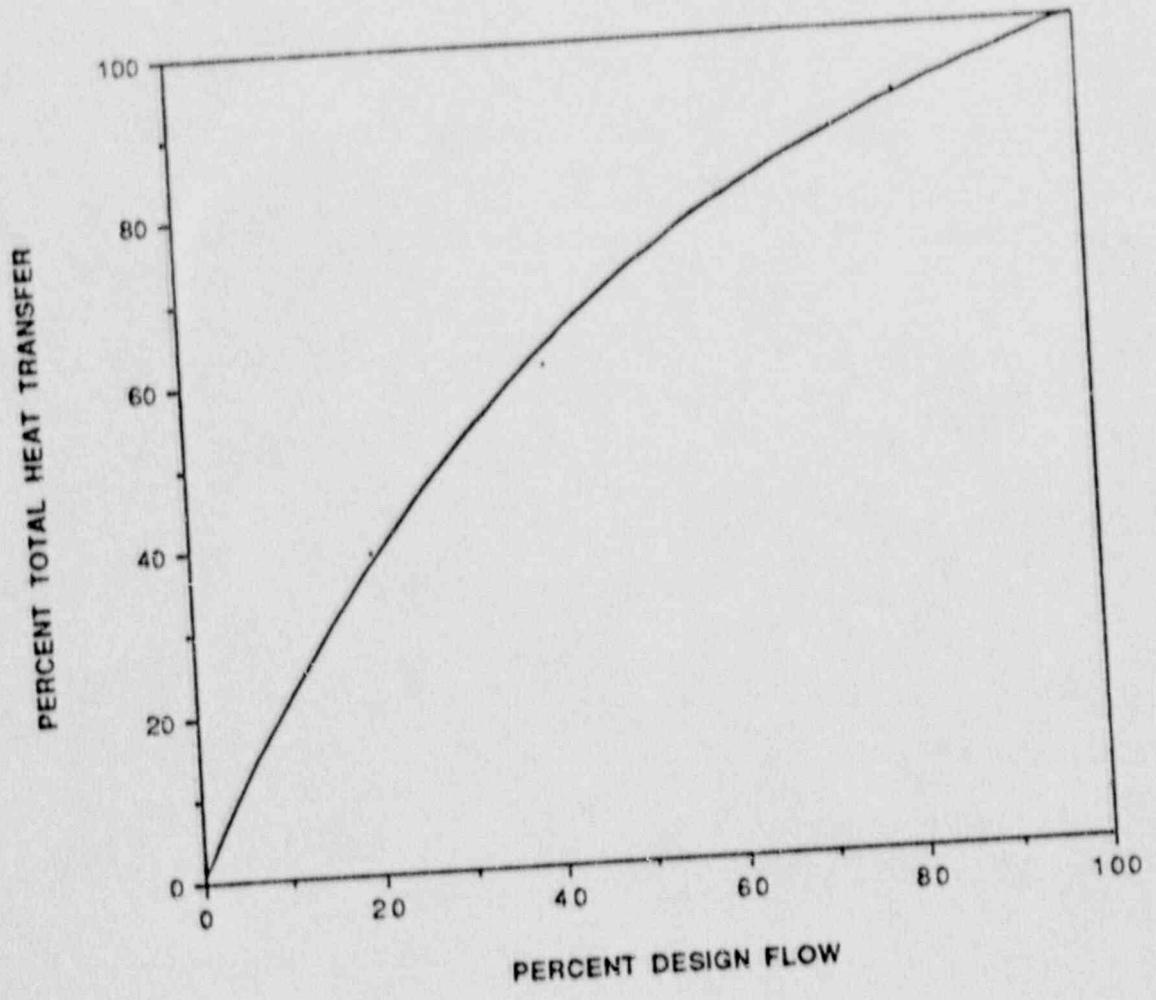
Table 1
Divisions 1 & 2 Shutdown Service Water (SX)
Pre- and Post-balance Component Flows

The minimum component mass flows shown in Enclosure 6 are then found by subtracting the measurement uncertainty from the indicated measurement value. For example, the first entry (1VH07SA) had a component design flow rate of 82 gpm, while the as-found flow (sonic transducer measurement prior to any flow adjustment) was measured at 20.5 gpm. The minimum possible flow is then found by subtracting the uncertainty in the measurement from the registered value. This means that the flow could have been as low as 16.0 gpm. Following the flow balance, the component had a flow measured by sonic transducer of 102 gpm.

Prior to flow balancing using ultrasonic velocity detection devices described previously in this report, the following Divisions I and II heat exchangers in the safety-related portion of the SX System were calculated to have insufficient cooling capacity to meet the LOCA and/or cooldown requirements as specified by the Clinton USAR. The conclusions reflect the pre-flow balanced condition as measured by the ultrasonic flow velocity transducers, and instrument accuracy has been accounted for in all calculations.
