U. S. NUCLEAR REGULATORY COMMISSION
REGION I

Report No. 50-219/93-18
Docket No. 50-219
License No. DPR-16
Licensee: GPU Nuclear Corporation
1 Upper Pond Road
Parsippany, New Jersey 07054
Facility Name: Oyster Creek Nuclear Generating Station (OCNGS)
Inspection Period: August 23-26, 1993 and October 18-20, 1993

Areas Inspected

ALARA, RIRs, QA audits, air and swipe sample counting facilities, and radiological controls organization staffing.

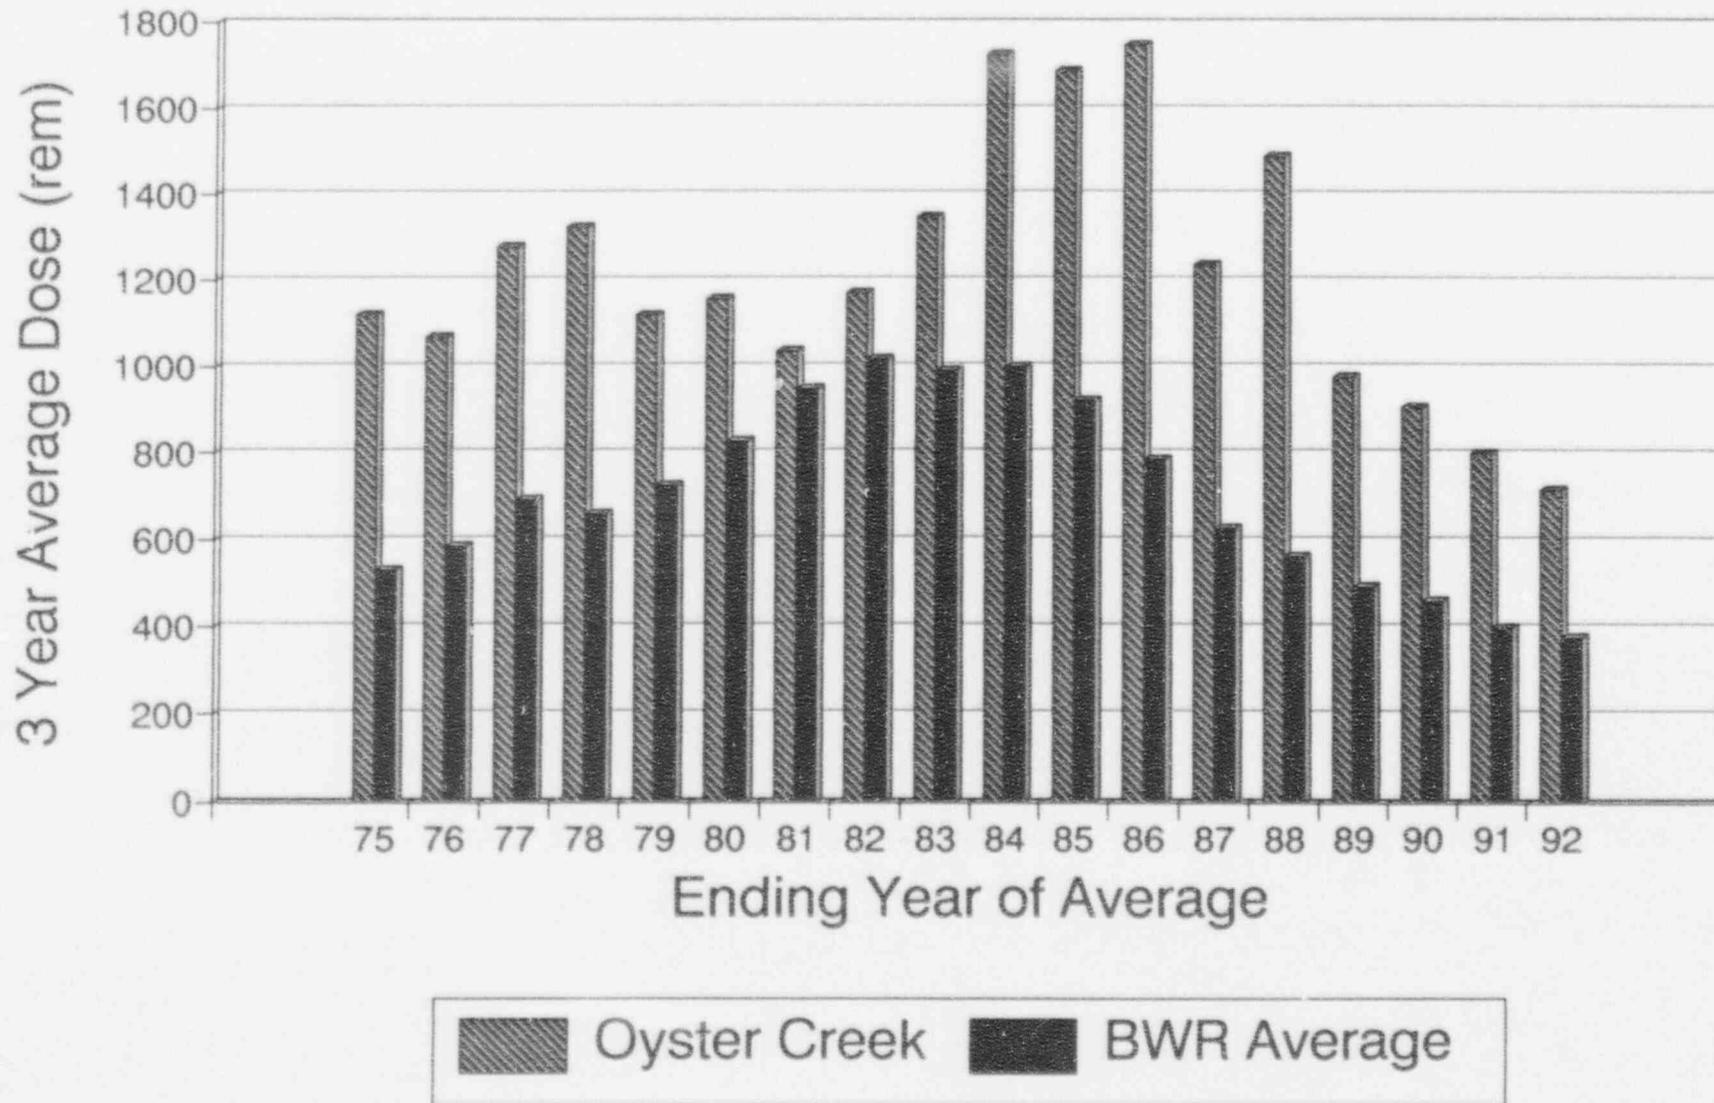
ATTACHMENT 1

Licensee progress in this area is given in Section 2.6 of this report. See Attachment 1 for a graphical representation of the licensee's three-year rolling average cumulative exposure. While the graph shows OCNGS as being a high exposure BWR, it also shows that source reduction efforts have achieved significant results (the slope of the OCNGS curve is greater than that of the BWR average curve).
