UNITED STATES
NUCLEAR REGULATORY COMMISSION

October 20, 1980

FACILITY: Trojan Nuclear Plant

SUBJECT: SUMMARY OF MEETING HELD ON SEPTEMBER 30, 1980 WITH PGE/
WESTINGHOUSE TO DISCUSS INTERIM LABORATORY EXAMINATION RESULTS
OF STEAM GENERATOR ROW 1 U-BEND TUBE SAMPLES REMOVED FROM
TROJAN

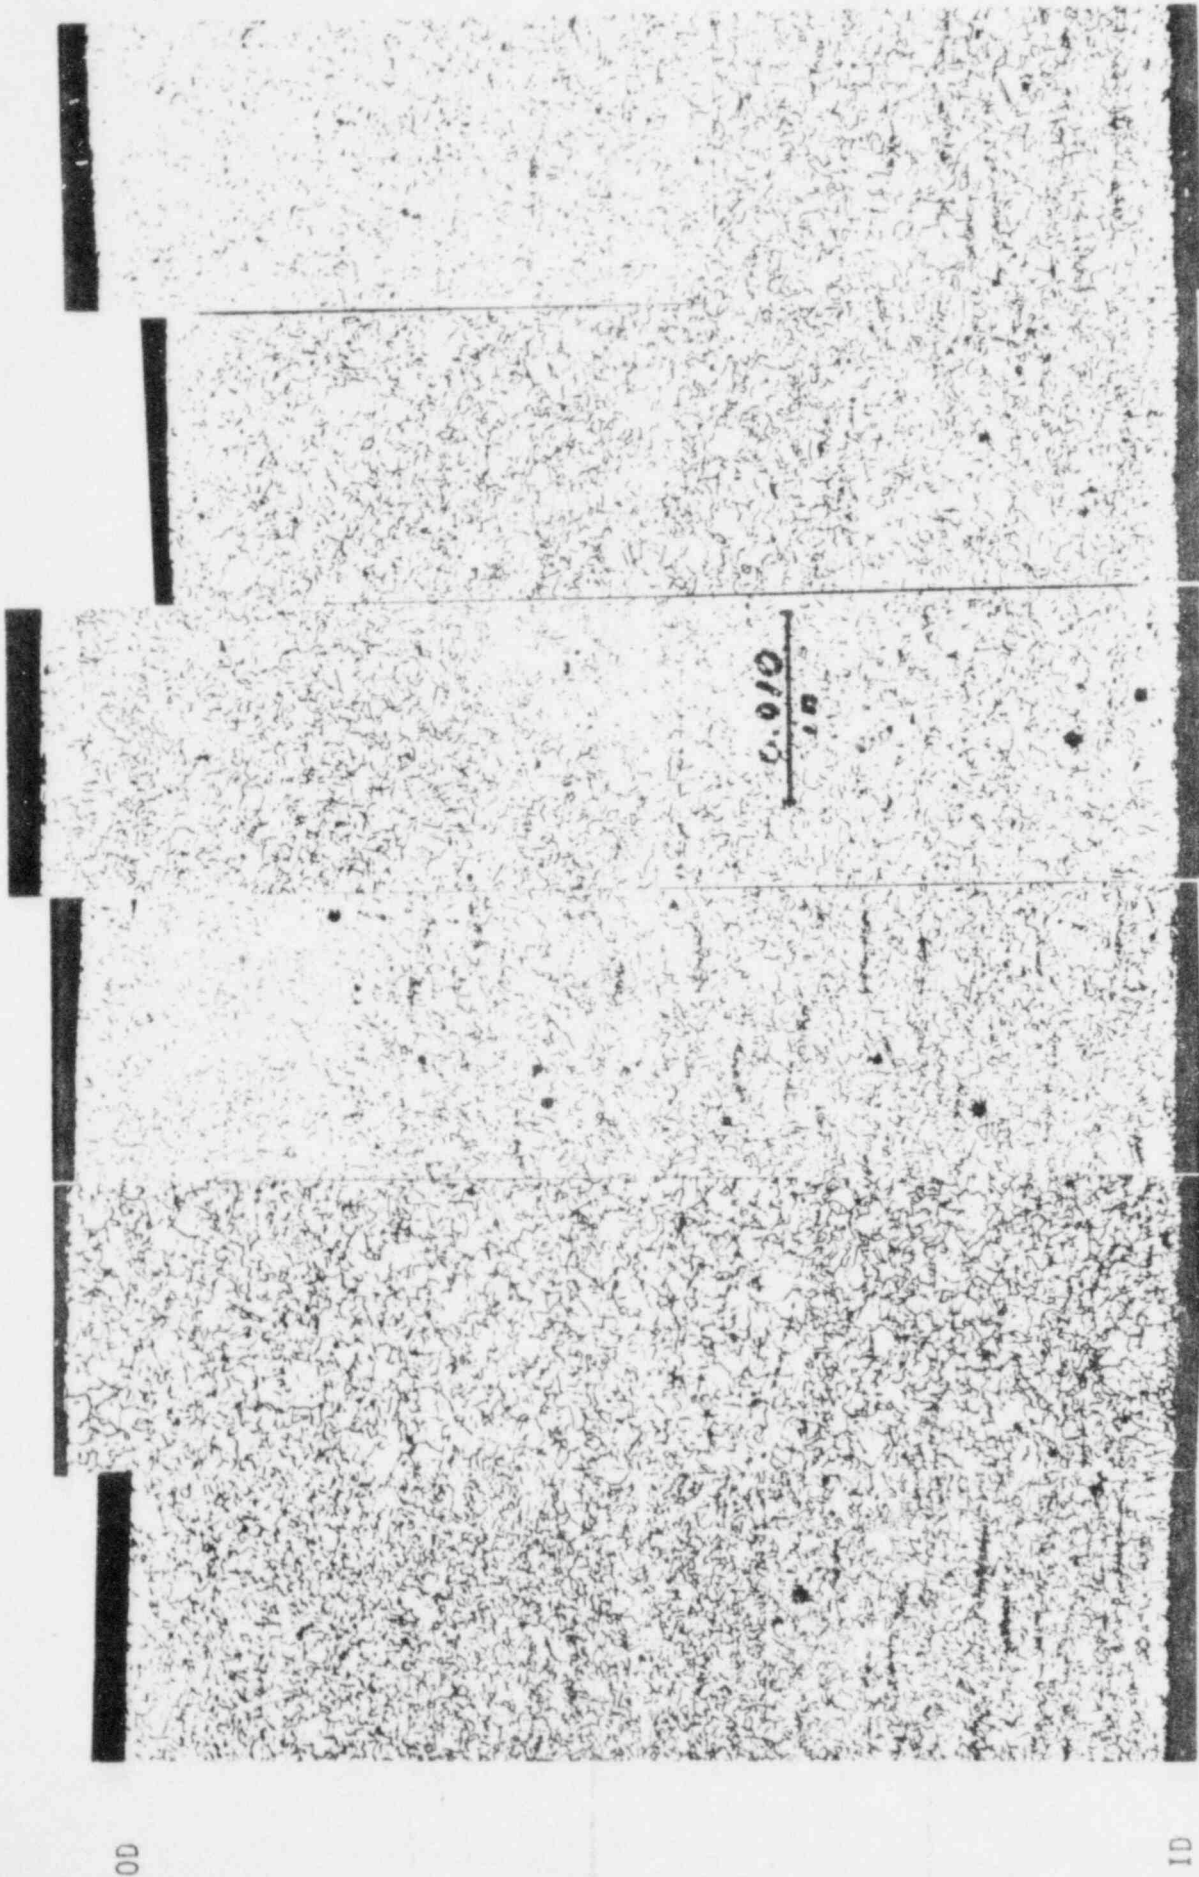
Figure 3. Comparison of straight section through wall microstructures for 3 tubes with and three tubes without x-ray indications.

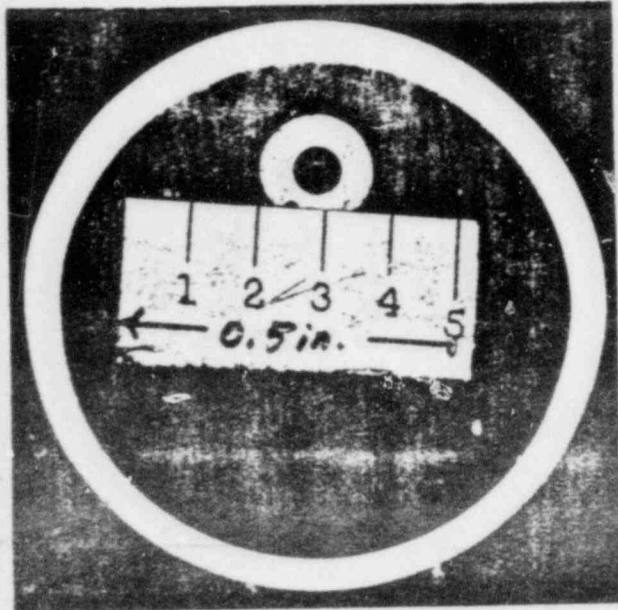
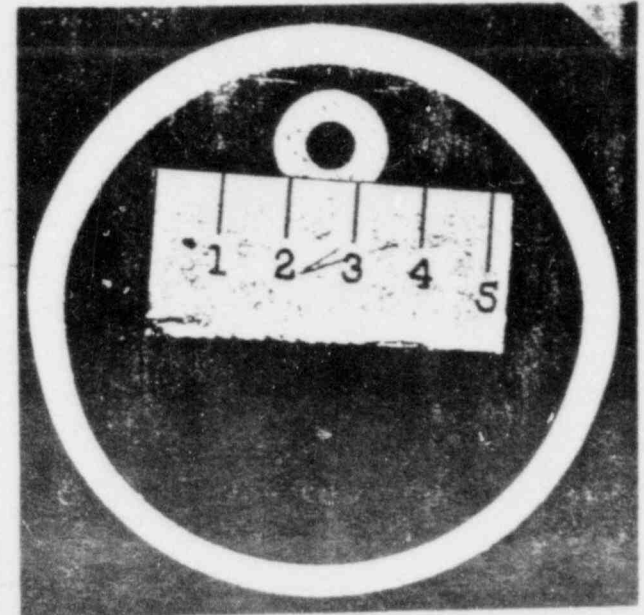
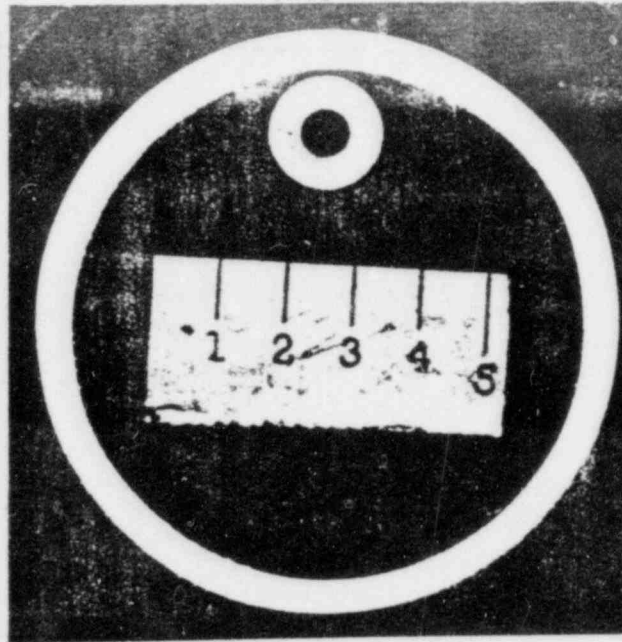
Figure 4. As-polished cross-sections at apex for tubes R1-C6, R1-C10, and R1-C22 showing variations in dimensions. Angular positions are given plus wall thicknesses in mils as-measured with thread micrometers prior to mounting.

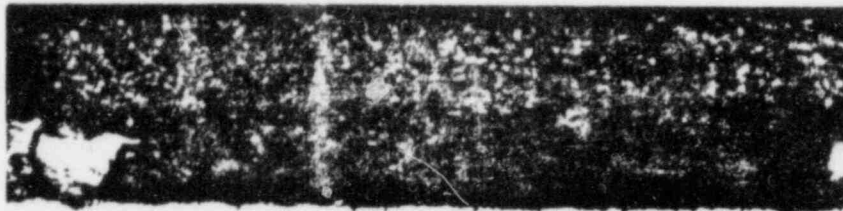
Figure 5. Shallow intergranular penetrations on the I.D. at the extrados on Section 6F (R1-C6). These were observed to a lesser extent at the flank (90°) and 0° positions.

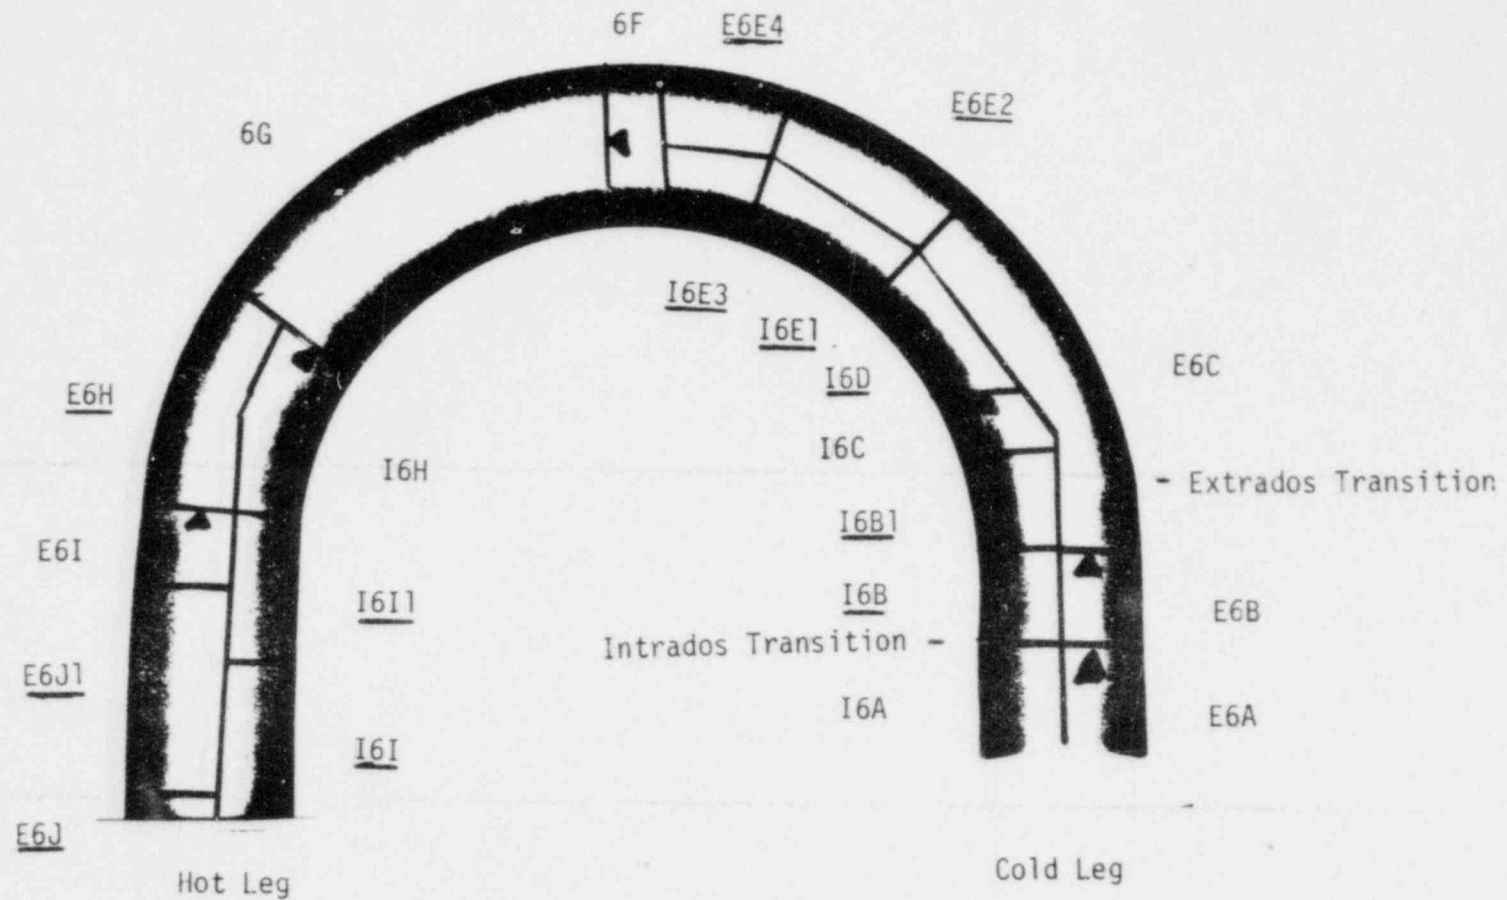
Figure 6. Print of double wall x-ray radiograph of RI-C6. Solid lines shown approximate locations of major cuts; sections are identified; surfaces polished for metallography are designated by ▲. Underlined sections were flattened and their ID surfaces examined at 5X. Further cuts of E6C are given in next figure.

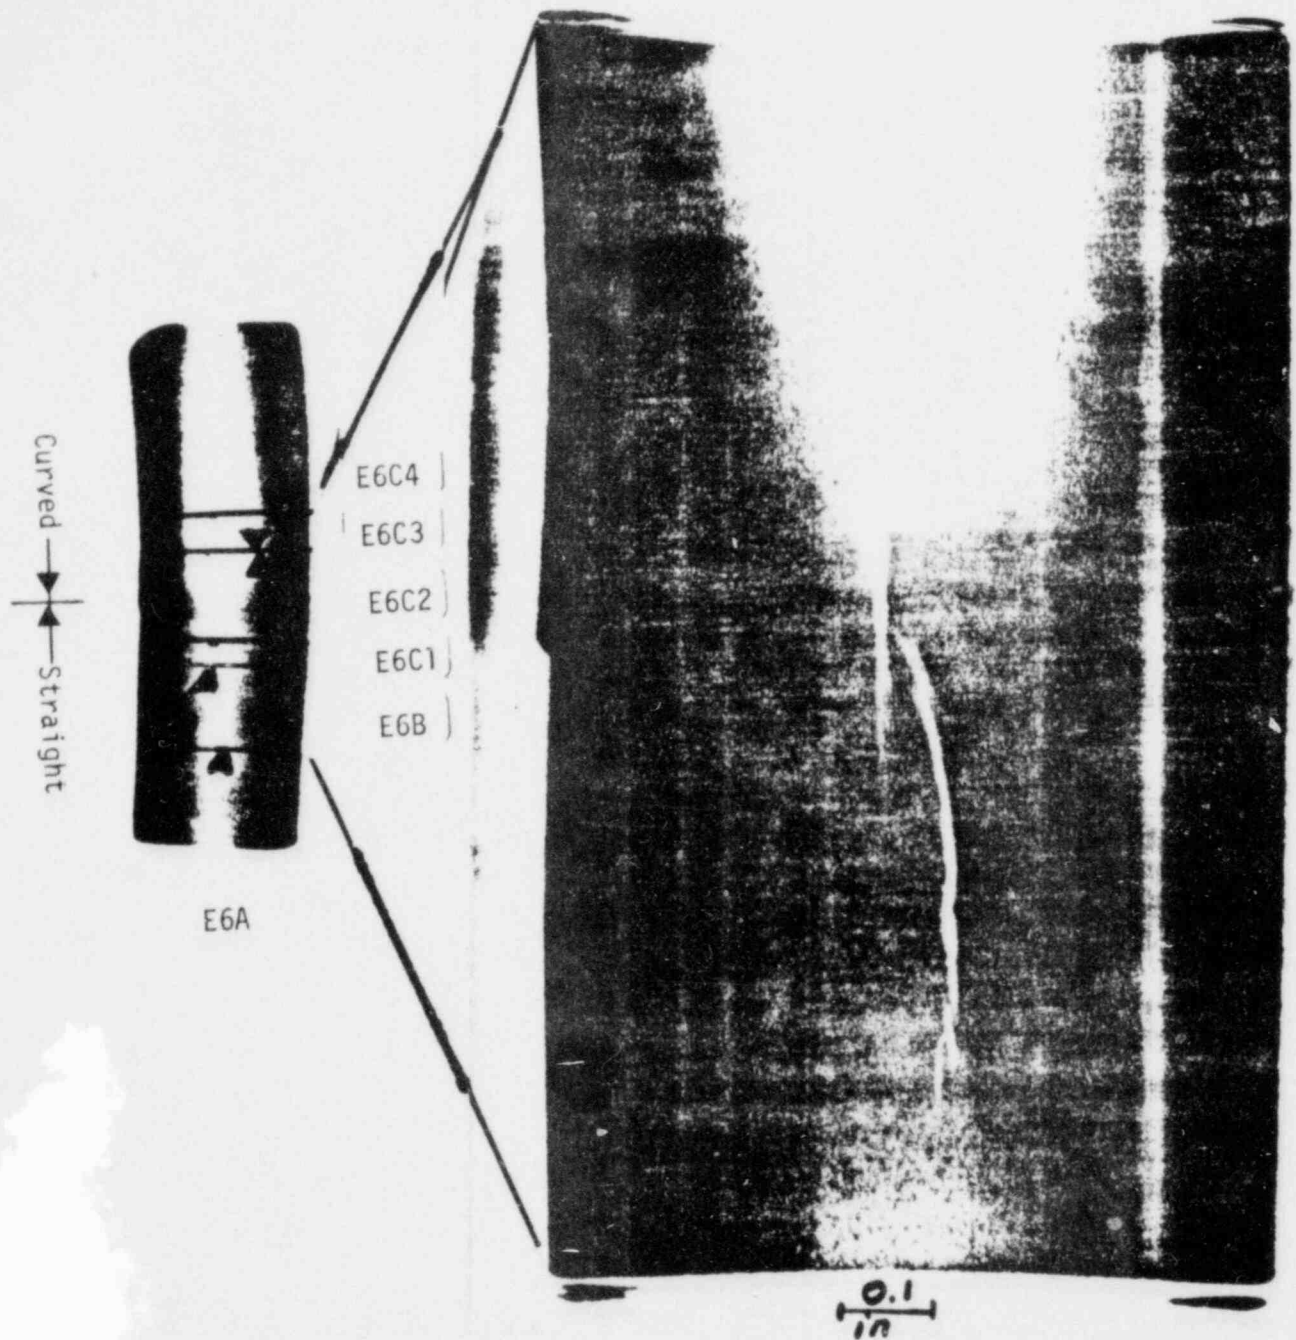
Figure 7. Prints of single wall x-ray radiographs of the cold leg of tube R1-C6 showing cracks at the extrados (180°) and near the transition from straight to curved. (Section was subsequently cut to form E6A, E6B and E6C.)

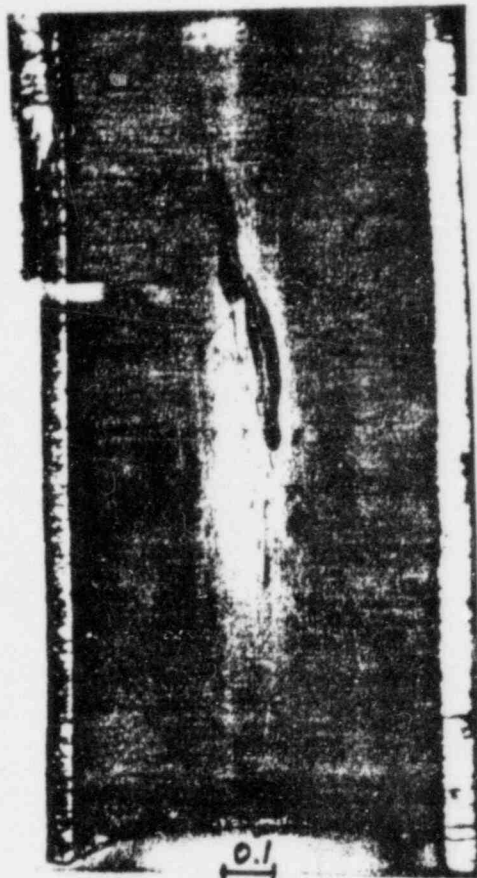
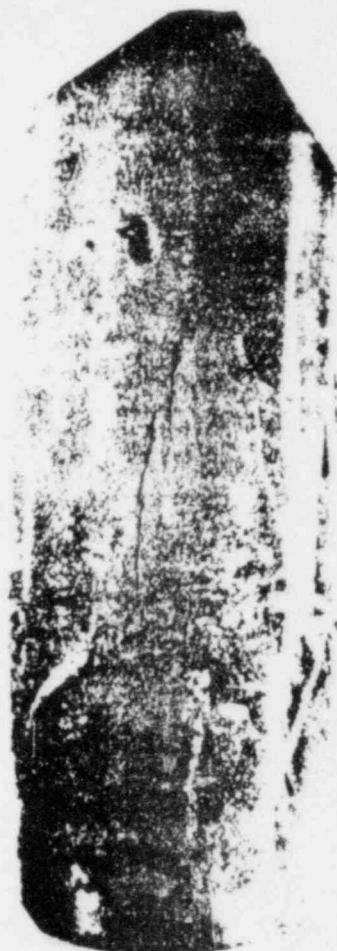
Figure 8. Photographs of I.D. and O.D. surfaces in the neighborhood of the crack on the cold leg of tube R1-C6. A bluish deposit color is evident on I.D. at location of crack. Distance of end of crack from cut tube-sheet-end was 0.71" on I.D. and 0.85" on O.D.

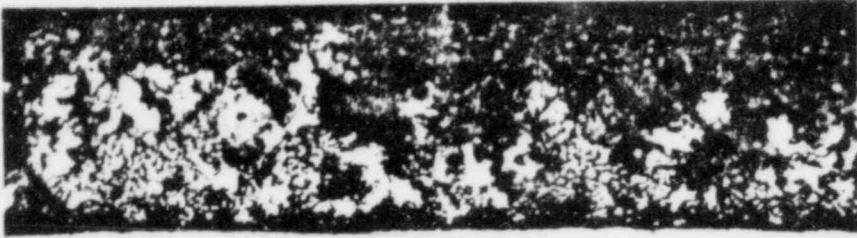
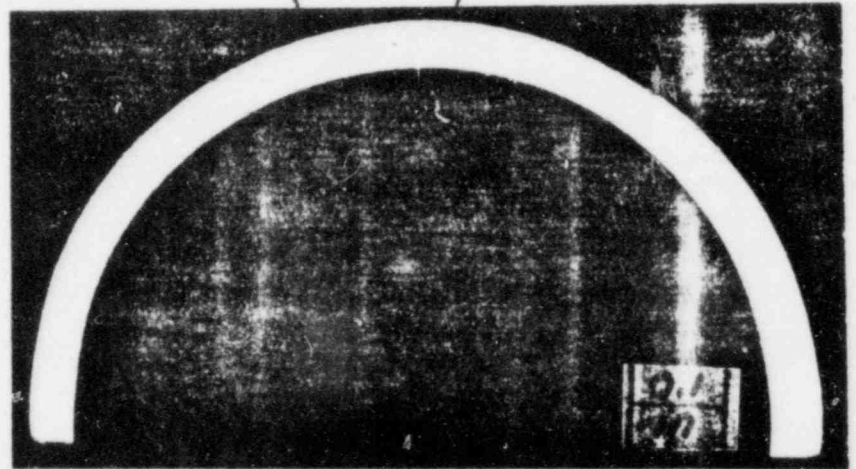
Figure 10. First plane of polish on section E6B showing through wall crack at extrados, 1.5 mils of deposits on O.D. and IG penetration on I.D.

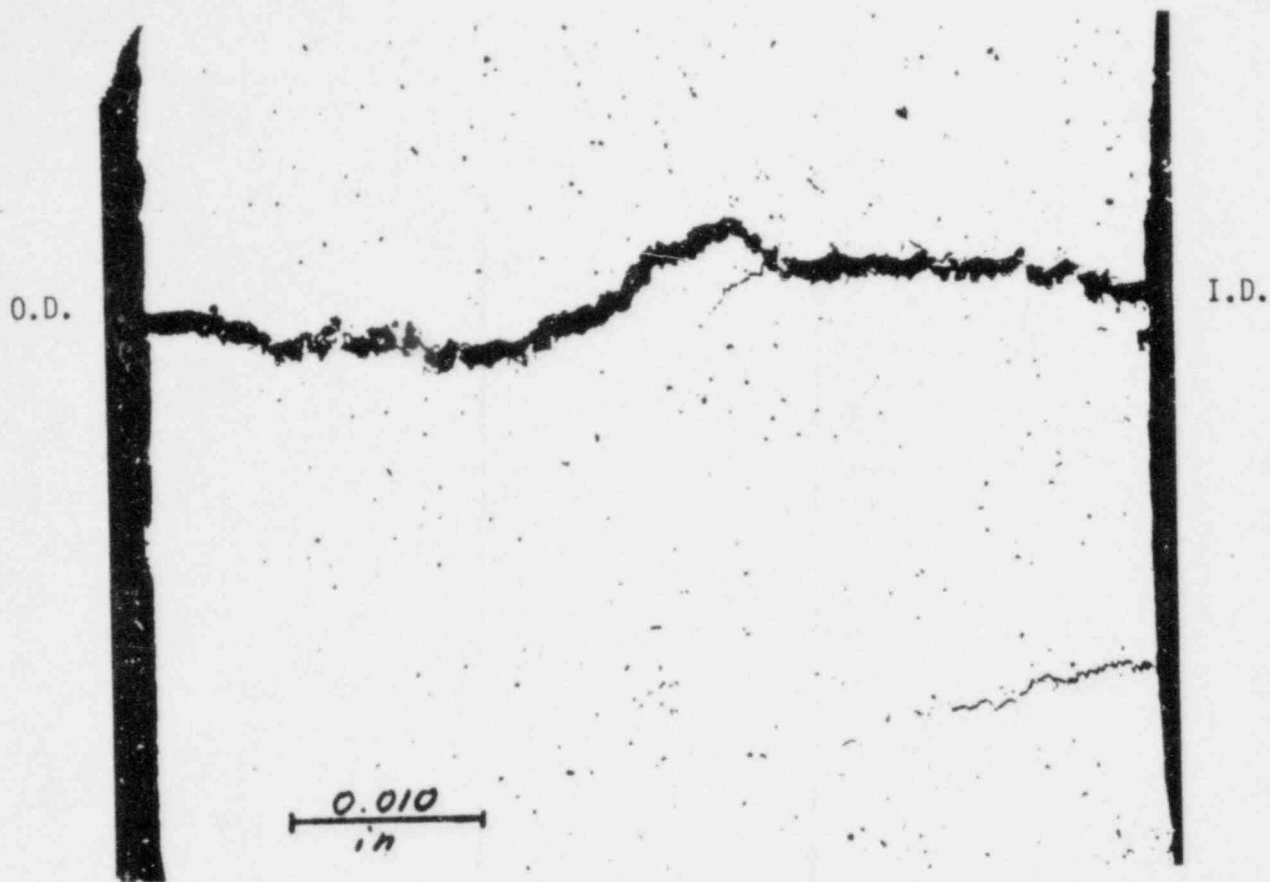
Figure 11. Through wall crack on first plane of polish on Section E6B; wall thickness is ~ 51.5 mils.

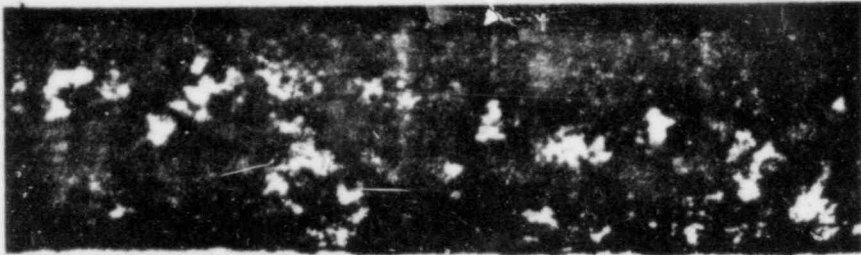
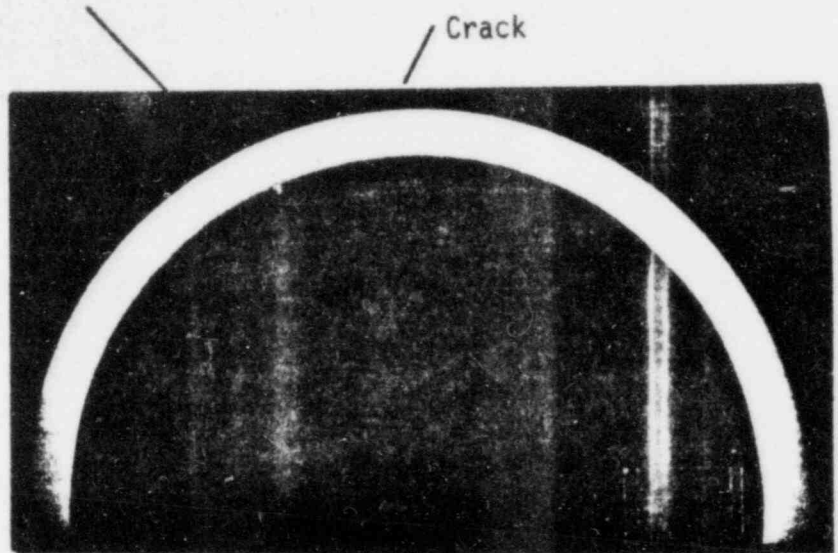
Figure 12. Second plane of polishing (45 mils below first plane) on Section E6B showing through wall crack, O.D. surface deposits, and shallow I.D. intergranular penetrations.

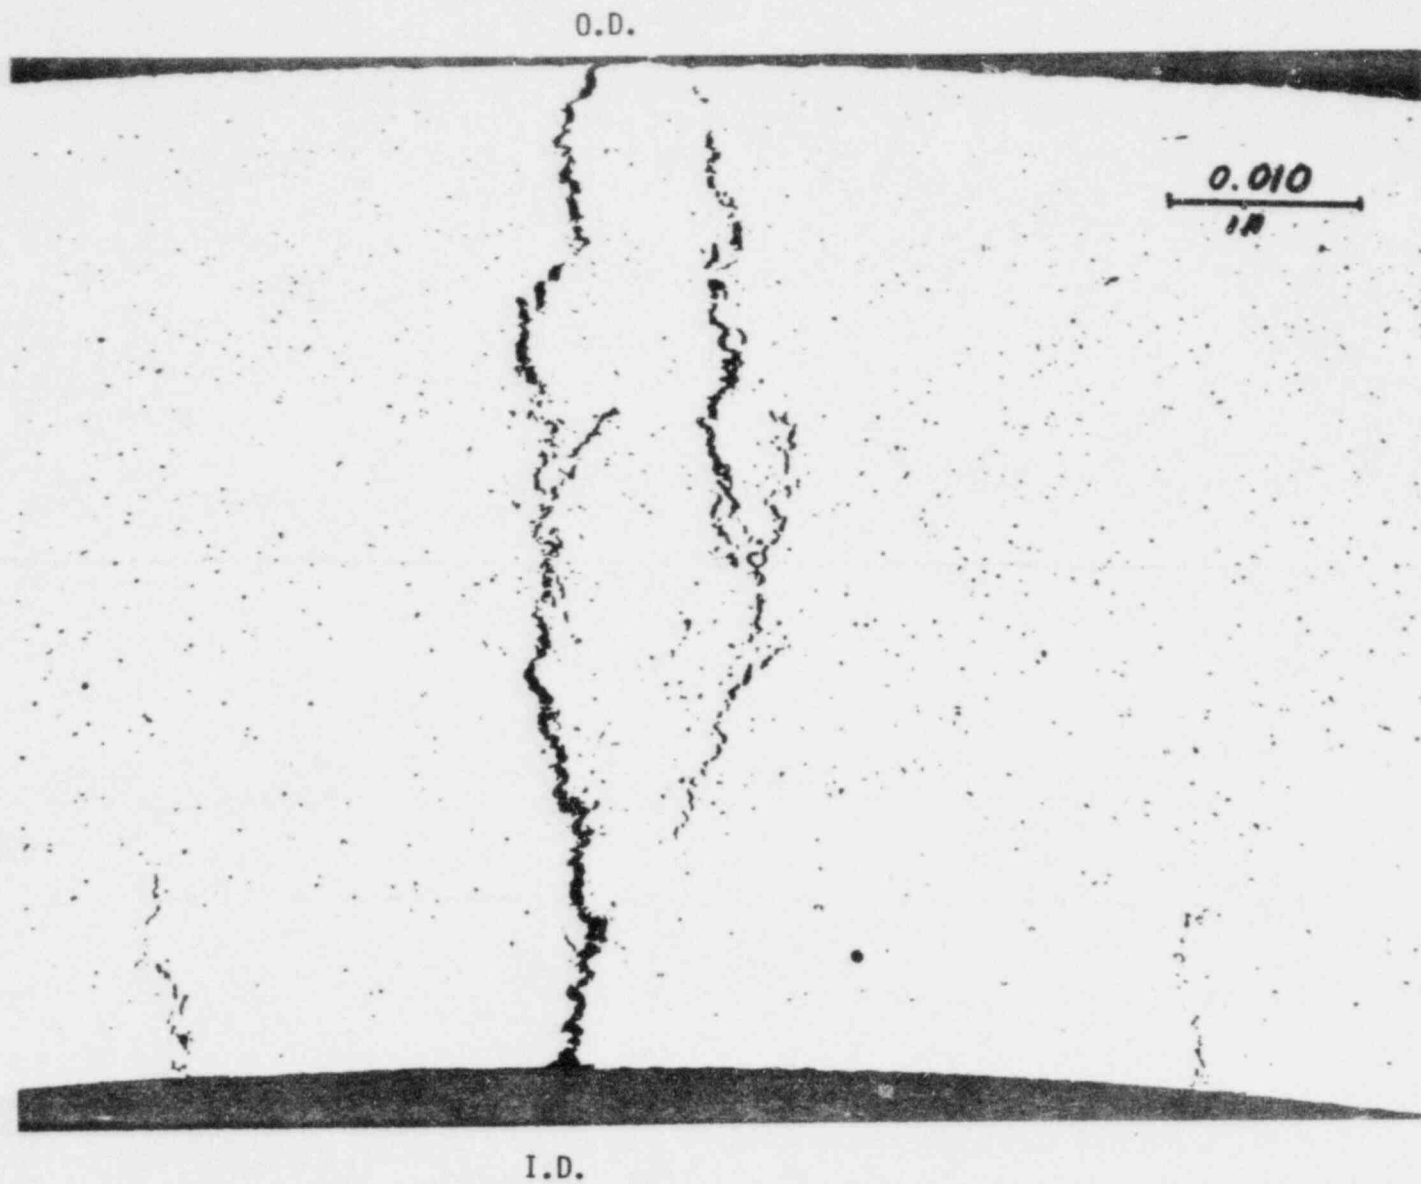
Figure 13. Through wall crack observed on second plane of polish of Sect. E6B.

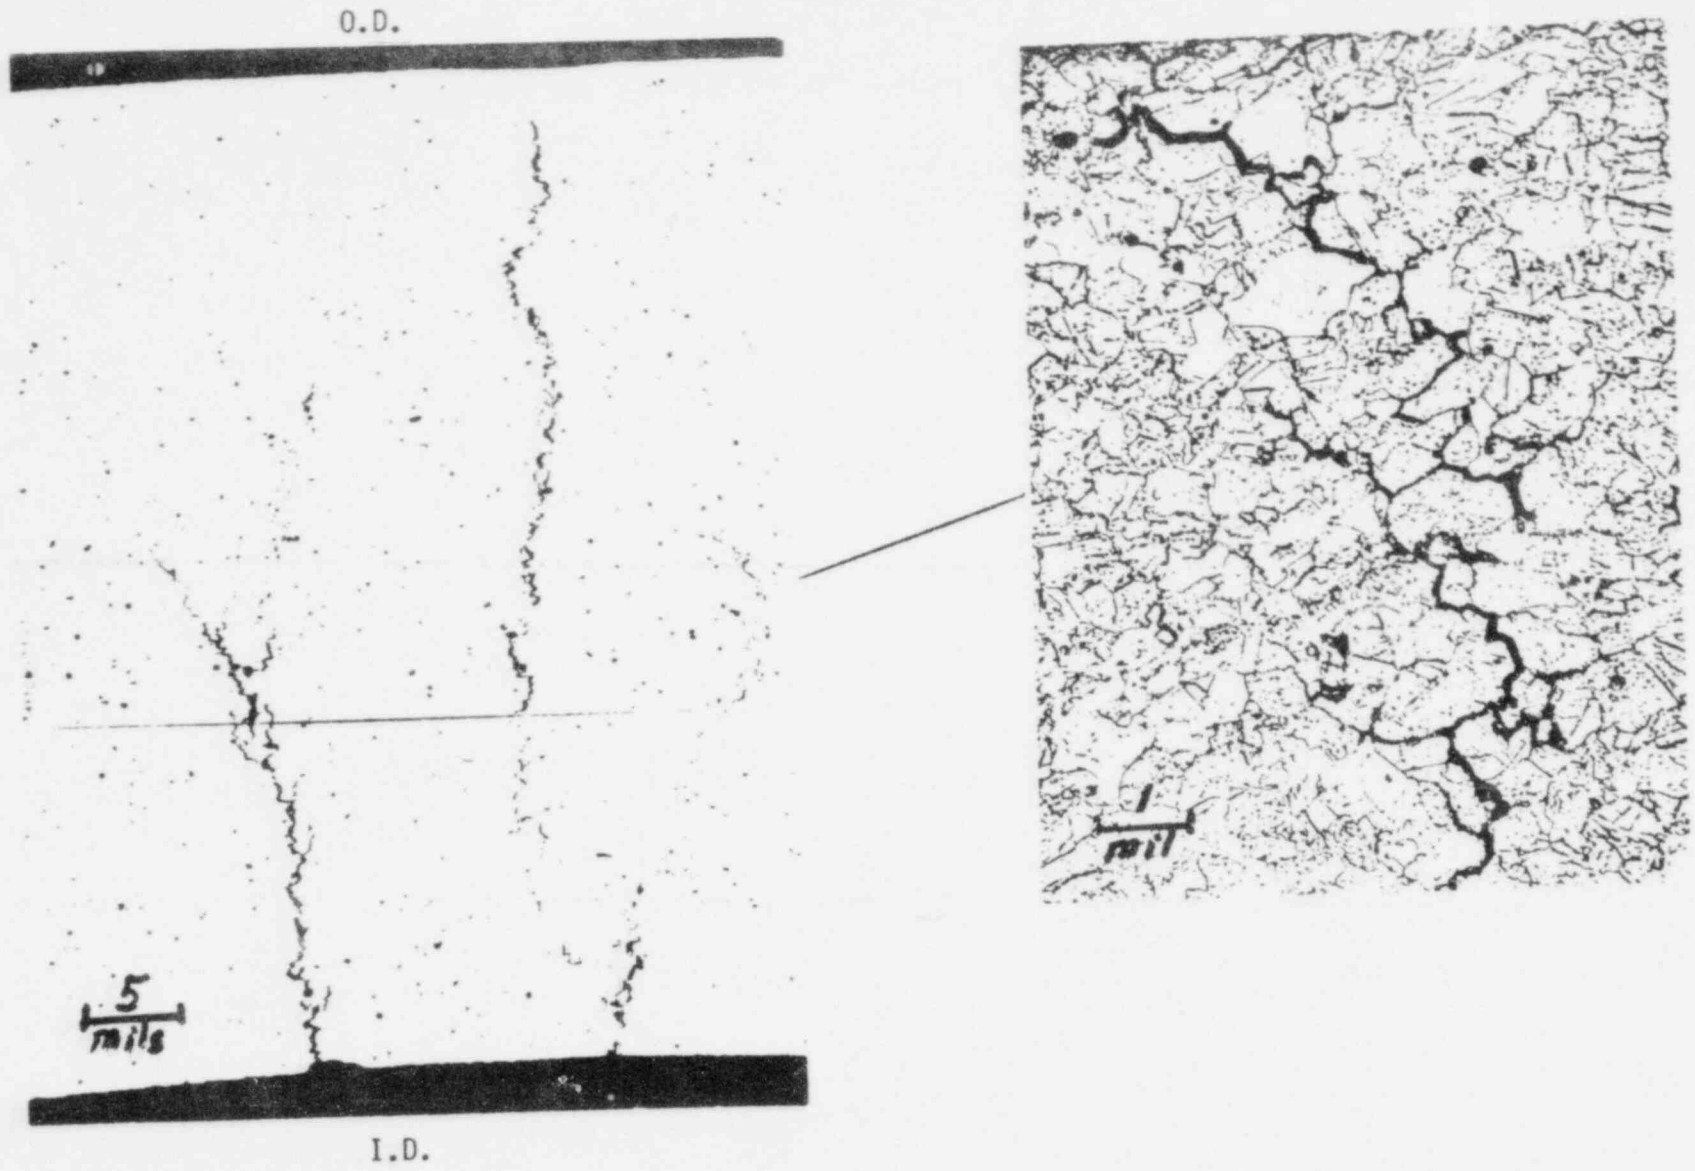
Figure 14. Third plane of polishing (33 mils below second plane) of Section E6B at the extrados.

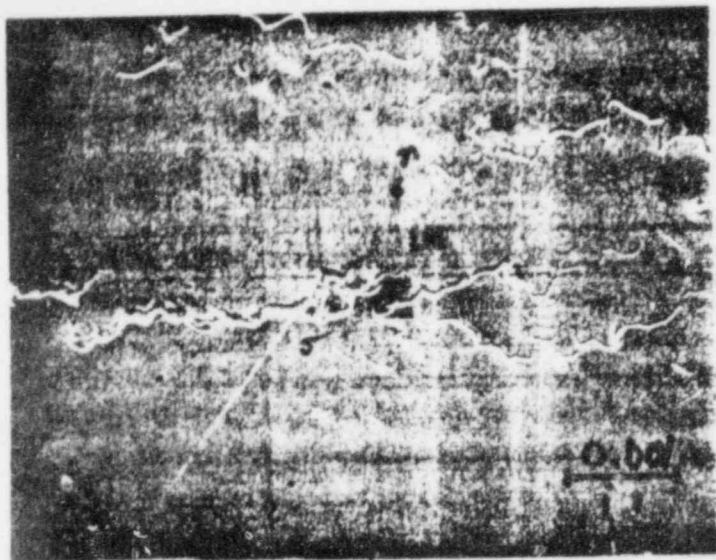
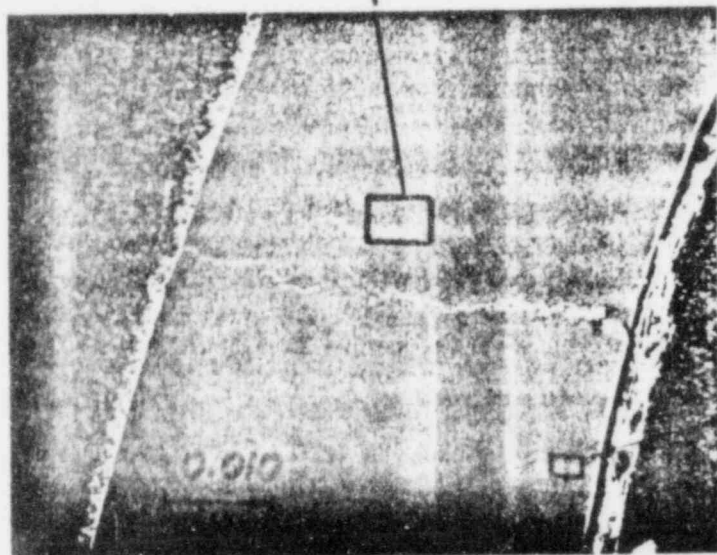
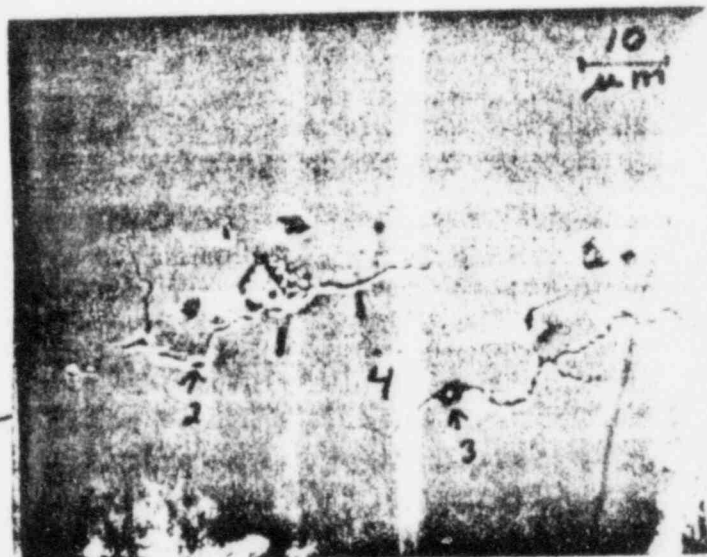
Figure 15. SEM micrographs of cracks in 2nd polished plane of sect. E6B (R1-C6 tube) showing areas examined with energy dispersive X-ray analyses (identified by numbers). Only Si and Na were identified as present plus alloying elements found in Inconel 600.

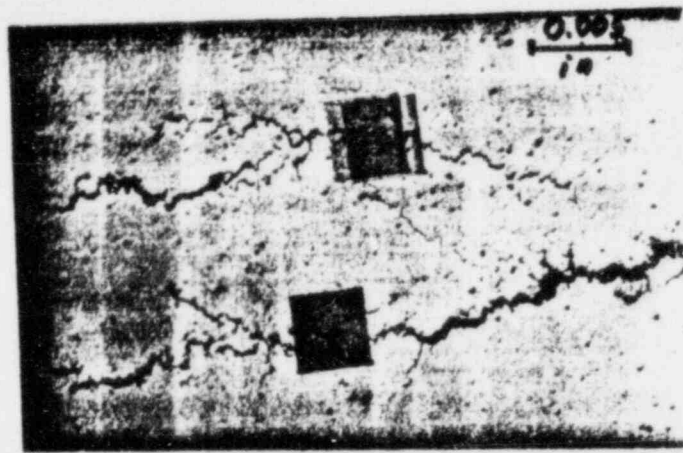
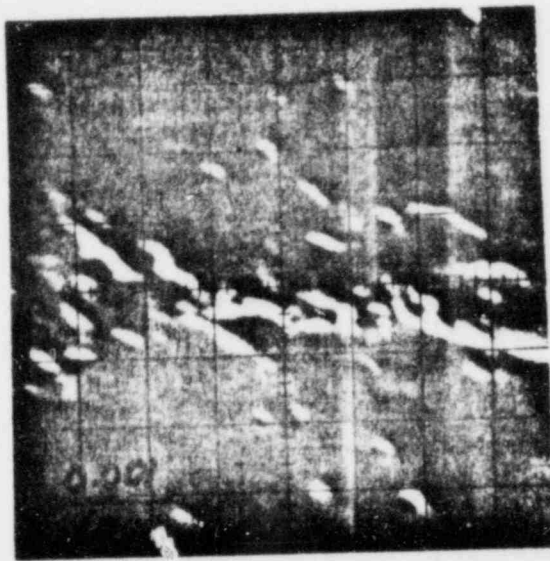
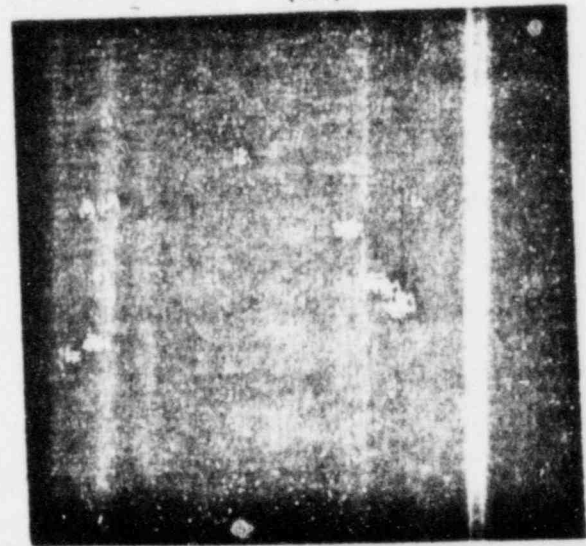
Figure 16. Two areas on the 2nd polished plane of E6B (R1-C6) were examined with Electron beam micro analysis for Si, P, S, Pb, K, Na and As, and are shown in the photograph obtained with the light microscope (LM). Similar results were obtained for both areas. Back scattered electron micrograph (BSE) is shown for Lower area. Si was detected in localized areas. None of the other elements was detected by area scans or by line traces through tight cracks.
