U.S. NUCLEAR REGULATORY COMMISSION

Report No. 50-320/82-07

Facility Name: Three Mile Island Nuclear Station, Unit 2

Inspection Conducted: May 23 - July 5, 1982

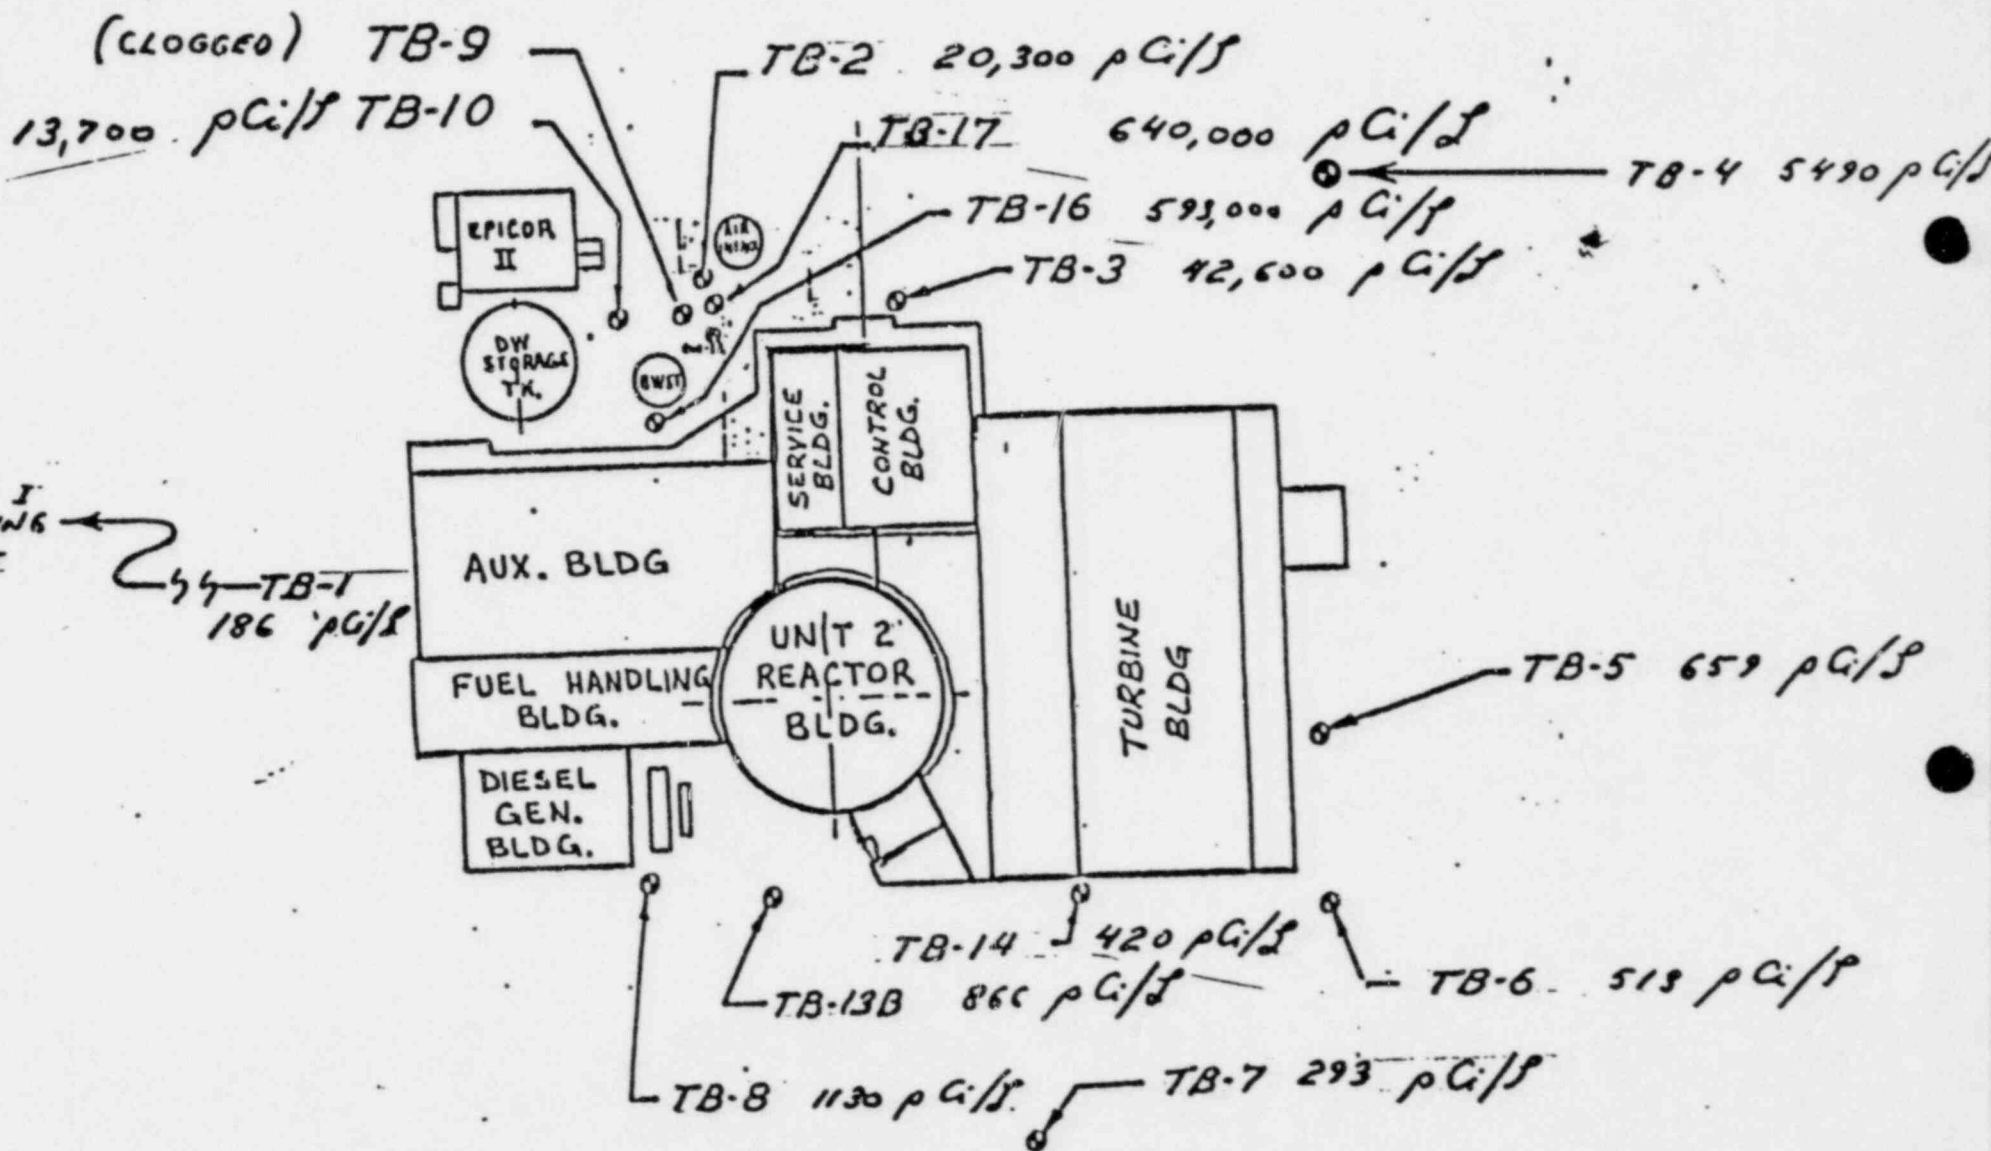
FIGURE 1

1. Groundwater Monitoring Program. The licensee samples onsite groundwater by means of test borings (see Figure 1). Weekly water samples are taken from borings 1, 2, 3, 10, 16, and 17. The other test borings are sampled monthly except test boring 9 which is clogged. During April, 1982, the licensee reported analytical results for groundwater samples taken from onsite test borings in February and March of 1982. Changes in tritium concentrations were noted for test borings 2, 3, and 17. A sample taken from test boring 17 on March 23, 1982, contained a tritium concentration of 1,100,000 pCi/l. The previous highest reading for test boring 17 was 678,000 pCi/l, for a sample taken February 25, 1982. Test boring 2, was reported as 954,000 pCi/l, for a sample taken February 12, 1982. More recent samples from test boring 2 showed reduced levels of tritium, down to 30,900 pCi/l for a sample taken March 23, 1982. The tritium levels for test boring 3 went from about 2,400 pCi/l on March 9, 1982, to 24,700 pCi/l on March 23, 1982. The licensee instituted a systematic program to identify the source of the tritium. The NRC independently analyzed water samples taken from these test borings on April 8, 1982.

The maximum permissible concentration (MPC) of tritium in unrestricted areas, as required by 10 CFR Part 20, is 3,000,000 pCi/l. The increased concentrations have remained below MPC. The increased tritium concentrations were only noted in the test borings near the Borated Water Storage Tank. The samples from aquatic environment in the TMI area did not indicate any apparent increase in tritium concentrations.

TEST BORING H³ CONCENTRATIONS

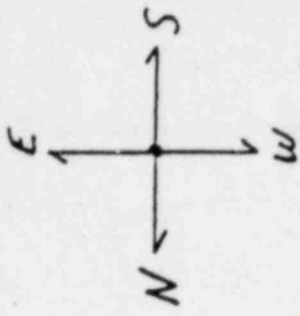
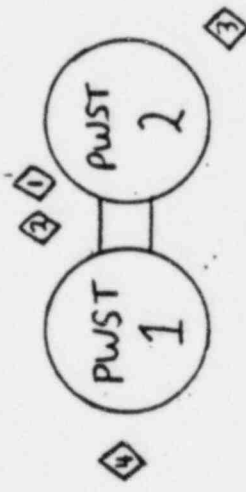
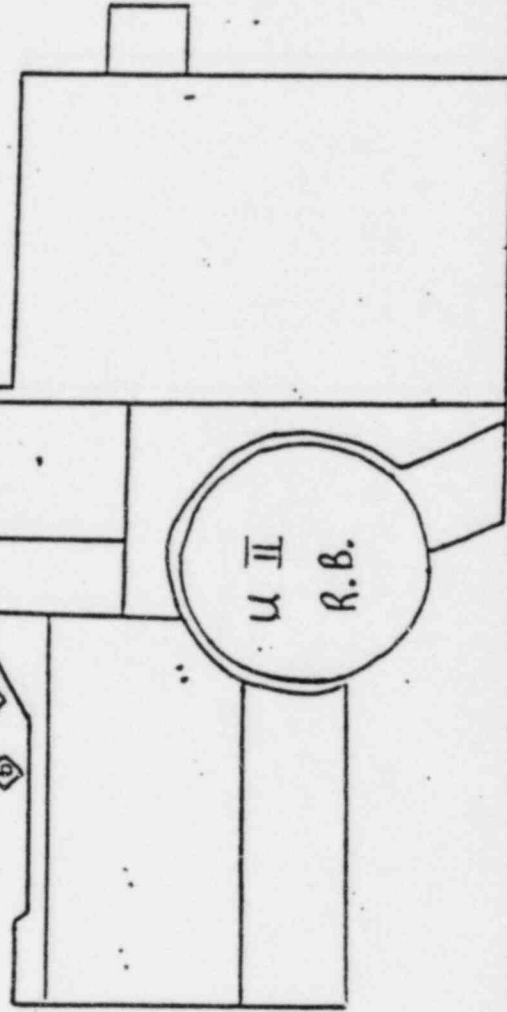
FIGURE 2

4. Special NRC Sample Program. During March and April 1982, the NRC sampled various onsite locations (Figure 2) to assess BWST leakage/cleanup, and the licensee monitoring program. Soil and liquid samples were tested by the Analytical Chemistry Laboratory, Idaho Operations Office, DOE. The results of these analyses are reported in the following table.
