Pacific Gas and Electric Company

Re: Docket No. 50-323, OL-DPR-82
Diablo Canyon Unit 2
Licensee Event Report 2-93-002-00
Entry Into Technical Specification 3.0.3 Due to Auxiliary Building
Ventilation System Inoperability Caused by Inadequate Work
Instructions

LICENSEE EVENT REPORT (LER)

TITLE (4) **ENTRY INTO TECHNICAL SPECIFICATION 3.0.3 DUE TO AUXILIARY BUILDING VENTILATION SYSTEM INOPERABILITY CAUSED BY INADEQUATE WORK INSTRUCTIONS**

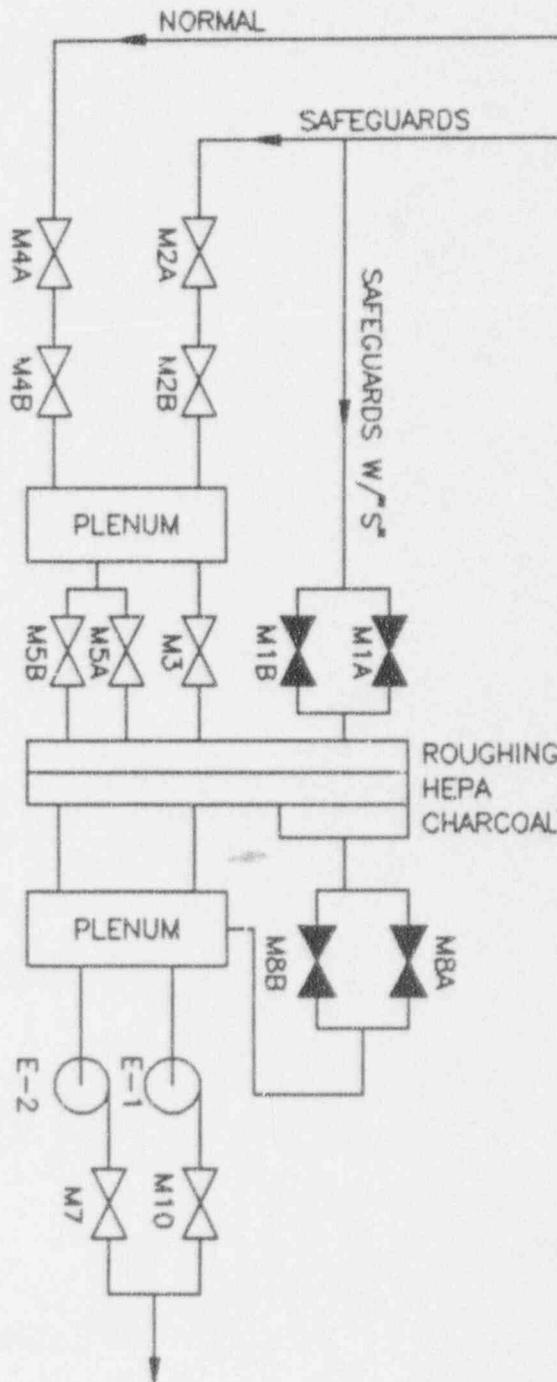
AUX BUILDING HEATING & VENTILATION SYSTEM (ABHVS)

alignment for this maintenance activity placed the ABVS in safeguards mode with an SI "S" signal, which automatically opens Dampers 8A, 8B, 1A, and 1B and closes Dampers 2A, 2B, 4A and 4B (see drawing on Page 8). This maintenance activity had been previously performed successfully using the same clearance alignment. The work order that implemented the maintenance activity required closing the dampers, but did not specifically identify which dampers. The alignment of this system specifies routing of flow through the charcoal filters, which requires that painting and welding restrictions be imposed in the auxiliary building for the duration of the clearance.

On March 4, 1993, Mechanical Maintenance personnel requested Operations approval to start work. The Unit 2 Shift Foreman determined that the work instructions were not specific regarding which dampers were required to be closed. The Mechanical Maintenance workers discussed the damper closure requirement with a maintenance engineer who previously had performed this activity and who indicated that MD-5A and MD-5B were required to be closed. The workers reported to the Shift Foreman and identified that MD-5A and MD-5B were required to be closed. The Shift Foreman agreed to the closure of those two dampers since this action maintained a flow path through MD-3. The maintenance workers were allowed to begin work and began so by closing MD-5A and MD-5B.

In order to enter the ducting that contained the FE-5016, an access hatch was required to be removed from the plenum in which the dampers were located. There was a differential pressure across the hatch. This prevented the workers from opening the hatch. Work was suspended and the Mechanical Maintenance foreman was contacted. The foreman noted that MD-3 on an upper elevation of the plenum was open. Although the maintenance personnel had informed the Unit 2 Shift Foreman that they were only going to close MD-5A and MD-5B, the work order instructions that required closure of the dampers were not specific as to which dampers to close. The Mechanical Maintenance foreman determined it was acceptable to close MD-3 since the work order instructions were not specific regarding the closure of dampers. This activity, previously performed under different alignment conditions, required MD-3 to be closed. When the Mechanical Maintenance foreman moved MD-3, a position

switch activated and signaled the ABVS control logic to shut down the only ABVS operable fan (2E-1). Fan 2E-2 was already inoperable for this maintenance activity. Since both Unit 2 ABVS fans were inoperable, the requirements of TS 3.7.6.1 were not met and TS 3.0.3 was entered. One train of the ABVS was restored within 15 minutes. As a result, the requirements of TS 3.7.6.1 were met and TS 3.0.3 was exited.

The immediate cause of this event was the inadvertent trip of the ABVS Exhaust Fan 2E-1 due to a damper manipulation.

The preliminary root cause for this event was determined to be inadequate work instructions. The work order did not state which dampers should be closed and which dampers should be left open. The alternate clearance was not sufficient to allow the access hatch cover to be removed.

PG&E operators instructed maintenance personnel to reopen MD-5A, MD-5B, and MD-3 and restarted Fan 2E-1, which reestablished air flow through one train of the ABVS such that the TS 3.0.3 action statement was exited.

MD-5A, MD-5B and MD-3 were reopened. The air flow was reestablished through Fan 2E-1 fan and TS 3.0.3 action statement was exited.
