December 10, 1993

Three Mile Island Nuclear Station Unit 2 (TMI-2)
Operating License No. DPR-73
Docket No. 50-320
TMI-2 Additional Information of Cork Seam

RESPONSE TO REQUEST FOR ADDITIONAL INFORMATION ON TMI-2 CORK SEAM CONTAMINATION

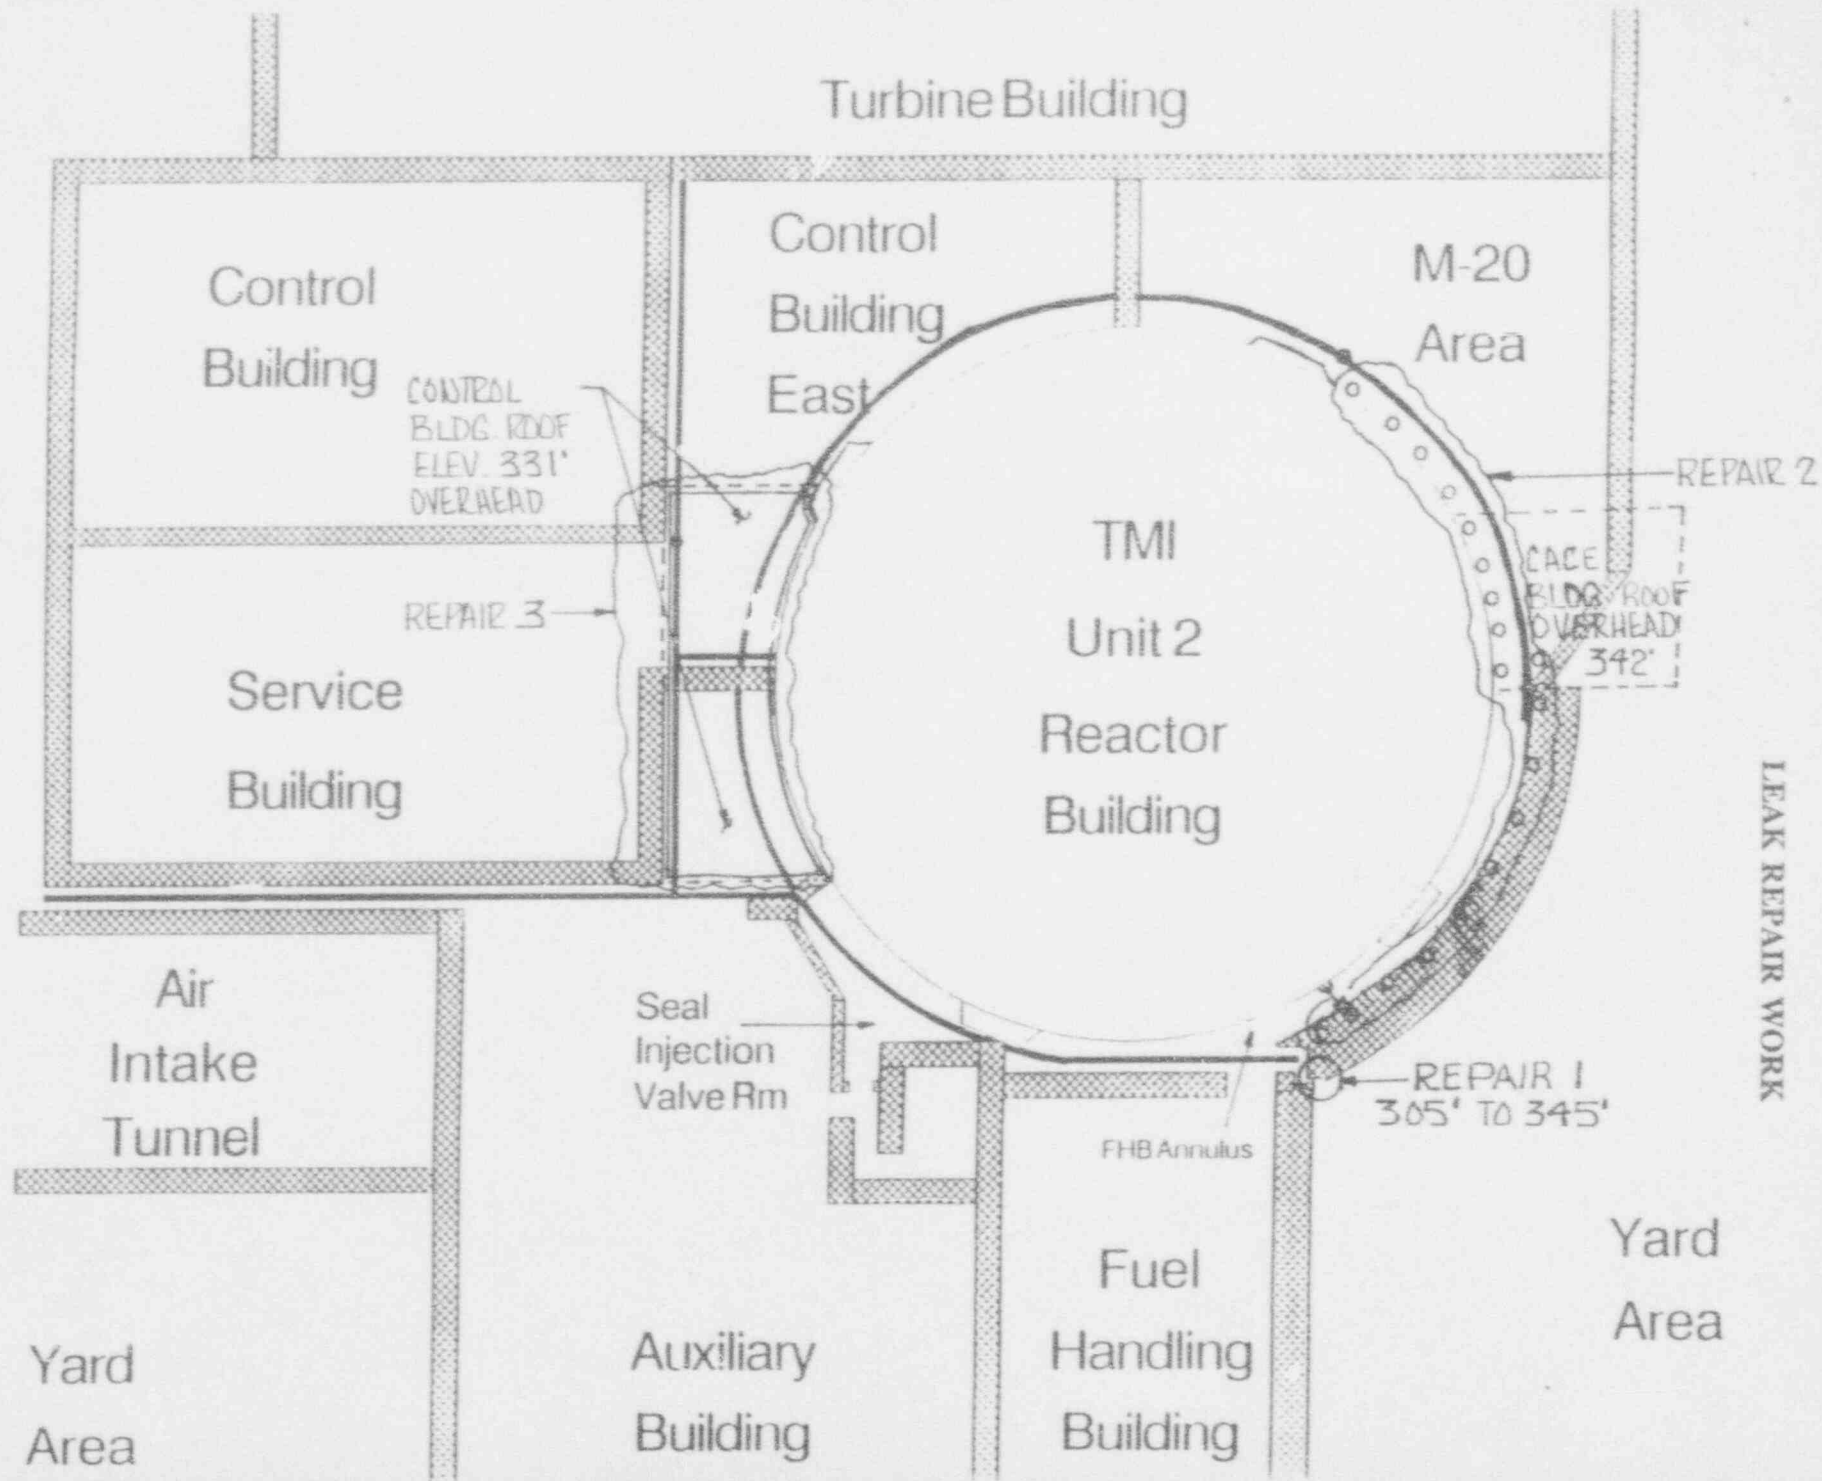
LEAK REPAIR WORK
FIGURE 1

RESPONSE: Leak repair work is proceeding in three areas at TMI-2 (See Figure 1). Repair 1 repaired the outside vertical seam at the corner of the Fuel Handling Building (FHB) and the Reactor Building, elevation 305' to 345'. This work was completed on November 19, 1993; the water leakage into the FHB Annulus 28.0' area following a heavy rain has been practically eliminated.

Repair 2 will mitigate water leakage into the M-20 area via the reactor wall corridor, elevation 305', and the CACE/Equipment Hatch Building roof, elevation 342'. This work is expected to be completed by December 15, 1993.

Repair 3 will mitigate the water leakage into the Control Building East area via the roof over the Personnel Hatch/Hot Instrument Shop, elevation 331'-6". This work is expected to be completed by December 31, 1993.

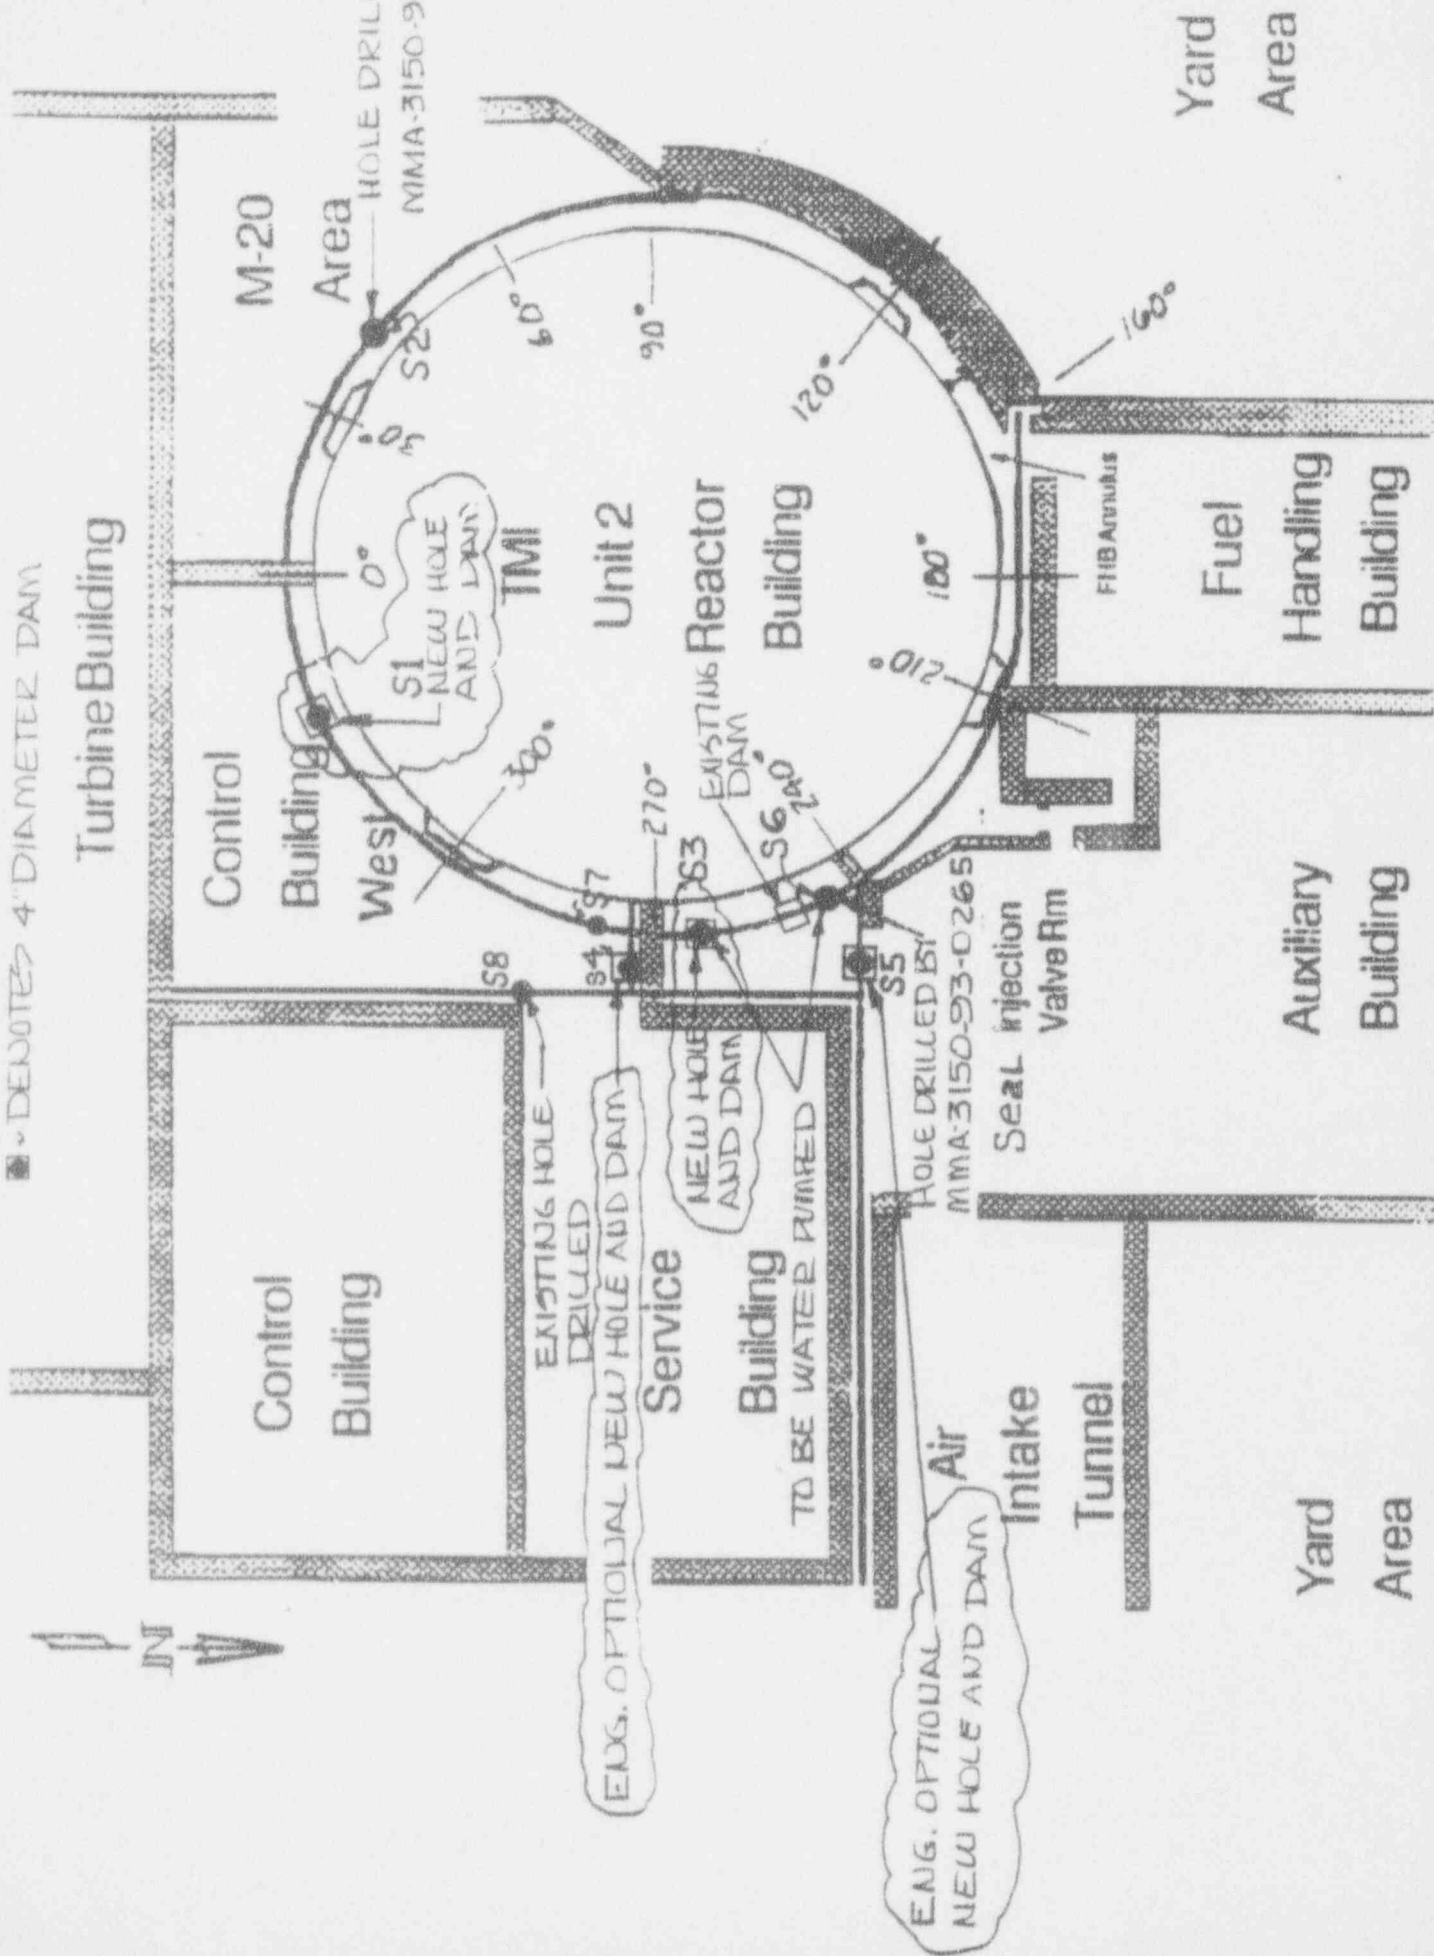
FIGURE 2

RESPONSE: During the removal of water from the cork seam, four four-inch diameter dams will be installed to prevent contamination from spreading and to provide monitoring locations, and two additional one-inch diameter holes (2 currently exist) will be drilled for pumping (See Figure 2). The dams will be made from an injectable polyurethane grout. This material adheres to wet surfaces and expands to form a closed cell foam that will fill any gaps in the concrete adjacent to the cork seam. In addition, after the dams and pumping/monitoring holes are installed and the water is removed, GPU Nuclear will evaluate whether additional actions are required, i.e., removal of cork material or capping of the cork seam.

After the water removal process has been completed, a liquid level monitoring device will be inserted in each of the four sections in the one-inch diameter holes. At least monthly, for a period of one year, these holes will be monitored for water entering the seam. The monitoring program will be reevaluated after the initial one year period.

HOLE DRILLING AND DAM INSTALLATION WORK
