WOLF CREEK GENERATING STATION  
ESSENTIAL SERVICE WATER SYSTEM  
PUMP RESTRAINT EMBED REPORT

Bechtel Power Corporation  
Gaithersburg, Maryland  
July 1, 1982

Prepared by:  
P. Labarta

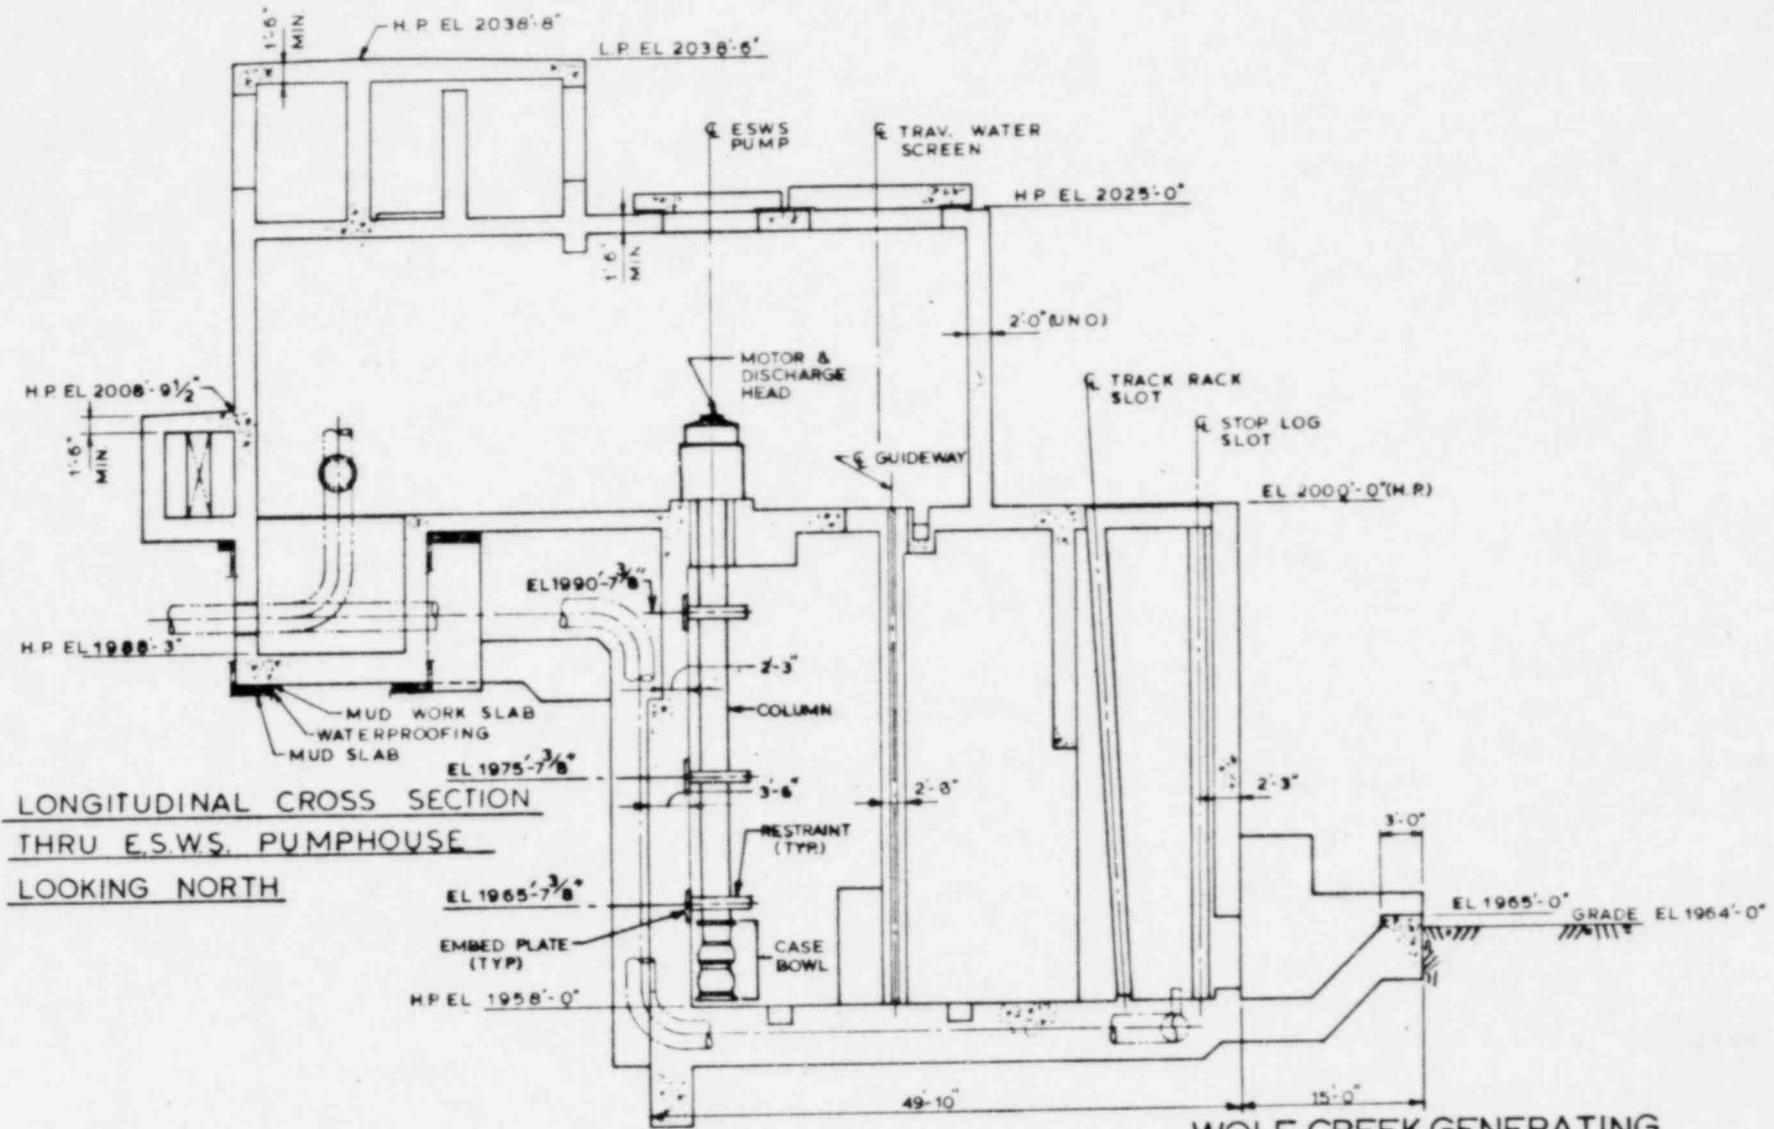
WOLF CREEK GENERATING  
 STATION E.S.W.S. PUMP RE-  
 STRAINT EMBED REPORT  
 FIGURE 1

The subject plates are embedded in the west wall of the E.S.W.S. pumphouse forebay structure and are utilized for the attachment of six stainless steel seismic restraints (3 each pump) to the concrete forebay wall. The pump and restraints are illustrated in Figure 1. The restraints are designed to provide lateral support during a seismic event for the pump column extending from the operating floor at elevation 2000'-0" to the forebay intake level at elevation 1958'-0". The supports are located at elevations 1965'-7-3/8", 1975'-7-3/8" and 1990'-7-3/8".

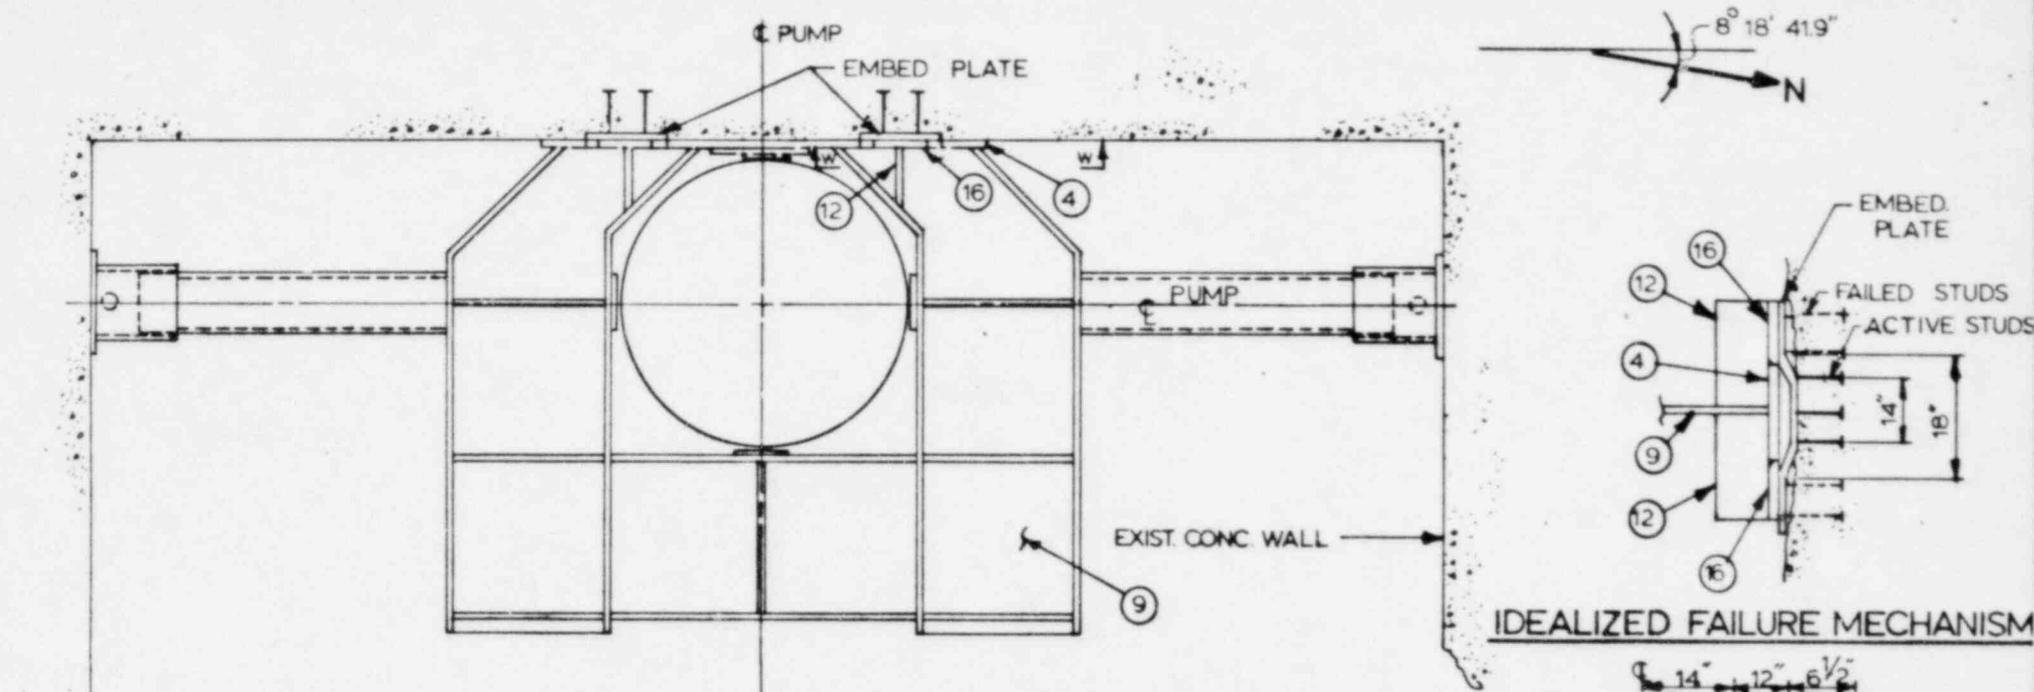
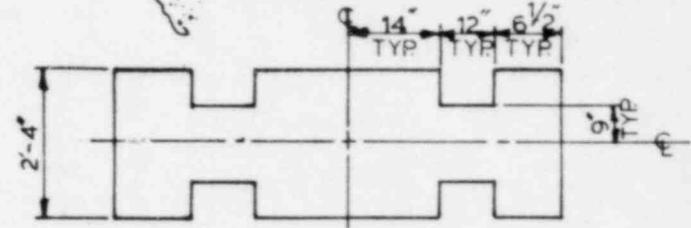
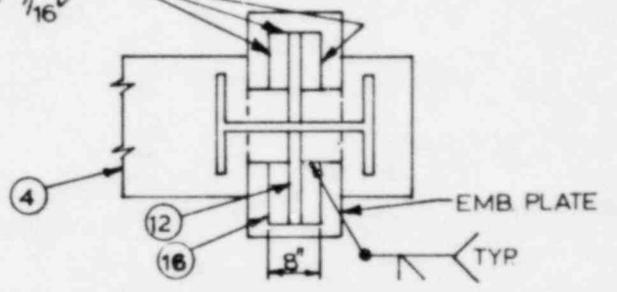
WOLF CREEK GENERATING STATION  
E.S.W.S. PUMP RESTRAINT EMBED REPORT  
FIGURE 2

The six affected restraints are identified as hangers No. K-EF11-R001 through and including K-EF11-R006. Two carbon steel embedded plates, 1'-0" wide x 4'-0" long x ½" thick with fourteen ¾" diameter x 7" long concrete anchor studs are provided at each restraint for attachment to the forebay concrete wall. The restraints are attached to the embedded plates at four locations using 8" wide x 11" long x 1" thick stainless steel plates (Item 16) welded to the embedded plates with 7/16" fillet welds on three sides. Restraint and attachment details are provided in Figure 2.

The cross-sectional studies of the stainless steel attachment plate and the carbon steel plate clearly indicate that the plate deformations are the result of transverse shrinkage due to excessive weld material deposited at the connection of the stainless steel restraint attachment plate (Figure 2, Item 16). Examination of the cross-sectional photographs (Appendix III, Figure 75 through 78, and 85) indicates the stainless steel attachment weld size (leg size) is in the range of 1/2" to 3/4"; this is apparent by visual comparison of the weld to the 1" thick stainless steel plate.

In adjusting the CE-917 and CE-918 model to account for the nonconforming restraint attachments, the restraint spring constants were calculated assuming all studs located under the upper and lower stainless steel plate attachment welds (Figure 2, Item 16) were failed anchor studs. This assumption accounts for uncertainties associated with the unknown extent of damage to the anchor studs on the embedded plates which were not removed from the wall, and provides a reasonable worst-case failure mechanism for analytical purposes. The analysis therefore is based on only six active studs of the original fourteen at each restraint attachment location. The active studs are located in the center area of the embedded plates where no welded attachment to the embedded plate exists.

Stress-strain characteristics consistent with the anchor stud laboratory test results were used to calculate the stiffness of the six active studs. The idealized failure mechanism used to represent the nonconforming restraint attachments in the seismic analysis is shown in Figure 2.

Maximum stresses and displacements for the restraints would occur at the attachment points to the carbon steel embedded plate. Due to the configuration of the idealized attachment failure mechanism (Figure 2), the plate is capable of tolerating relatively large horizontal deformations without exceeding yield stresses. The plate stresses associated with the calculated horizontal displacements are below the yield point of the plate material.
