# Umetco Minerals Corporation

WHITE MESA MILL • P. O. BOX 669 • BLANDING, UTAH 84511  
☎ (801) 878-2221

Re: Umetco Minerals Corporation  
SUA-1358: Docket No. 40.8681  
White Mesa Mill, Blanding, Utah  
License Condition 26

Re: Annual Technical Evaluation of White Mesa Mill Tailings Management System  
for Period from July 31, 1992 through August 25, 1993  
Materials License No. SUA-1358

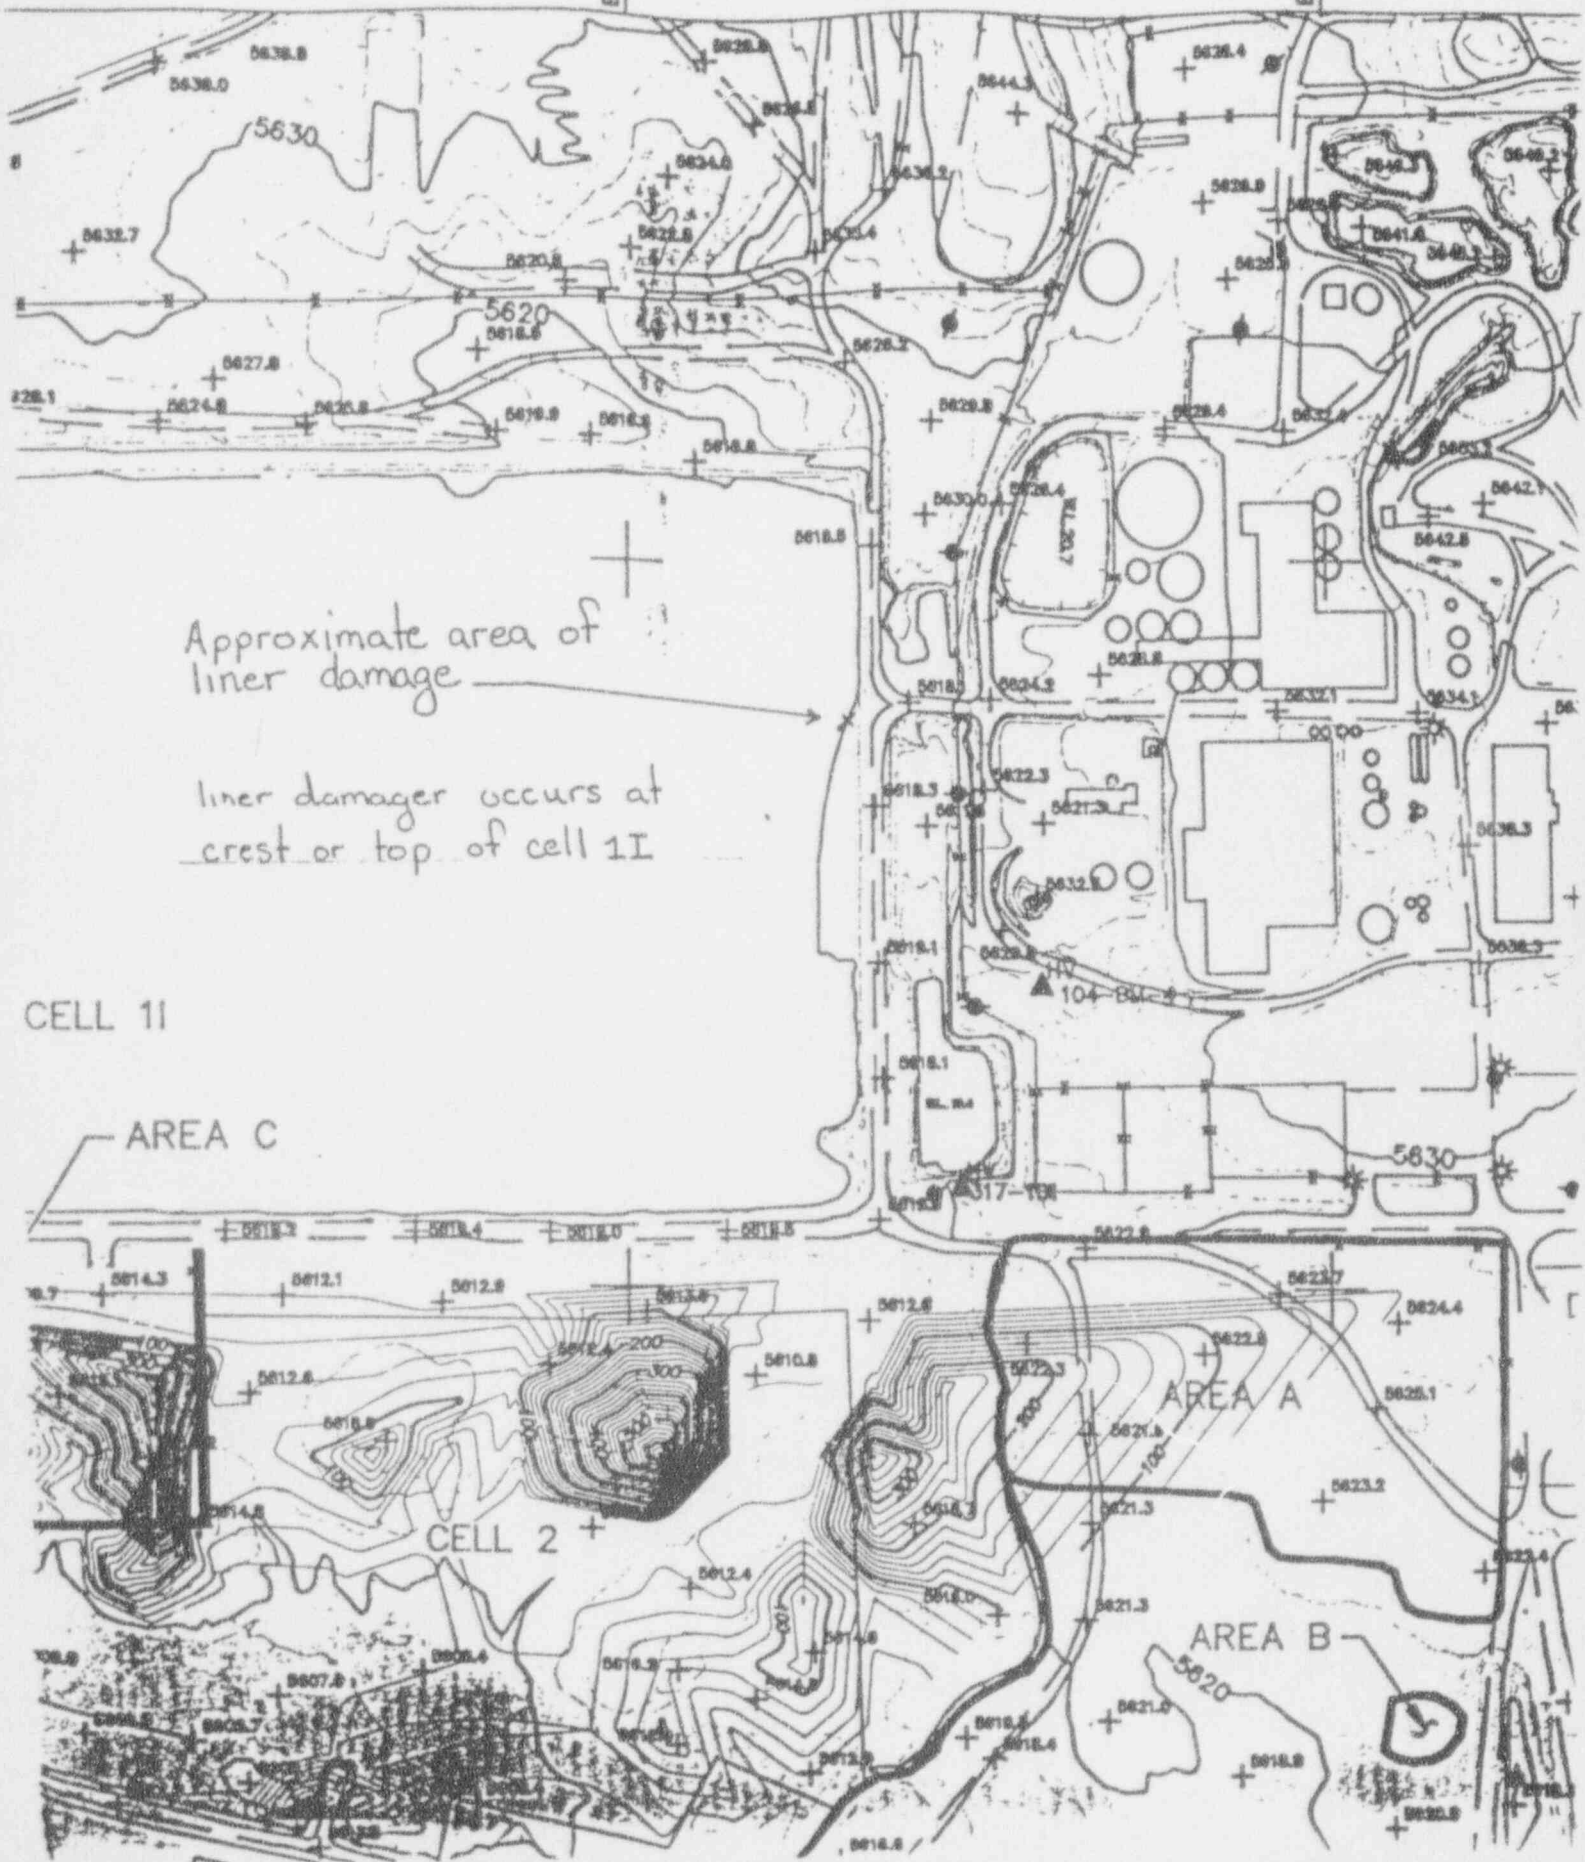
On January 9, 1993, during the daily tailings inspection the shifter noticed an erosion channel at the east end of Cell 1I. Upon inspection it was noticed that the liner had been damaged. Butch Brice was notified, inspected the area and notified John Hamrick of the situation. Efforts to minimize the amount of water that would be channeled into this area were made as a measure to reduce any further liner damage.

The liner damage was a result of an erosion channel on the inside of Cell 1I dike from mill drainage waters that have accumulated in the area of the old fly ash pond. The exposed liner ripped and fractured which appears to have damaged approximately 20 square feet of liner along the east inside bank of Cell 1I.

Approximate area of  
liner damage

liner damage occurs at  
crest or top of cell 11

Since discussions with Pete on 1-11-93, we have received an additional 2.23 inches of moisture. With the additional moisture the size of the pool at the old fly ash pond increased and the erosion channel was backfilled to prevent any water from going under the liner and minimizing additional liner damage.

When weather permits the area where the liner damage has occurred will have the backfill remove and liner repairs made. The areas where erosion has occurred will result in an inspection of the liner if exposed, and the area backfilled or repaired if necessary.

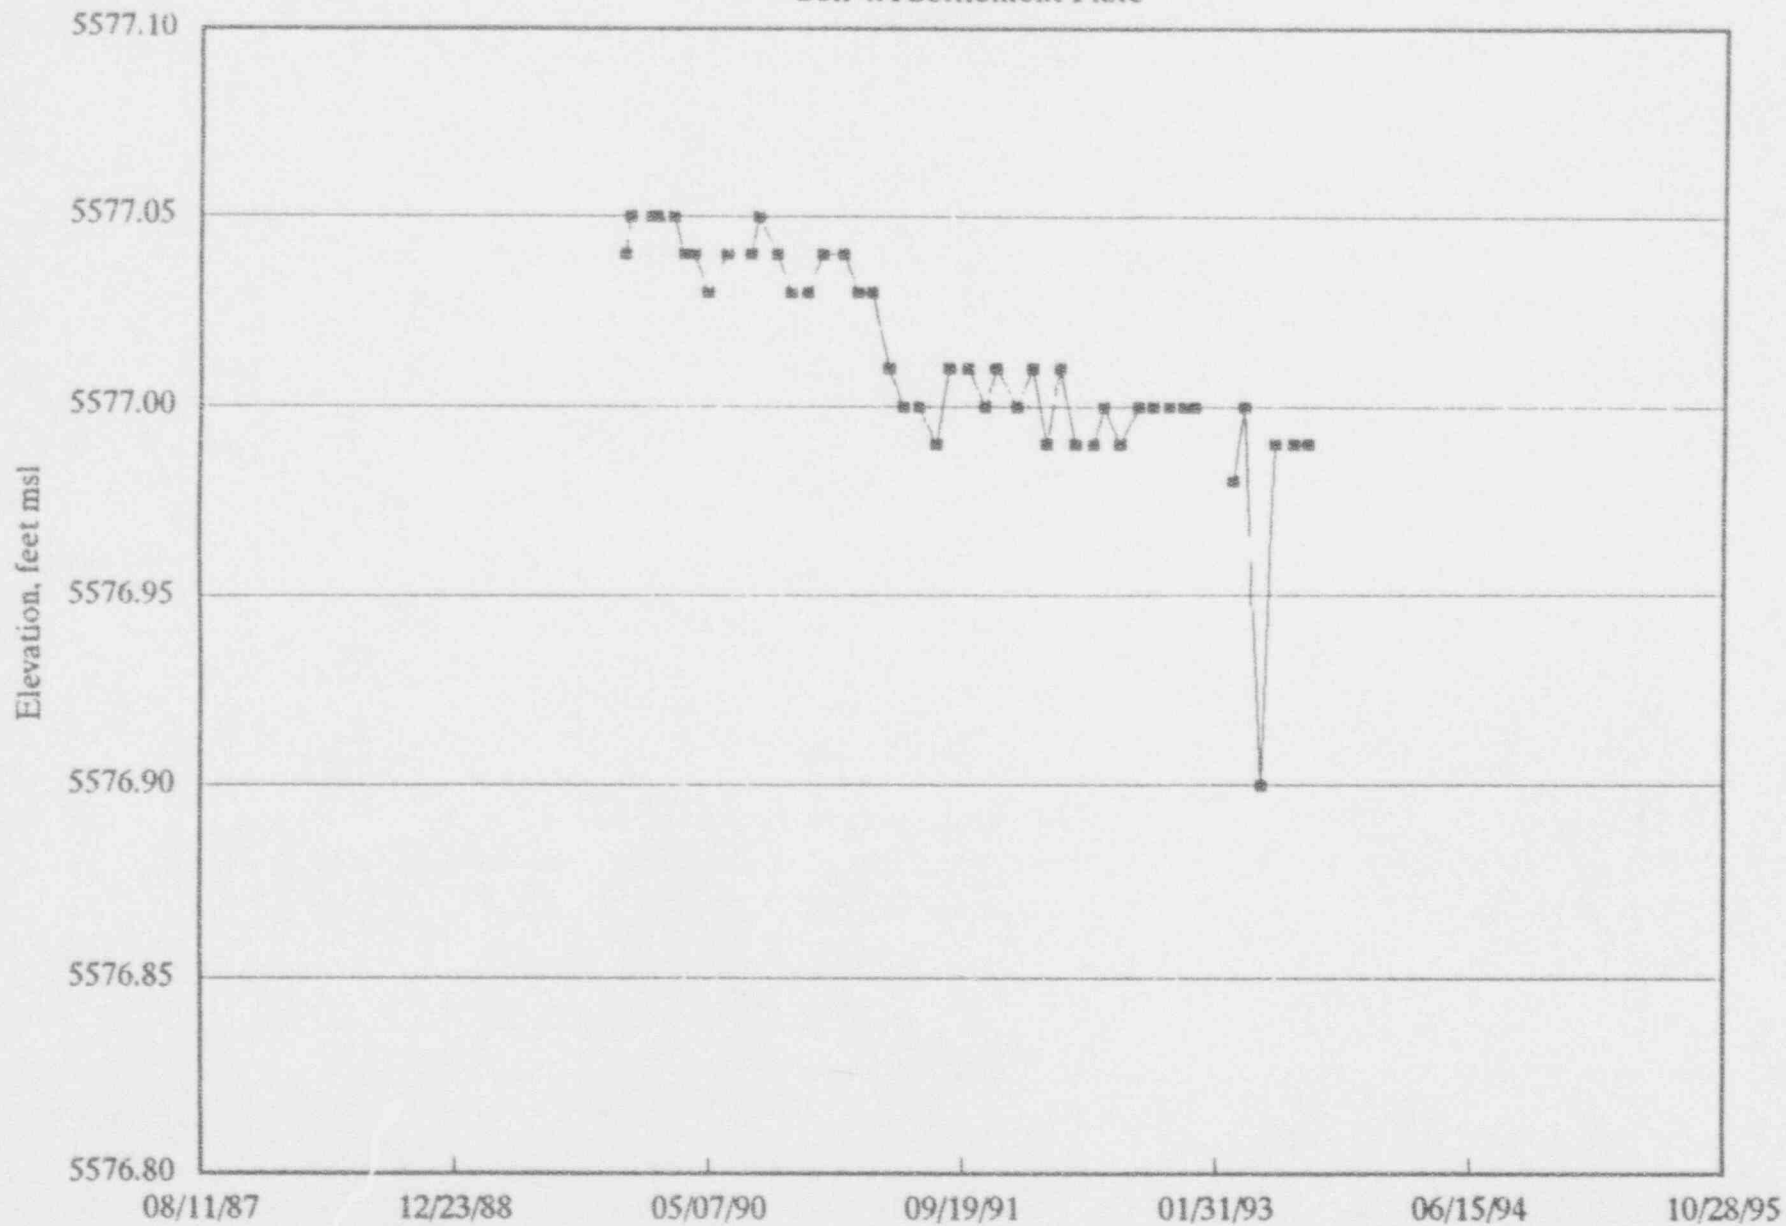
Cell 4A Settlement Plate

I have enclosed two copies of the Cell 3 and Cell 4 1993 Movement Monitor results for your review, filing and distribution. The survey was conducted by me on August 11 and 12, 1993. Based on comparison with previous data, no significant movement was observed.
