U.S. NUCLEAR REGULATORY COMMISSION
REGION IV

Inspection Report: 50-285/93-25

Facility Name: Fort Calhoun Station (FCS)

Inspection Conducted: November 19-22, 1993

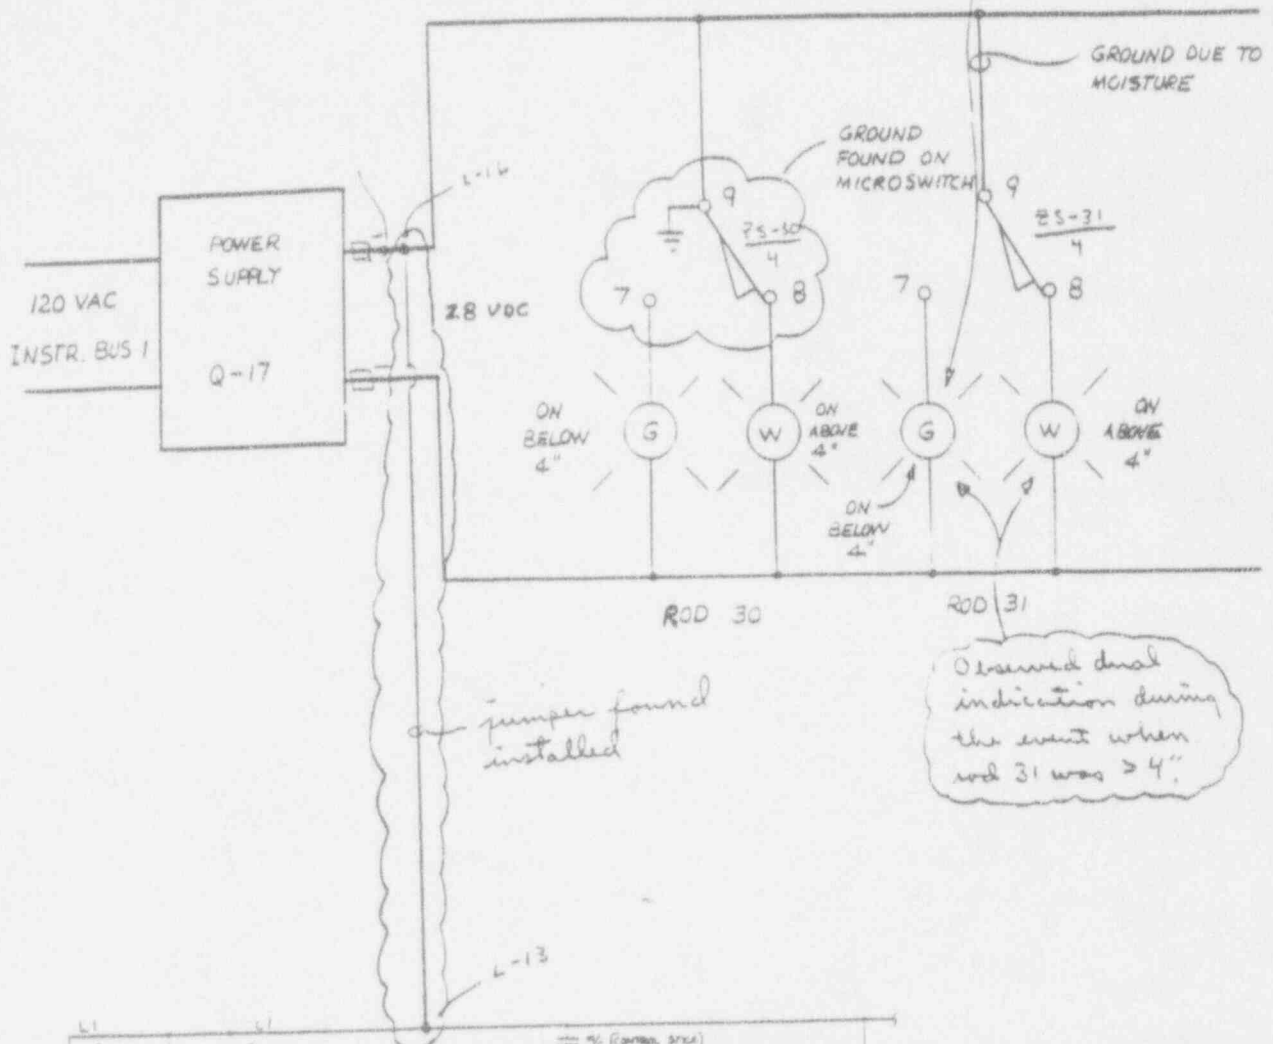
CEA 31 Rod Control Circuitry Showing Electrical Faults

- A jumper wire between the 120 VAC and 28 VDC system. This jumper was installed between terminals L-13 and L-16 located in the main control board. This jumper was apparently installed during plant construction and was shown on plant wiring diagrams. The licensee could not determine the purpose of this jumper and considered it to be a design error. This jumper provided the electrical connection fault that, when combined with the multiple grounds, was needed to cause uncontrolled operation of the CEDM.

- A ground fault, a short, and misadjustment on Limit Switch ZS-31/4 for the CEDM. A microswitch contained within this limit switch was found to be shorted between Terminals 7, 8, and 9 and grounded. The licensee considered the short and grounding to be caused by the presence of a "white" substance within the switch. The licensee speculated that the "white" substance was a boron residue that could have come from wetting the switch. This switch wetting could have been the result of leaks on the reactor head, while coming out of past refueling outages, that sprayed the CEDM. The short caused the abnormal condition of both the green rod bottom light and the white normal operating region light on the core mimic system to be on at the same time. The ground fault provided a path that could cause the CEDM withdrawal contactor coil, RA-31, to be energized.

- A ground fault on Limit Switch ZS-30/4 for the CEDM for CEA 30. The cause for this ground fault could not be determined. This ground fault provided a circuit path that could cause the CEDM withdrawal contactor coil, RA-31, to be energized.

- A ground fault in Limit Switches ZS-31/1 and ZS-31/2 for the CEDM. These limit switches, located in the same vicinity as Limit Switch ZS-31/4, also contained moisture which contributed to the ground fault condition. As discussed for limit switch ZS-31/4, the moisture was probably the result of spraying the CEDM. This ground fault (and the one in the CEDM connector discussed below) provided the other side of the circuit path that was needed to keep coil RA-31 energized.

- A ground fault in the connector for the CEDM. This connector contained moisture and was in the same vicinity as the CEDM limit switches. Again, this moisture was probably the result of spraying the CEDM. Personnel that worked near the reactor vessel head during the refueling outage were interviewed and the source of the moisture could not be definitely determined.

Green light stayed on while rod 31 was > 4"

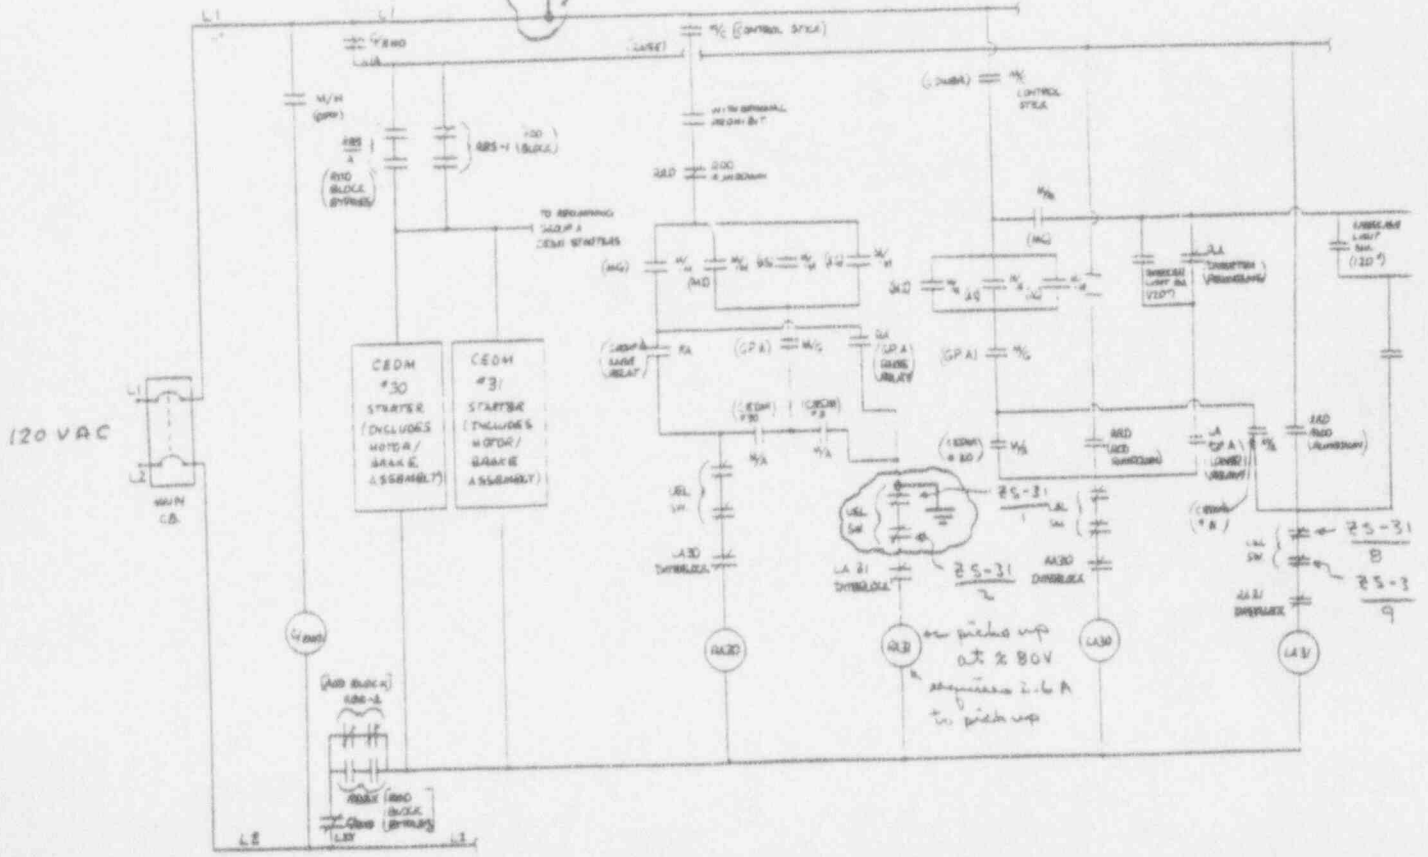
Observed dual indication during the event when rod 31 was > 4"

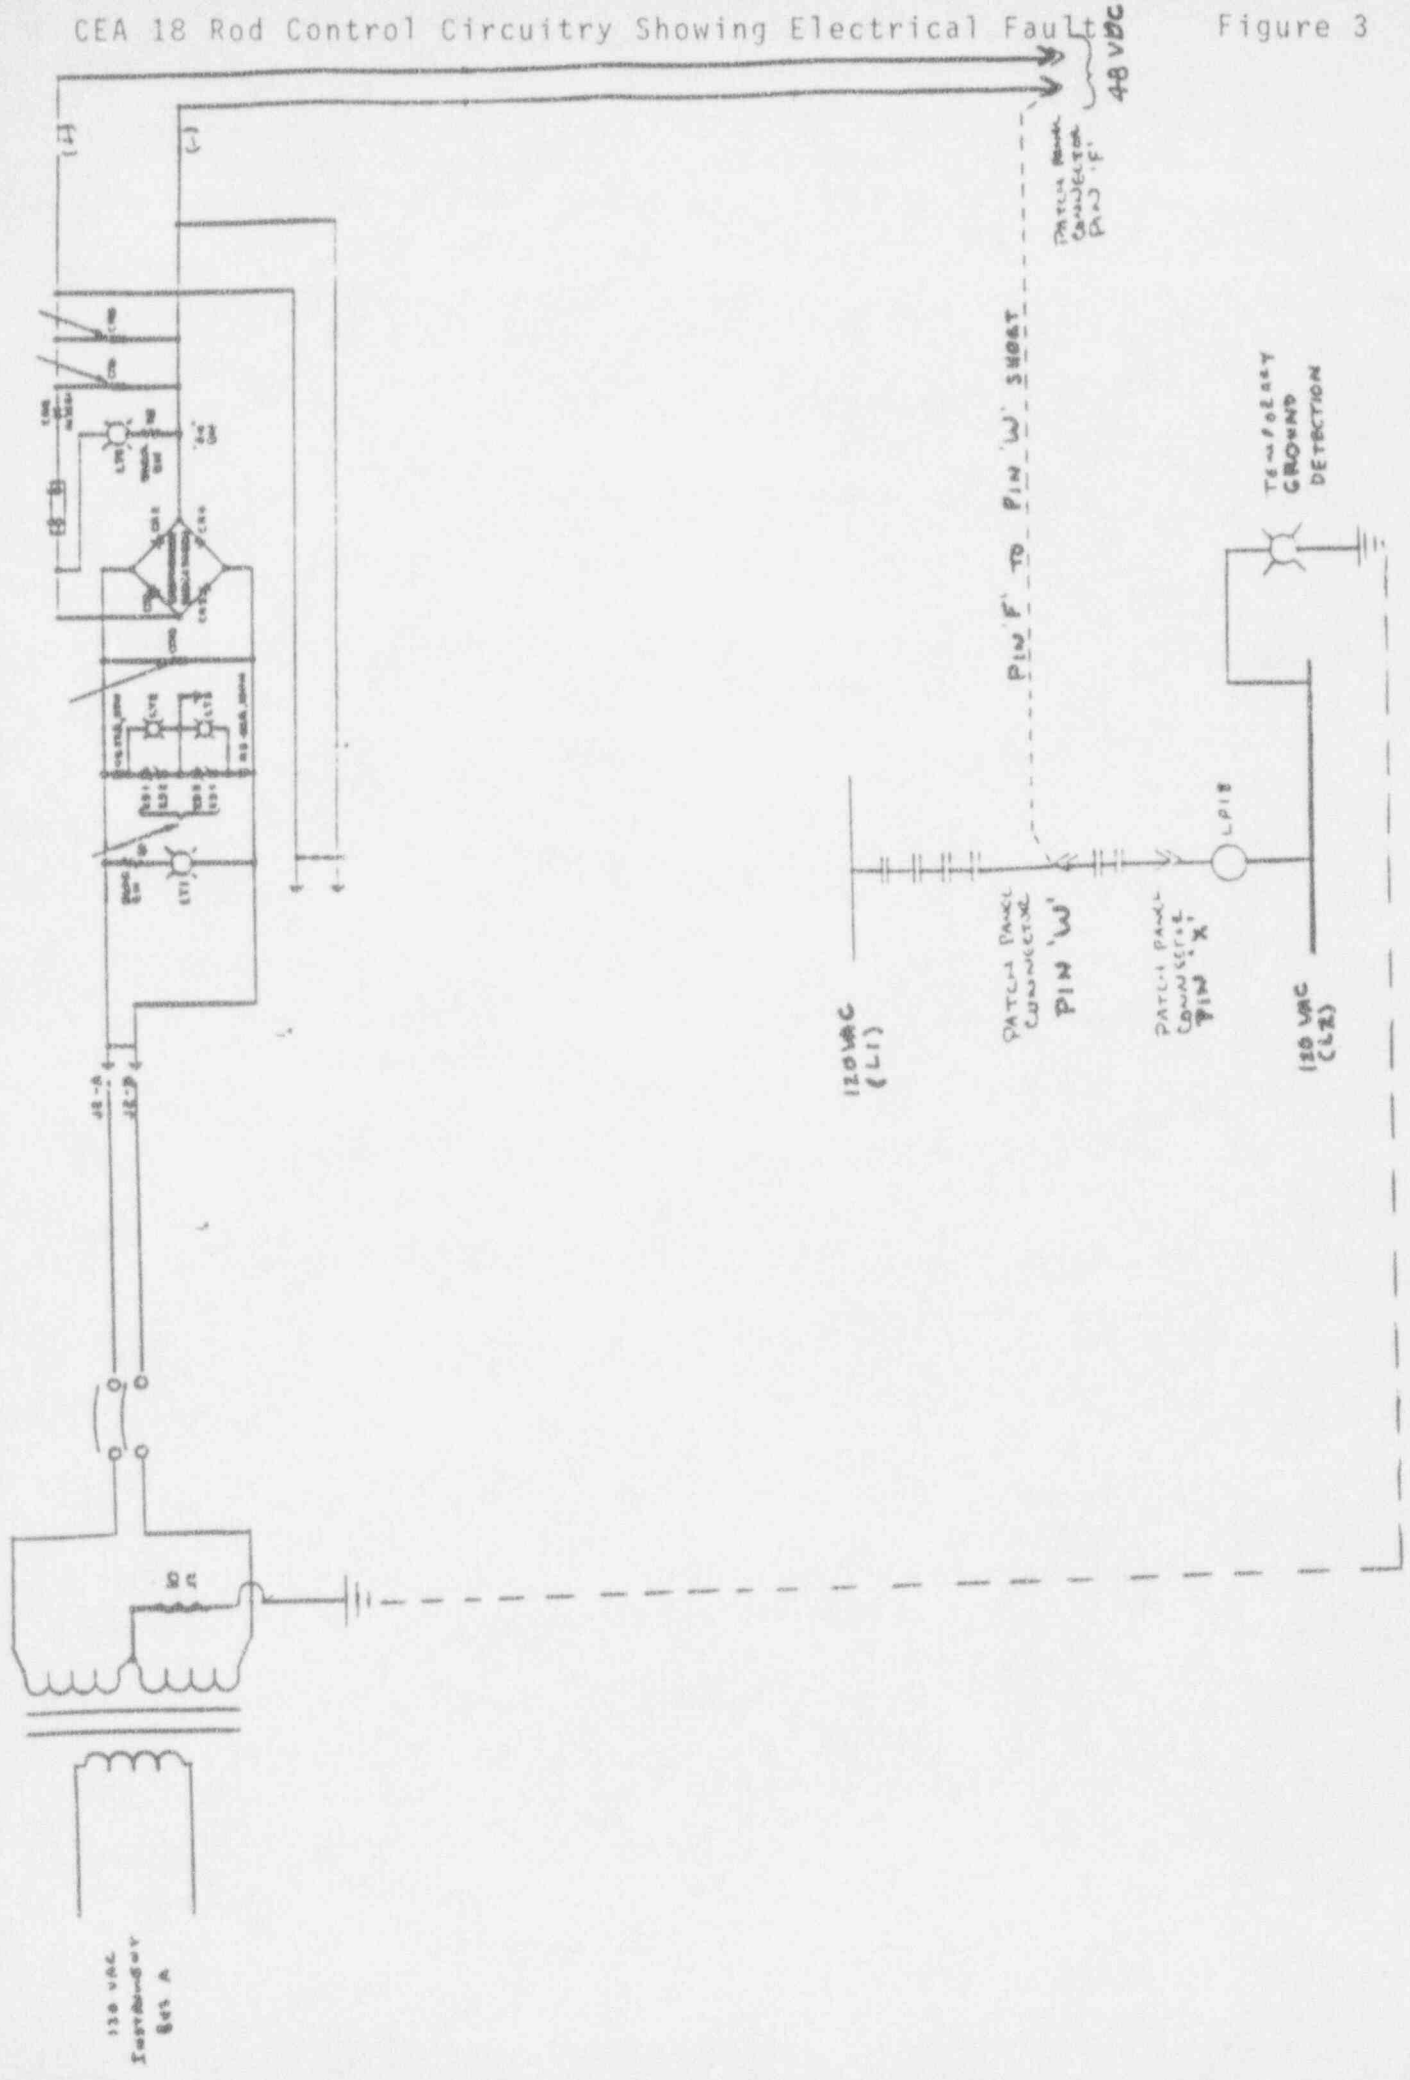
FIGURE 3 - CEA 18 Rod Control Circuitry Showing Electrical Faults

The pin-to-pin short was caused by loose wire strands that caused a short between terminal pins "W" and "F." This short connected the CEDM insertion contactor coil LP-18 to a 48 VDC clutch coil supply. Even though this CEDM is nontrippable and does not utilize a clutch coil, the 48 VDC power was available in the connector. This connection combined with the temporary ground detection system that was installed to test for grounds during rod control system testing, provided a circuit path that kept Coil LP-18 energized.

Subsequent testing performed by the licensee indicated that this coil, once energized, would maintain its contacts closed with a voltage as low as 2 to 4 volts. Calculations performed by the licensee indicated that this coil would have a voltage of approximately 4.6 volts across it due to this combination of the pin-to-pin short and the temporary ground detection system. Therefore, when CEA 18 was being inserted with the temporary ground detection system installed, the conditions were suitable for the contactor to remain energized and the CEA to continue its insertion after the operator released the rod control joy stick.
