LASALLE COUNTY STATION UNIT 1
STRUCTURAL BOLTING TIGHTNESS INSPECTION PROGRAM
FOR CONTAINMENT VALVES

I N S P E C T I O N R E S U L T S
(Inspection Performed July 1, 2, 6, & 7, 1982)

LASALLE COUNTY STATION UNIT 1
STRUCTURAL BOLTING TIGHTNESS INSPECTION RESULTS
FOR CONTAINMENT VALVES

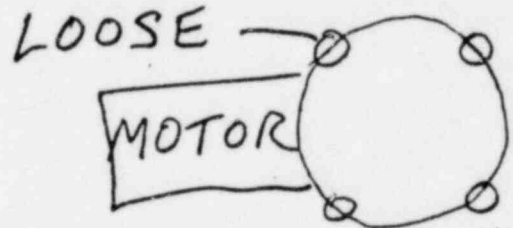
PROBLEMS FOUND/CORRECTIVE ACTION TAKEN ONE BOLT MISSING ON SWITCH HOUSING COVER - REPLACED

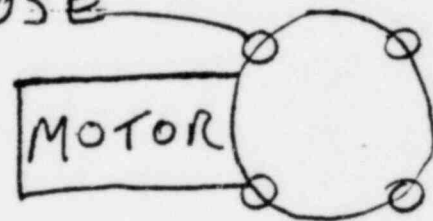
LOOSE

PROBLEMS FOUND/CORRECTIVE ACTION TAKEN 2 BOLTS LOOSE
ON SWITCH HOUSING COVER - TIGHTENED

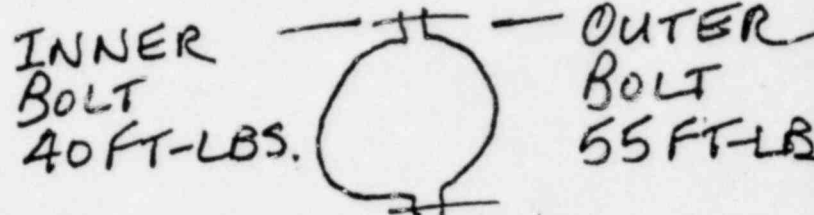
TOP OF VALVE

BOLTS OK. POSSIBLY - DUE TO TIGHTENING UPPER BOLTS
