Compressed-Air and Backup Nitrogen Systems in Nuclear Power Plants

Prepared by E. W. Hagen

Oak Ridge National Laboratory

Manuscript Completed: November 1981
Date Published: July 1982

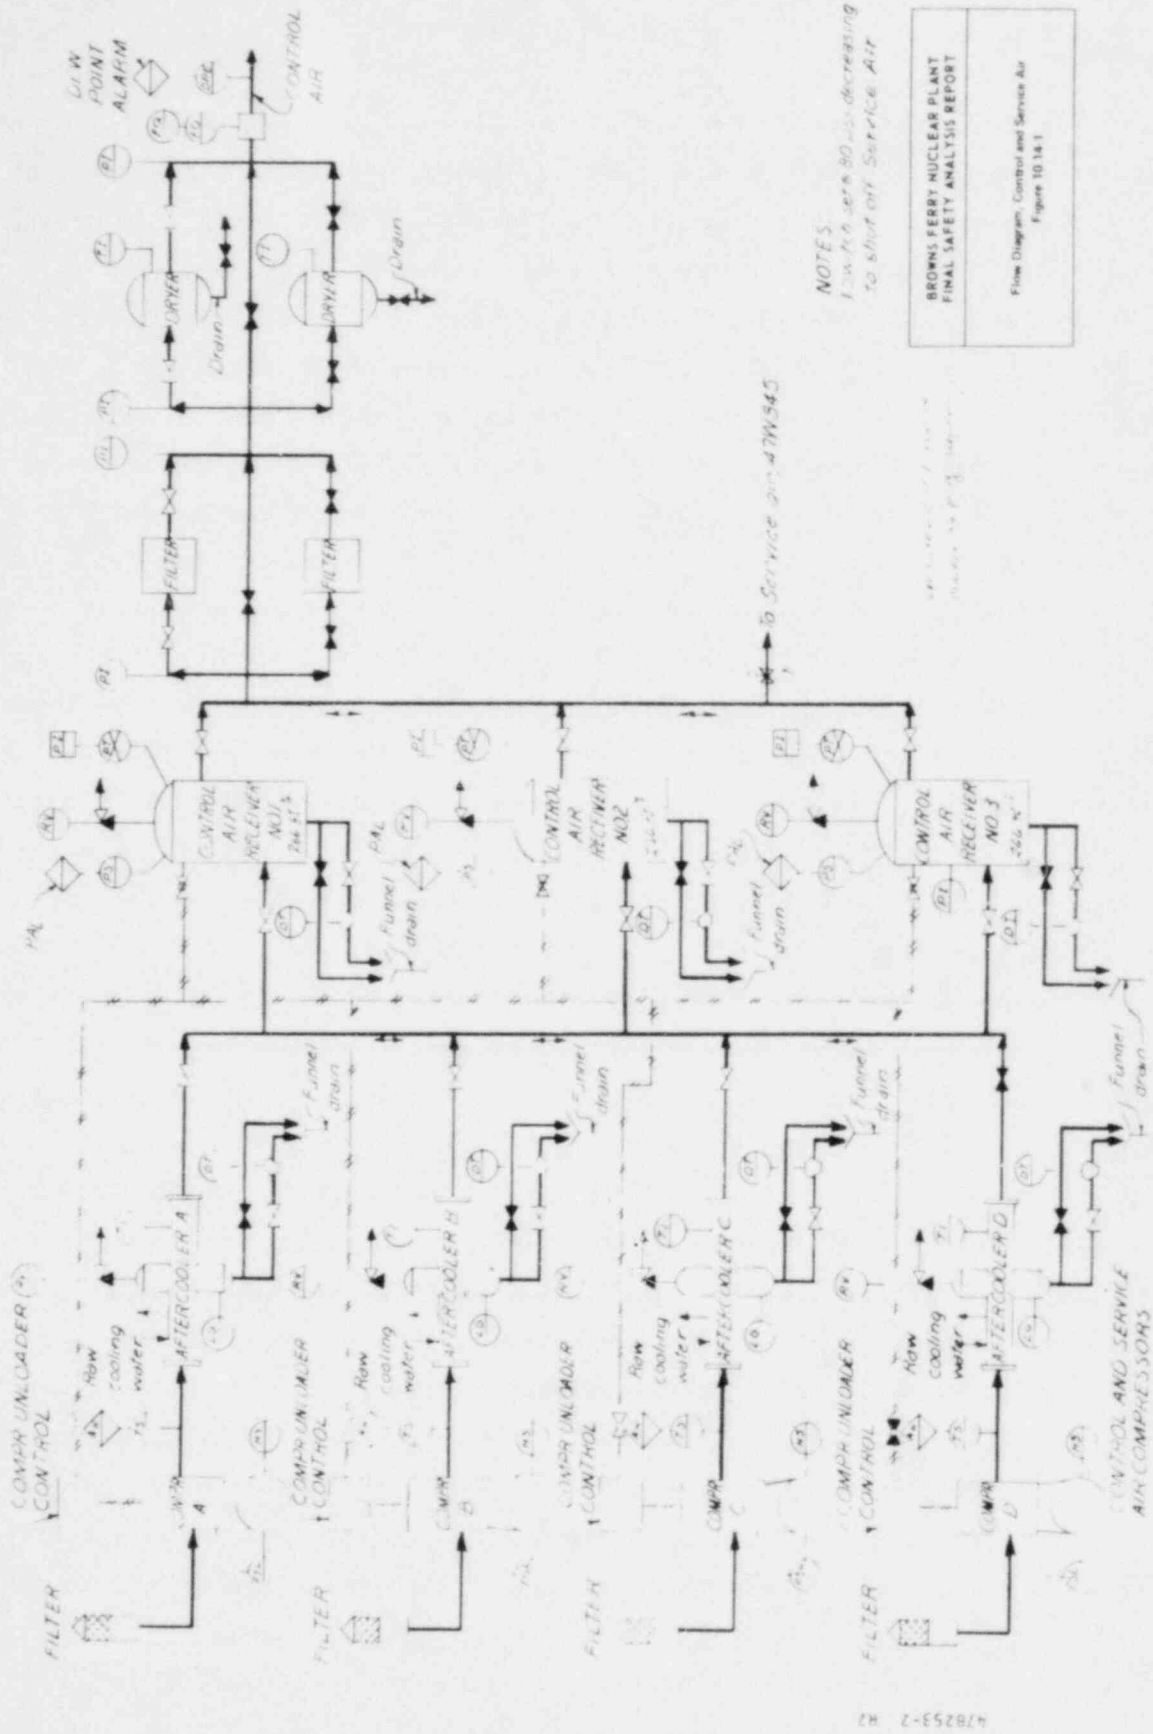
| BROWNS FERRY NUCLEAR PLANT FINAL SAFETY ANALYSIS REPORT |

The SAS distribution header is taken off the air receivers common discharge manifold (for example, see Figs. 1 and 2). The takeoff is made from the top of the manifold to reduce moisture carried through the line. The SAS header is connected to the IAS header through a normally closed, automatically actuated valve and check valve in series to preclude inadvertent use of instrument air by the SAS. This allows the SAS to back up the IAS, therefore ensuring priority for instrument air requirements. Whenever necessary throughout the unit, air for personal breathing apparatuses can be obtained from the SAS headers.

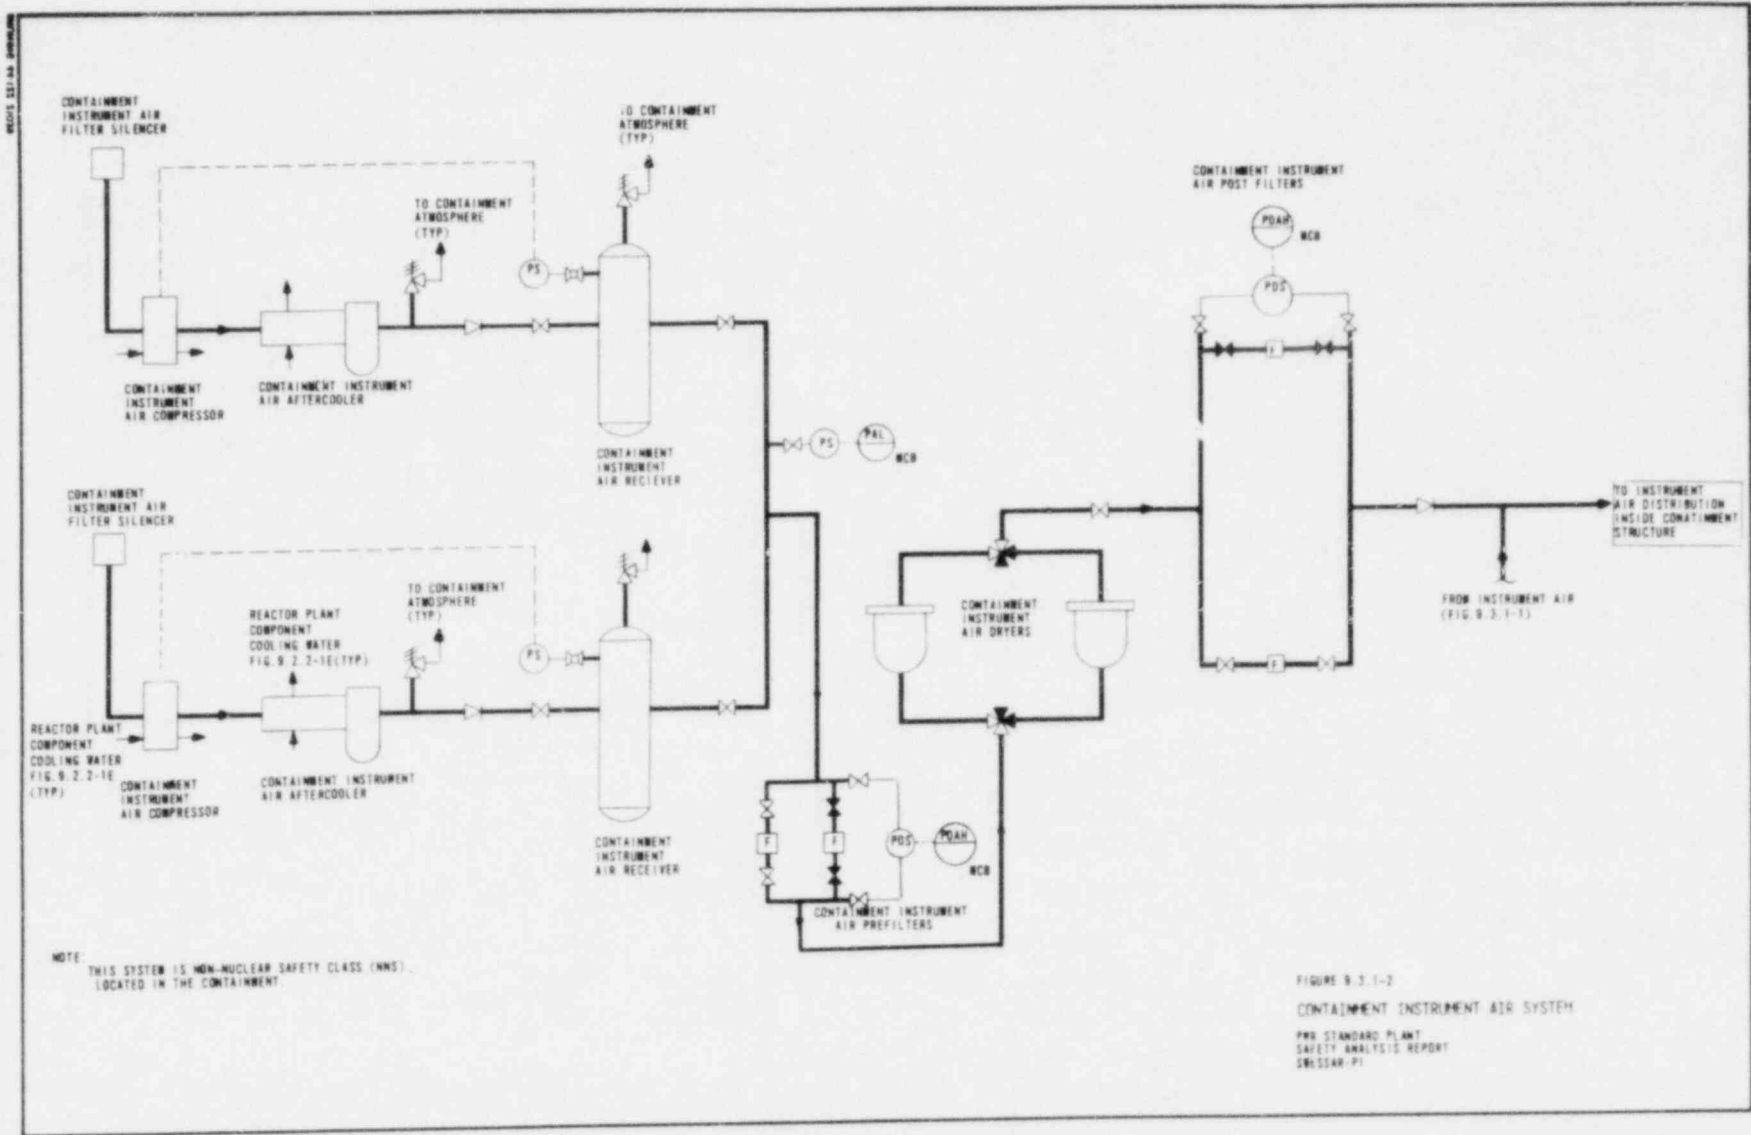
Fig. 3. Containment instrument air system.

The SAS and IAS provide backups for the CIAS by a cross-tie. The SAS line penetrating the containment contains one locked closed isolation valve outside the containment and one check valve inside. It provides service air for use inside the containment. The IAS line penetrating the containment contains one air-operated isolation valve outside the containment structure and a check valve inside. This backup supplies air to the CIAS and for the containment leakage monitoring system. In addition, a limiting orifice is provided for each penetration should the penetration rupture.

Design for fail safe operation and/or accident prevention can never be foolproof. Human error accounted for a breach of containment integrity at Surry, reported as A0-S1-75-02 [January 23, 1975 (Ref. 16)]. The control room operator noted during startup of unit 1 (unit 2 was at power) that the CIAS pressure was the same as that for IAS instead of being about 10 psig lower, which is normal. Two containment isolation valves were

found open. In establishing the valve lineups, the operator assumed that all valve numbers beginning with the number "2" were associated with unit 2, not realizing that there were two valves from unit 2 IAS connected to unit 1 containment. He assumed that these two valves with numbers beginning with "2" were at the unit 2 containment boundary and were therefore locked closed. He did not verify the valves by checking the valve taps.

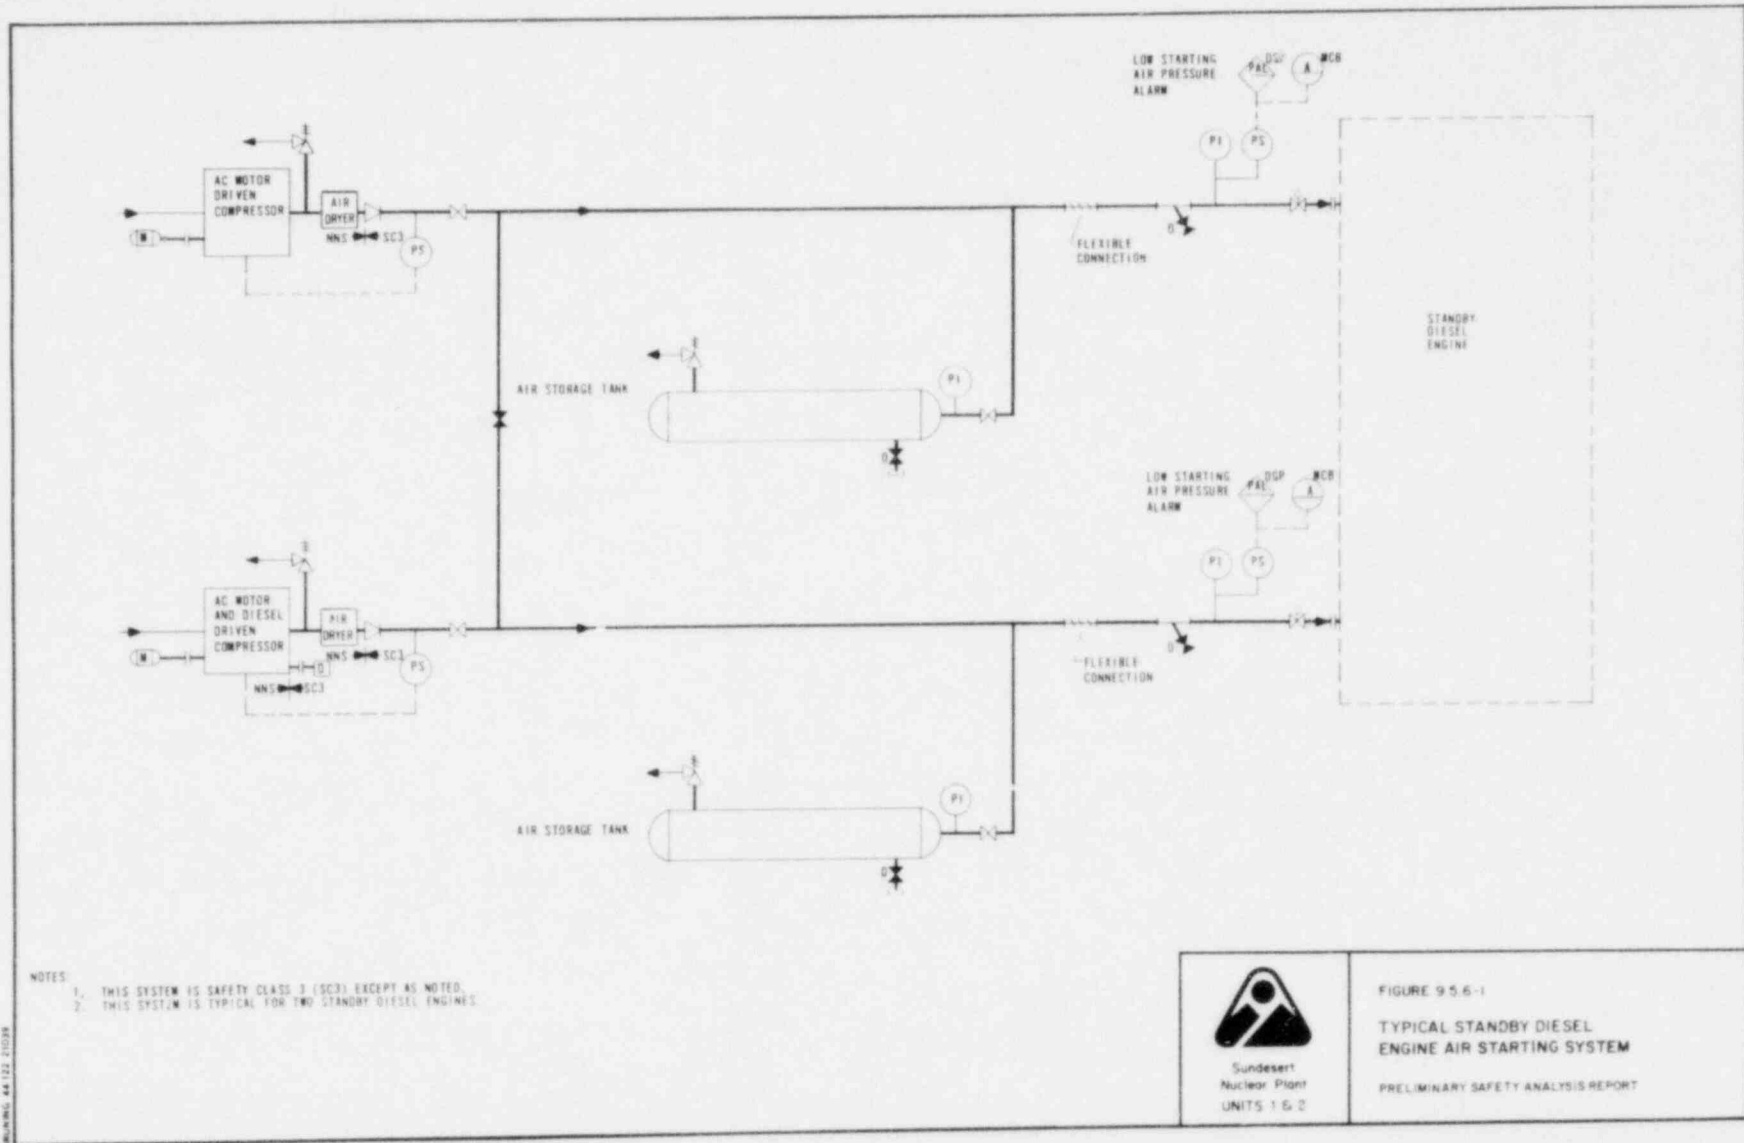
Fig. 4. Representative standby diesel engine air-starting system.

LER 77-26 [June 30, 1977 (Ref. 17)] reported three of four diesel generators inoperable for 6 h at Peach Bottom 3. The E1 diesel generator was taken out of service and safety blocked for its annual maintenance outage. This blocking included venting of the starting air receiver tanks for this diesel. Later, the control room operator noticed a diesel trouble alarm on both the E3 and E4 diesels. The plant operator noted that

both air receivers on both diesels were essentially depressurized and that the associated compressors had tripped on thermal overload. He reset the overloads, returned the compressors to service, and established 70 psig in the starting air receiver tanks prior to informing the control room operator of his findings and corrective actions. The control room operator notified shift supervision, who in turn notified the plant staff. Because the air receiver tanks were by this time pressurized, no shutdown or power reductions were initiated. Another operator was dispatched to the diesel building to check on the status of the pressurization. He found that the receiver tanks were at ~170 psig and that air compressors were again tripped on thermal overload. He again reset the overload devices, returned the compressors to an operable status, and reported this information to shift supervision. As a result of additional plant staff investigation and discussions, the valves that interconnect the diesel starting air systems were checked. The E3-E4 sectionalizing valve was found to be partially open. This valve was then closed to isolate the starting air systems of the E3 and E4 diesels. Also, the check valves of the starting air receiver tanks failed to maintain the air pressure in the tanks, thus allowing the tanks to drain.

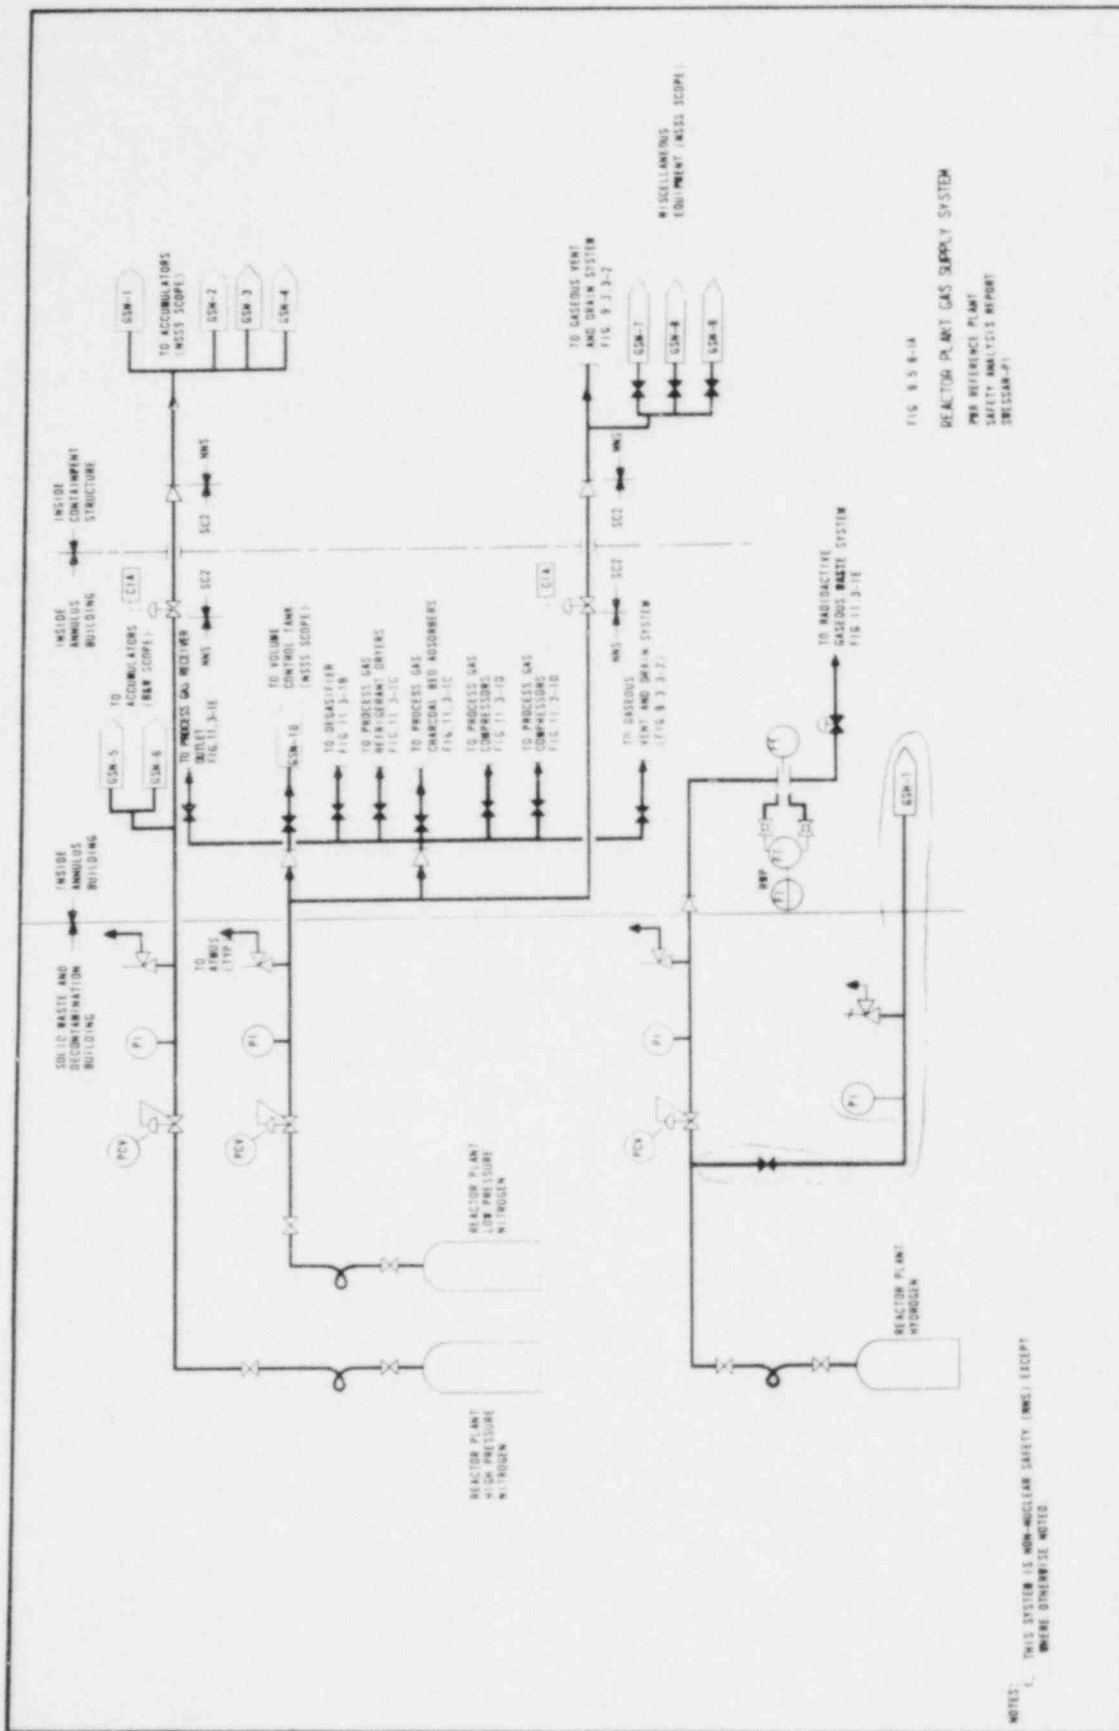
Fig. 5. Reactor plant gas supply system.

Nitrogen supply to the accumulators is on an intermittent basis to maintain the pressure required for emergency operation of the accumulators. Usually a one-month supply is connected to each manifold with various additional storage facilities available to meet specific plant needs. A pressure regulator reduces the nitrogen bottle pressure, and each distribution manifold is equipped with a pressure relief valve to release excessive pressure to the atmosphere. Gas supply lines penetrating the containment have a locked closed containment isolation valve outside the containment structure and an automatic valve inside in accordance with General Design Criteria 54 and 57 (Ref. 19). However, as happens with the compressed-air systems, an open or malfunctioning relief valve will take a unit down. For example, LER 80-69 [October 20, 1980 (Ref. 20)] reports that reactor vessel relief valve opens at Pilgrim. The unit was in steady state operation at 96% power when a reactor safety relief valve (SRV) opened. Station procedures were followed - the unit was taken off line to cold shutdown, and the drywell deinerted. Excessive nitrogen supply pressure resulted in some leakage through the solenoid valve into the diaphragm of the SRV.

The design of the SRV is such that the air pressure on the diaphragm needed to open the SRV reduces as the main steam pressure increases. The design of the control valve will not allow it to close with either air or nitrogen pressure greater than 135 psi. Therefore, 160-psi nitrogen pressure caused the control valve to stay in the open position, thus preventing the SRV from closing. This event occurred again and was reported as

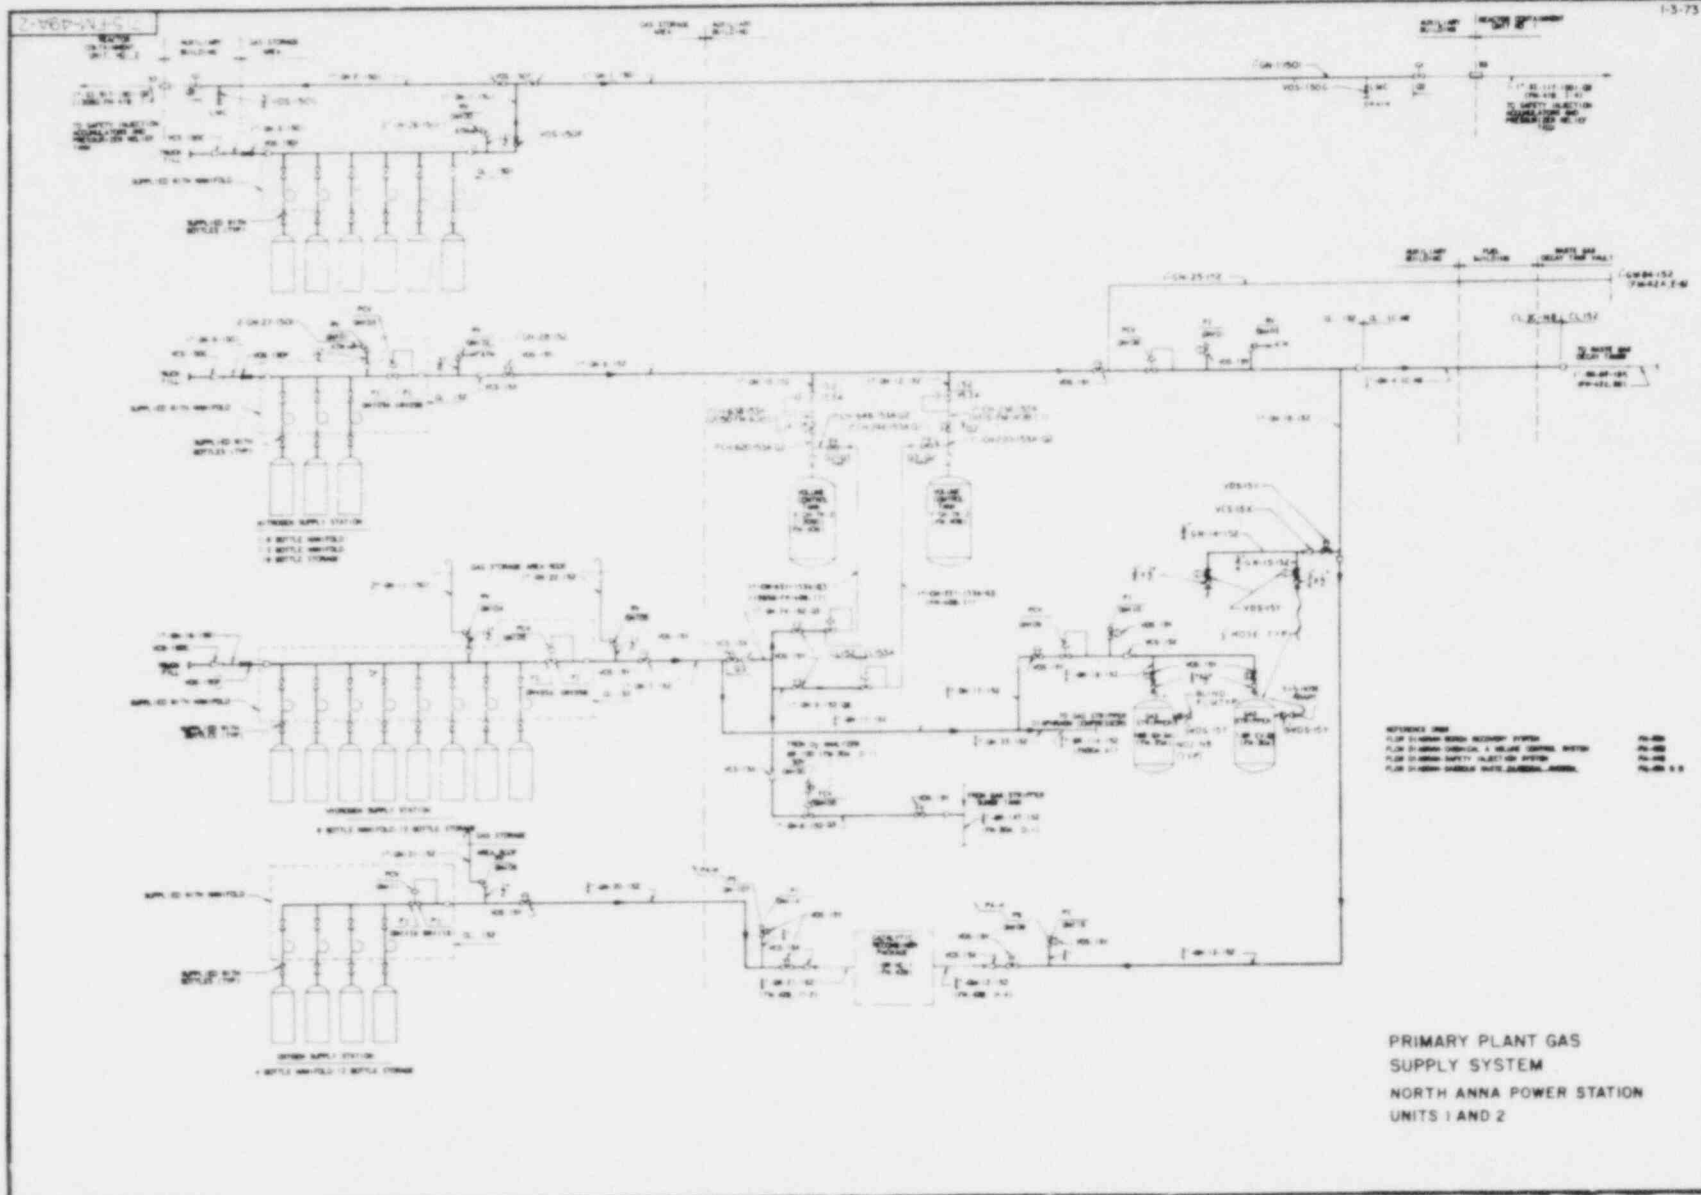
Fig. 6. Primary plant gas supply system.

LER 80-80 [November 14, 1980 (Ref. 21)]. An initial impulsive solution would be to add relief capability, but adding more equipment should be resisted. The valve should have been replaced with one of a different design. However, no changes were ordered or made.
