Docket No. 50-412

SUBJECT: NRC AUGMENTED INSPECTION TEAM (AIT) REGARDING THE
FAILURE OF THE EMERGENCY DIESEL GENERATOR LOAD
SEQUENCERS NRC INSPECTION REPORT 50-412/93-81

INSPECTION OF EMERGENCY DIESEL GENERATOR
LOAD SEQUENCER FAILURES

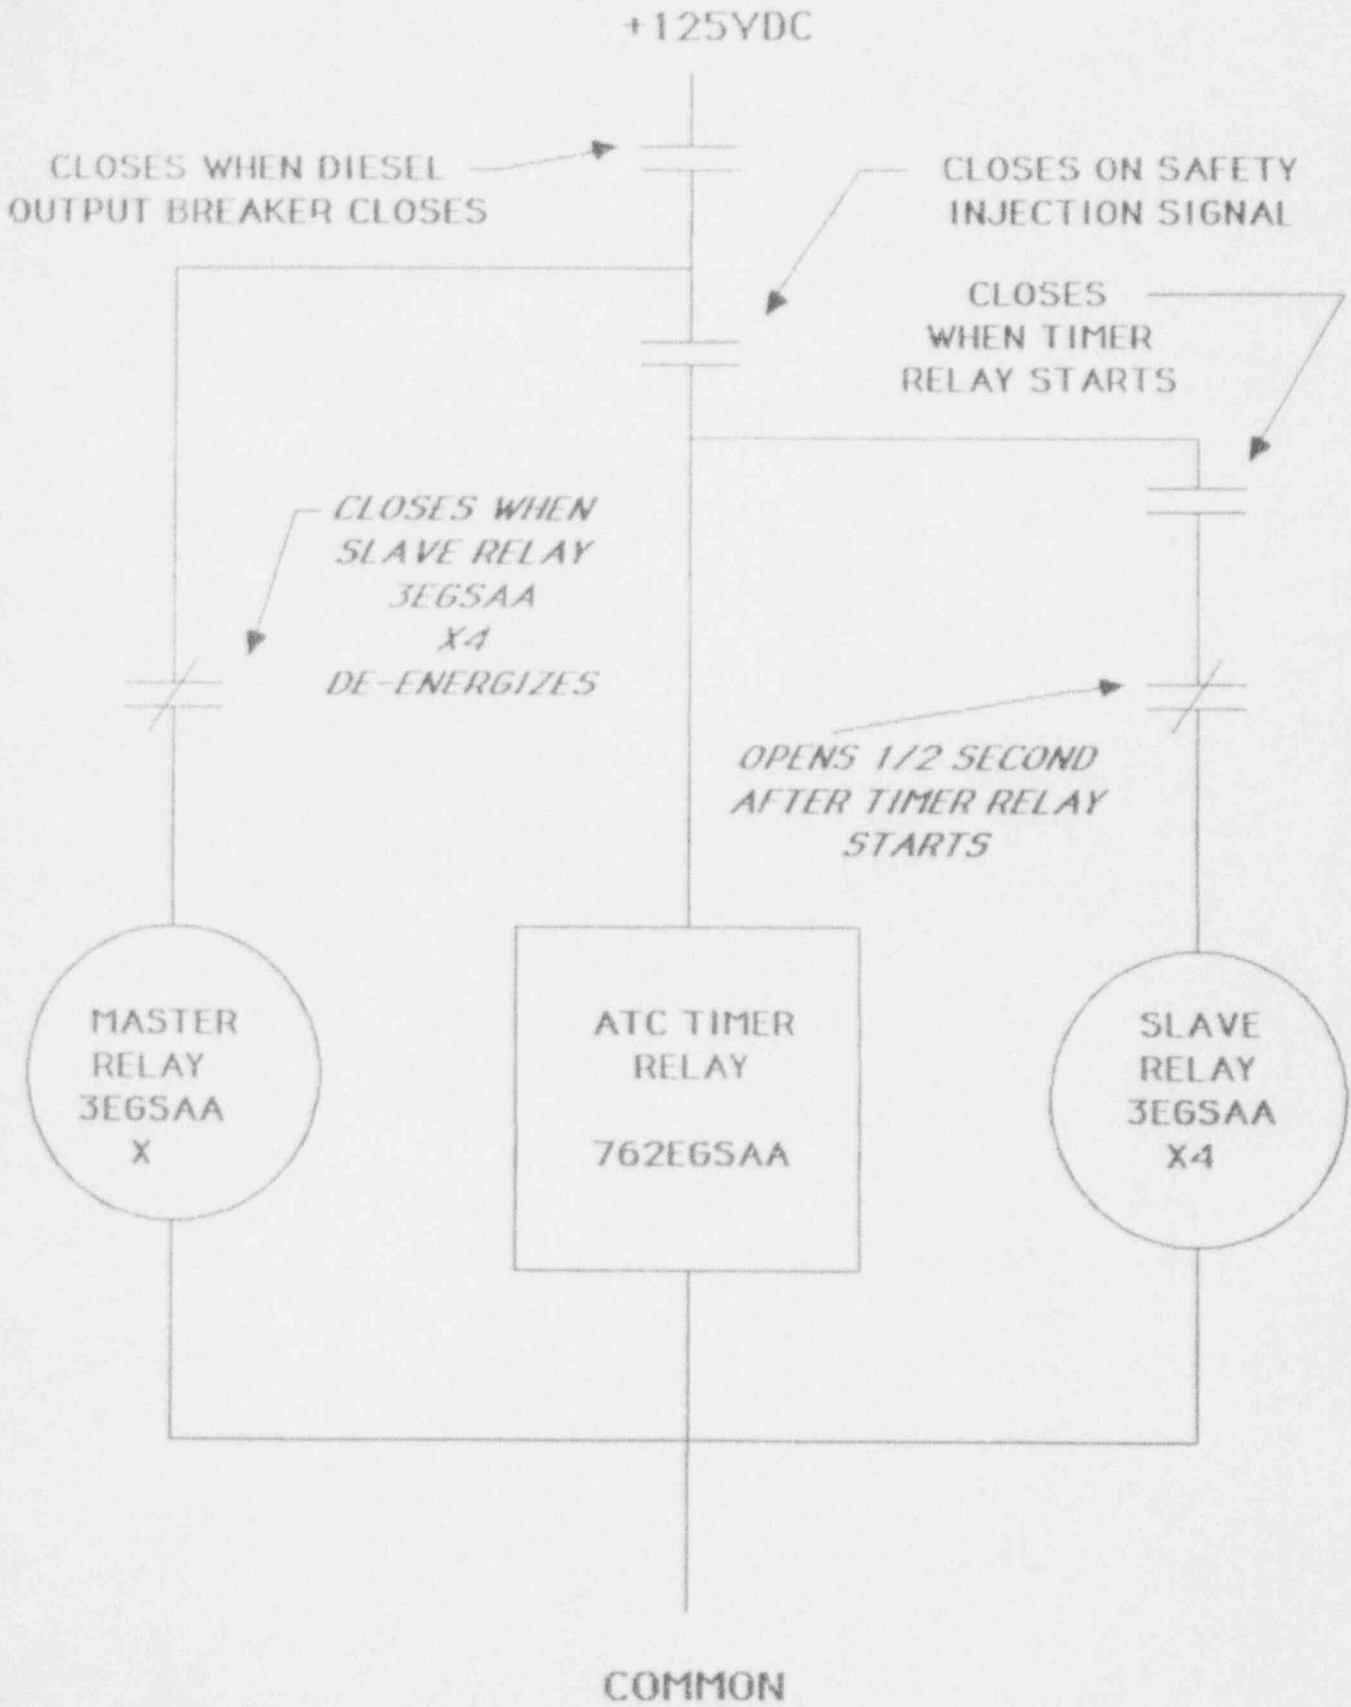
DIESEL GENERATOR SEQUENCER LOGIC

- THE DIESEL GENERATOR LOAD SEQUENCER WOULD NOT AUTOMATICALLY START EMERGENCY EQUIPMENT.
- THE FAILURE WOULD ONLY OCCUR DURING A LOSS OF OFFSITE POWER WHEN A SAFETY INJECTION WAS REQUIRED.
- MANUAL OPERATOR ACTIONS WOULD BE REQUIRED TO LOAD SAFETY-RELATED EQUIPMENT.
- RESETTING OF THE MOTOR-CONTROL-CENTERS WOULD REQUIRE OPERATOR ACTIONS FROM OUTSIDE THE CONTROL ROOM.
- THE TEAM DETERMINED THAT THE SAFETY SIGNIFICANCE OF THIS EVENT WAS HIGH BECAUSE A COMMON CAUSE FAILED REDUNDANT TRAINS OF SAFETY-RELATED EQUIPMENT.

- A NUMBER OF BENCH AND INSITU TESTS WERE PERFORMED TO DETERMINE THE CAUSES OF THE EQUIPMENT FAILURE.
- DIODES WERE INSTALLED AROUND THE SLAVE RELAYS TO REDUCED THE MAGNITUDE OF THE VOLTAGE SPIKES CAUSED BY THE DROPOUT OF THESE RELAYS.
- THREE ATC TIMER\RELAYS IN THE SEQUENCER WERE REPLACED WITH NEW TIMER/RELAYS.
- POST MODIFICATION TESTING IDENTIFIED A PROBLEM WITH THE AUXILIARY FEEDWATER PUMP STARTING LOGIC.
- ADDITIONAL SEQUENCER AND PUMP STARTING LOGIC DESIGN CHANGES WERE REQUIRED TO ELIMINATE THE AUXILIARY FEEDWATER PUMP LOGIC PROBLEM.
- EXTENSIVE POST MODIFICATION TESTING OF THE LOAD SEQUENCERS WAS CONDUCTED TO DEMONSTRATE OPERABILITY AND RELIABILITY.

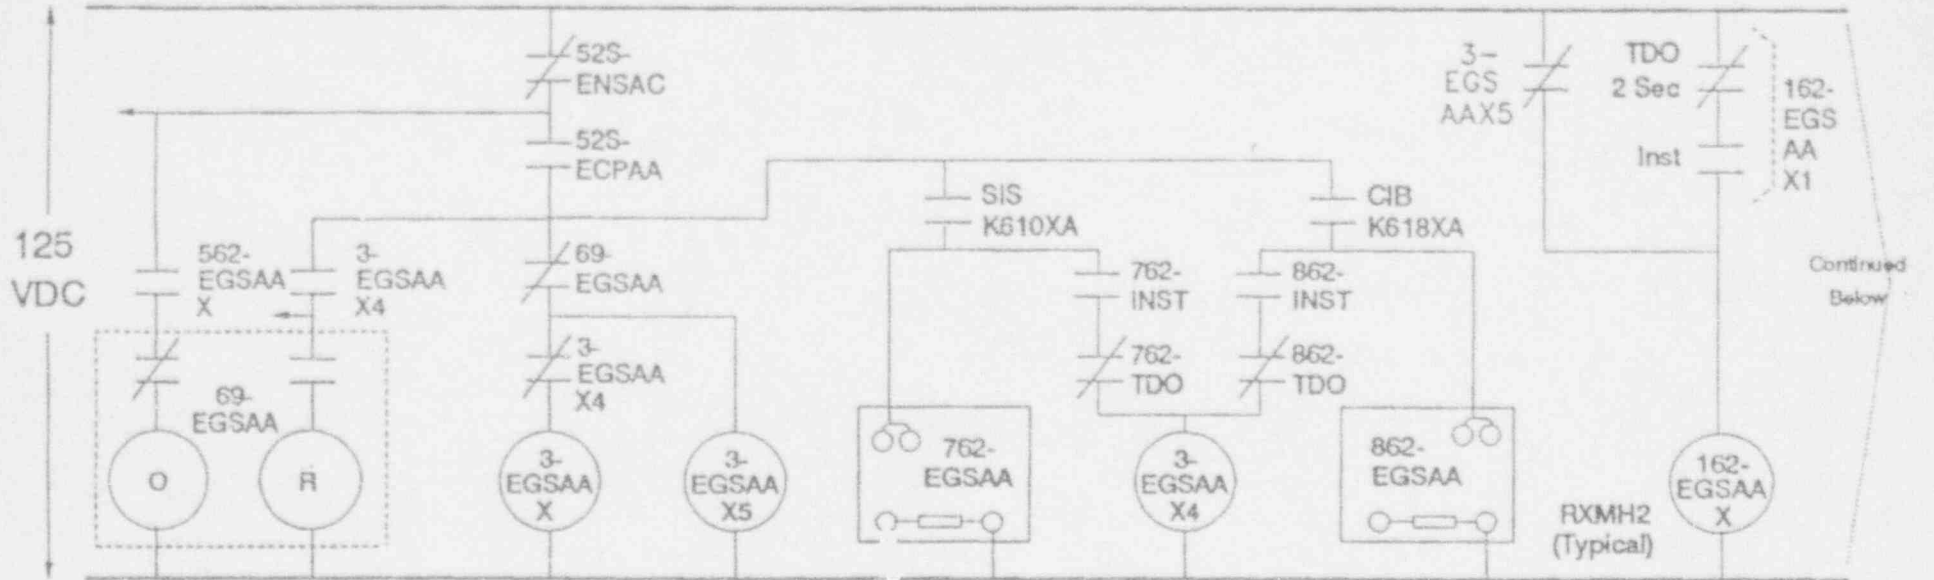
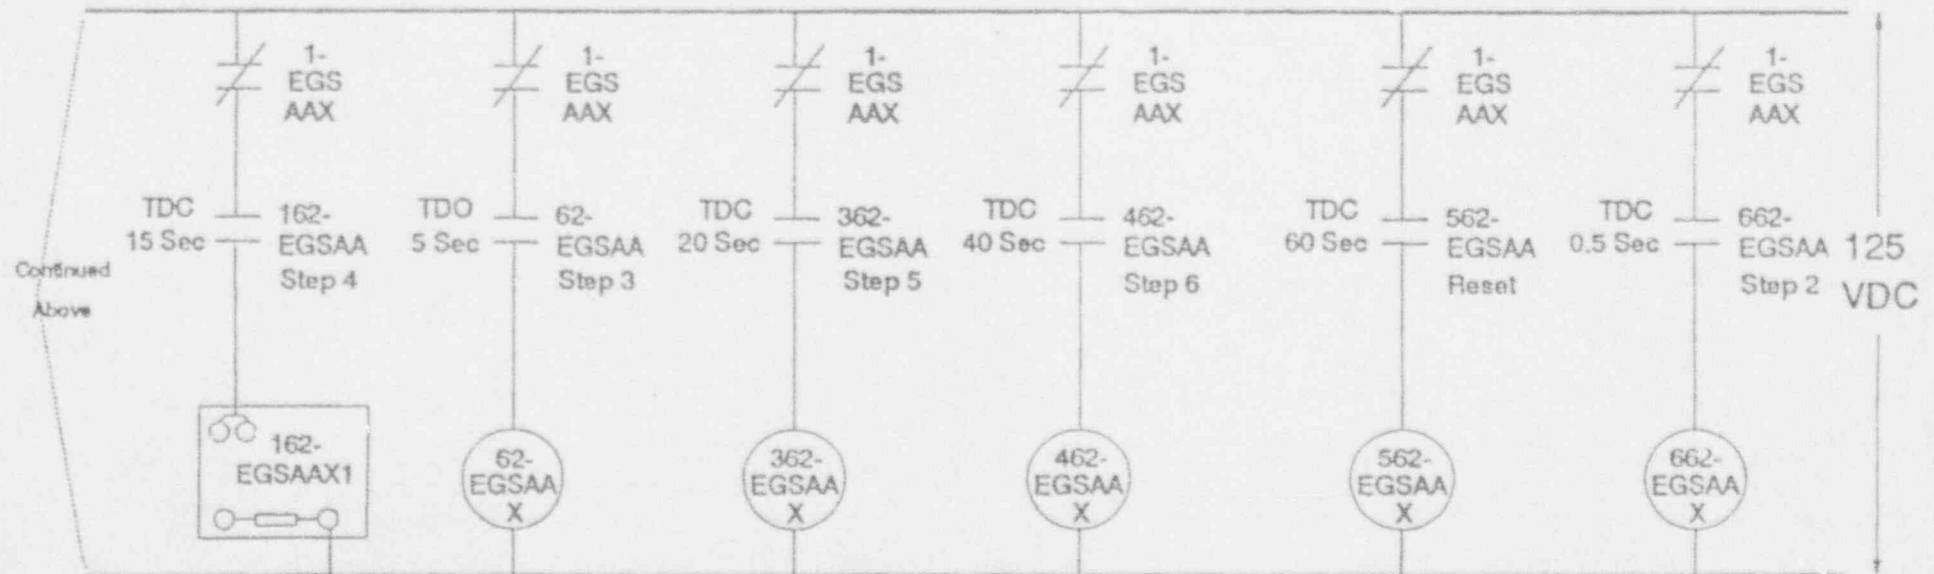
Figure 1

The cause of the load sequencer failure was determined to be the malfunction of the safety injection microprocessor timer/relay (762-EGSAA) that is used for sequencer reset. Specifically, the microprocessor timer/relay time delay contact opened after a 1/2 second time delay and then inadvertently re-closed a very short time later (approximately 30 milliseconds). Closing of the 762-EGSAA time delay contact energized the 3-EGSAAX4 relay, which "locked-out" (deenergized) the load sequencer master relay and prevented further load sequencer operation.

12241-E-12A Sh.1 (Simplified) - Before Modification

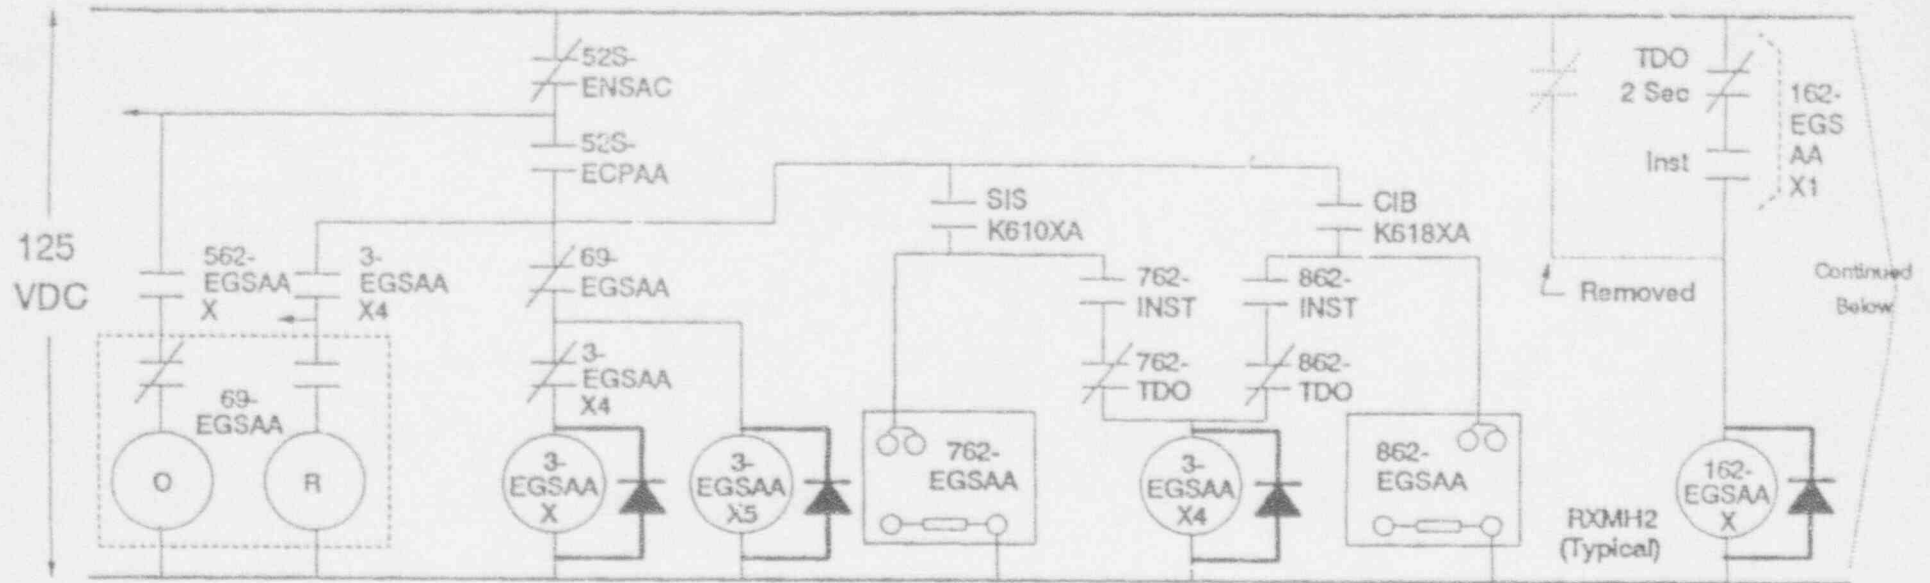
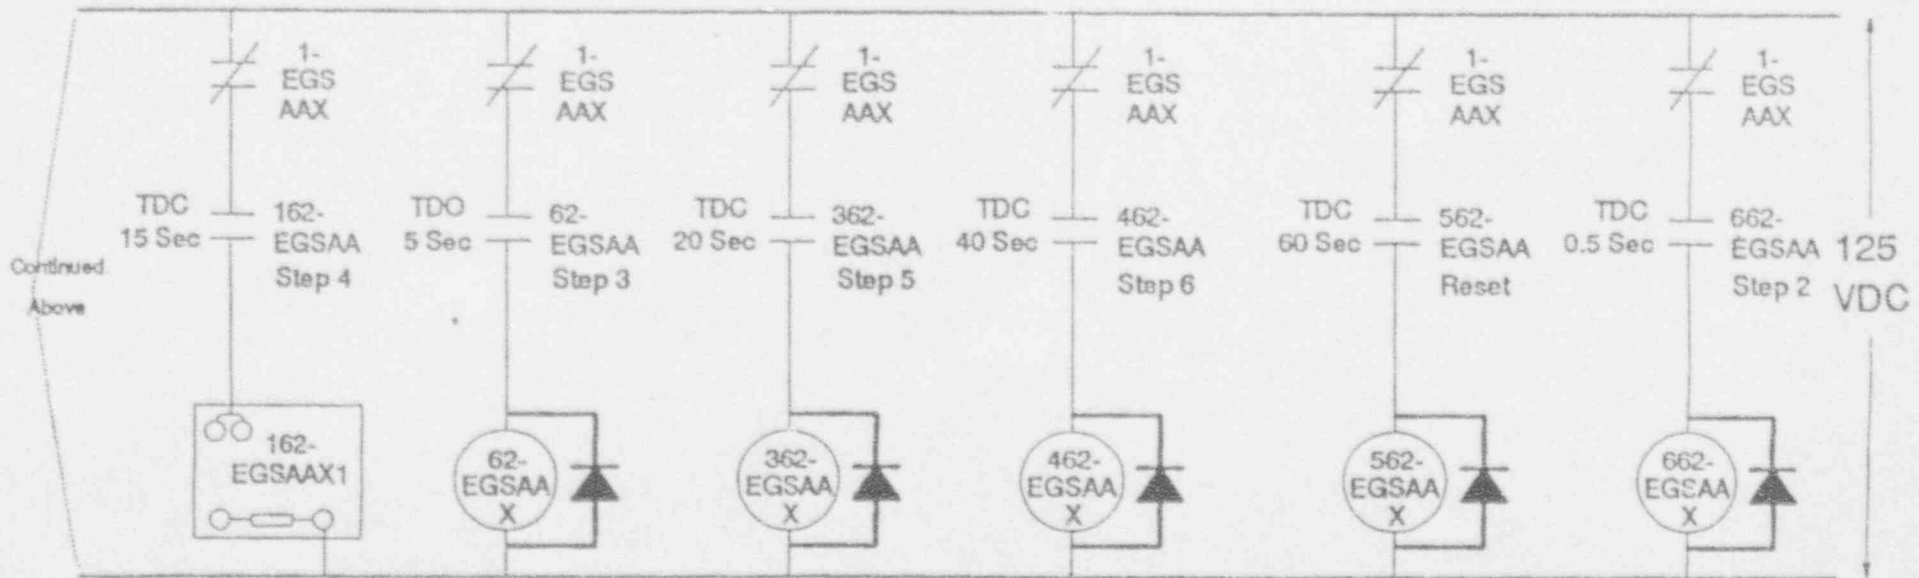
Figure 2

Diode suppression of the voltage spikes at the auxiliary relay removed the cause of the arc shower effect and allowed the microprocessor timer/relay to function properly. The effectiveness of diodes in suppressing the voltage spikes created during the deenergization of the auxiliary relays was determined by testing. The microprocessor timer/relay and auxiliary relay were bench tested in the in-plant configuration with the addition of a diode installed in parallel with the coil of the auxiliary relay. The results of these tests showed no failures after approximately 80 operations and indicated a significant reduction in the magnitude of the negative voltage spikes.

12241-E-12A Sh.1 (Simplified) - After Modification

A modification of the emergency diesel generator sequencers was implemented to reduce the magnitude of the voltage spikes. The modification installed diodes around the auxiliary relays to reduce the magnitude of the voltage spikes. Nine voltage spike suppression diodes were installed in each emergency diesel generator load sequencer. The post modification testing identified a deficiency with the installation of the diodes. The installation of the diodes increased the drop-out time of the relays, which caused the auxiliary feedwater pump to start at the wrong sequence step. The auxiliary feedwater pump starting circuits and the sequencer logic circuits were modified to correct this problem.
