AEOD/S93-06

SPECIAL STUDY REPORT

POTTER & BRUMFIELD MODEL MDR ROTARY RELAY FAILURES

December 1993

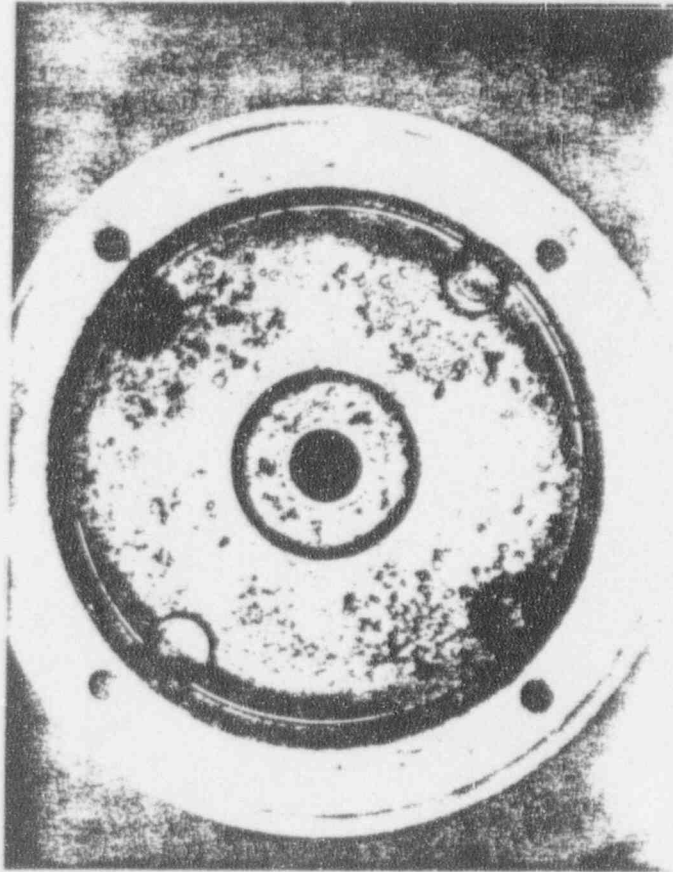
Figure 3-1 P&B MDR relay stud bell and bearing assembly

1. Mechanical binding of the rotor due to organic outgassing and deposition of contaminants and corrosion particles. The contaminants accumulated on the rotor shaft, upper and lower bearing races, magnet, coil, top brass plate, and brass spacers as the relay breathes. This has also produced shaft wear and metal chips in some cases, which could also bind the shaft. The binding caused the rotor shaft to bond or stick to the bearing, preventing the rotor shaft from rotating and the contacts from opening or closing when the relay coils are energized or de-energized. The binding failures ranged from slow shaft rotation, to partial rotation, to being completely frozen in place.

The hole in the center is the "bearing" and the four semi-circular areas are the bottom of the studs that hold the switch assembly in place. Varnish and corrosion products are shown as the irregular, darker deposits on the inside surface of the stud end bell.

P&B has changed the coil coating from varnish to epoxy, brass components to stainless steel, and other wiring materials to eliminate chlorine, as listed in Section 2.3. (MDR relays made prior to 5/90)

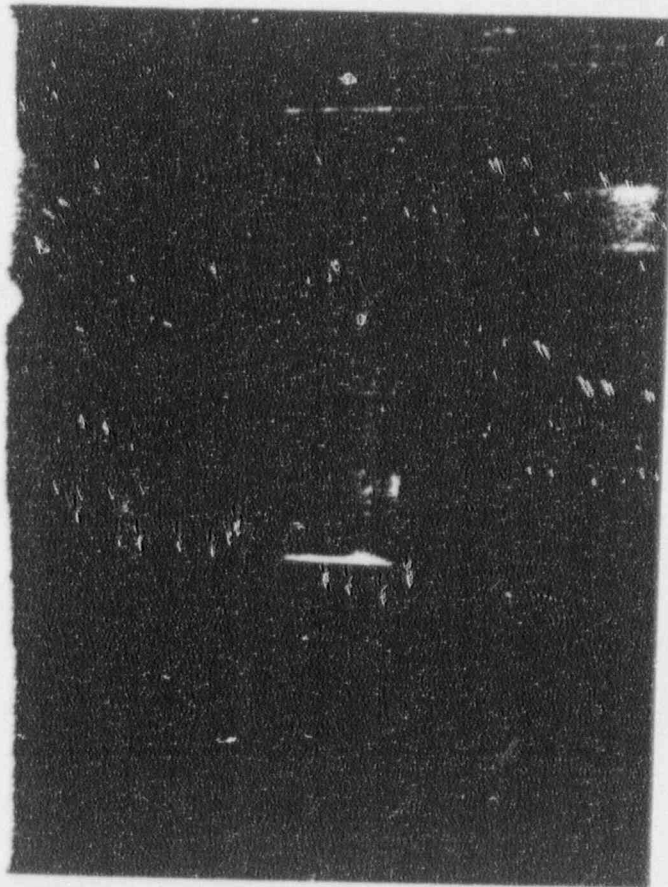
Figure 3-2 P&B MDR relay rotor assembly

The two dark bands on the rotor assembly lower shaft is the area in the relief spaces of the bottom spacer. Varnish and corrosion deposits are shown on the lower section of the rotor assembly lower shaft as irregular lighter areas above and below the lower dark band.

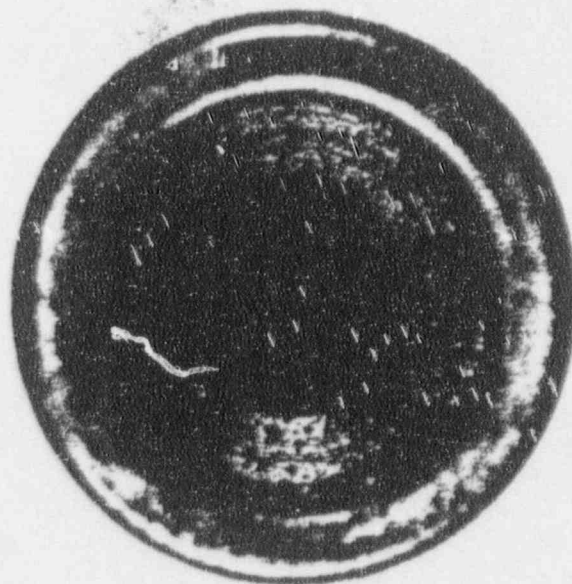
Figure 3-3 P&B MDR relay bottom spacer

The dark circle in the center of the bottom spacer is the hole for the rotor assembly upper shaft. The next concentric circular area is the relief area of the bottom spacer, where varnish and corrosion product deposits are shown as irregular lighter areas. The outer concentric circular area is the bottom spacer mating surface with the bottom shock plate, which is free of deposits.

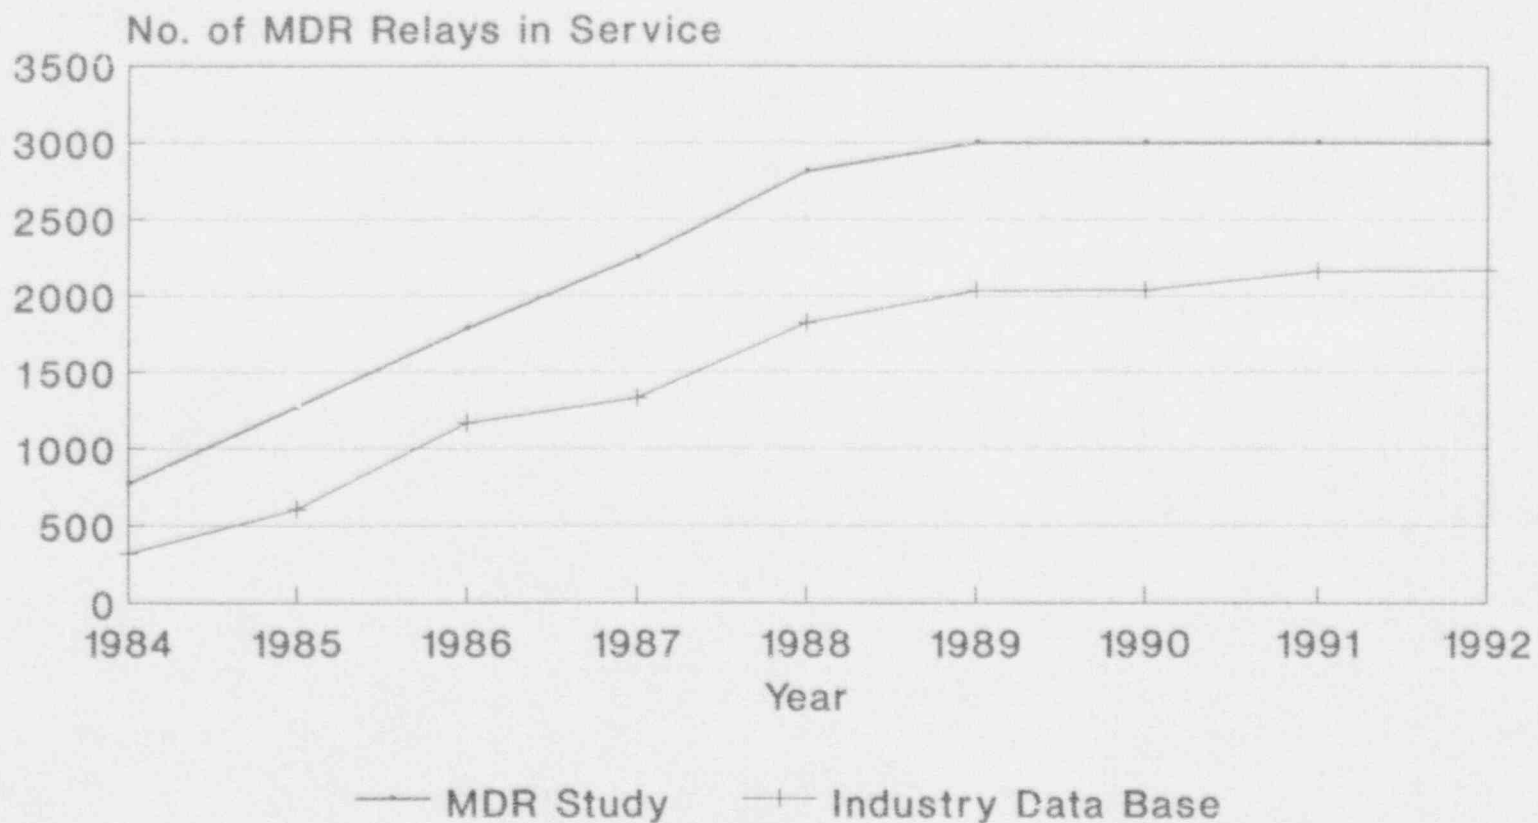
Figure 3-9 P&B MDR relays in service vs year

Figure 3-9, "P&B MDR Relays in Service vs Year" helps explain some of the differences between the industry database MDR relay failure rates and this study's. While the industry database included 319 MDR relays in its population in 1984, this study found 767 (140 percent more) in service. Discrepancies occurred in each year as more MDR relays were put into service. The largest difference occurred in 1989, when the database listed 2034 in service and this study found 2999. In addition, only 75 percent (92) of the MDR failures included in the 124 failures considered in this study were the same as those from the NPRDS database.

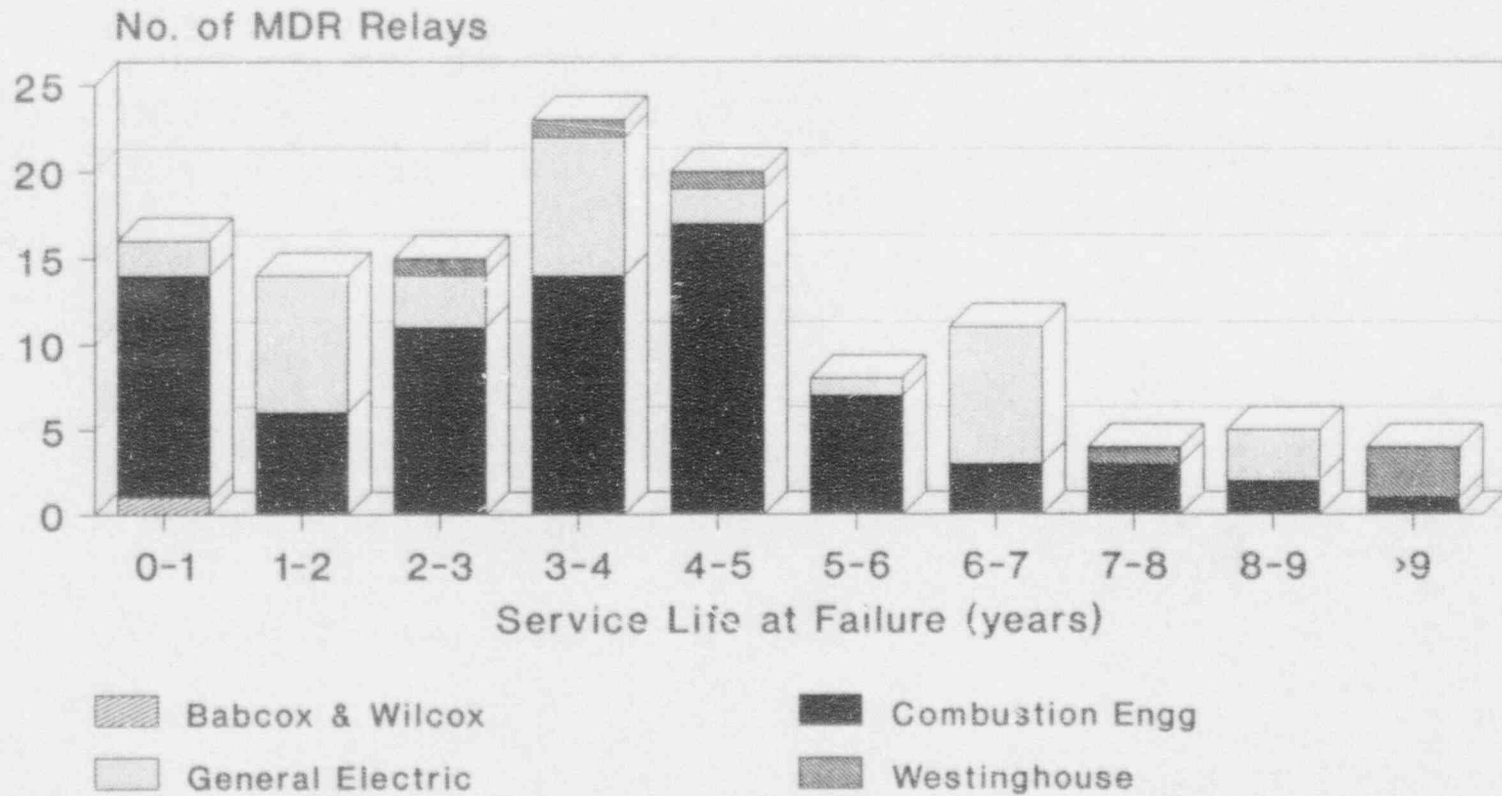
Figure 3-11 P&B MDR relay failures vs service life at failure by NSSS

Figure 3-11, "P&B MDR Relay Failures vs Service Life at Failure by NSSS" and Figure 3-12 "P&B MDR Relay Failure Rate vs Service Life by NSSS" shows the number of MDR relay failures and failure rates vs service life at failure by each reactor vendor. The highest number of CE failures appeared at about 4 to 6 years service life. This may reflect: (1) the accumulated service life of the MDR relay population shown in

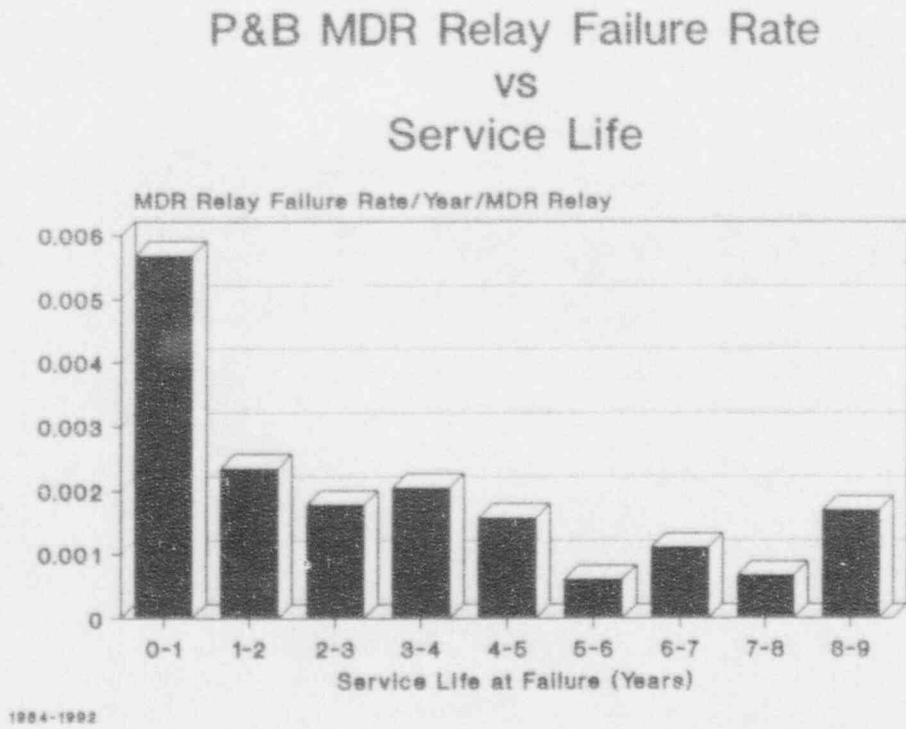
Figure 3-12 P&B MDR relay failure rate vs service life by NSSS

Figures 3-9 and 3-13, "P&B MDR Relay Accumulated Service Life," representing $1.83E+7$ hours of relay operation, and (2) the history of excessive voltage applied to certain MDR dc coils at CE plants for several years and the replacement of those relays. Thereafter, CE plant MDR failure rates leveled off.

The inservice MDR relay failure rate for the other reactor vendor plants' MDR relays increased again after 7 or 9 years inservice life. Most MDR relays used in CE plants do not have inservice lives in that range. The older relays were the ones failing most often in the MDR relay failure increases in 1991 and 1992. This may be a harbinger that increased age may affect MDR relay dependent failure rates and simultaneous failures in the future.
