HOPE CREEK GENERATING STATION
DOCKET NO. 50-354
UNIT NO. 1
LICENSEE EVENT REPORT 93-011-00

LICENSEE EVENT REPORT																			
FACILITY NAME (1) HOPE CREEK GENERATING STATION												DOCKET NUMBER (2) 0 5 0 0 0 3 5 4						PAGE (3) 1 OF 5	
TITLE (4): Engineered Safety System Actuation - service water pump start due to an invalid refuel floor high radiation signal.																			
EVENT DATE (5)				LER NUMBER (6)						REPORT DATE (7)				OTHER FACILITIES INVOLVED (8)					
MONTH	DAY	YEAR	YEAR	*	NUMBER	*	REV	MONTH	DAY	YEAR	FACILITY NAME(S)				DOCKET NUMBER(S)				
1	1	2 1 9 3	9	3	- 0 1 1	-	0 0	1	2	2 0 9 3									
OPERATING (9) MODE		1		THIS REPORT IS SUBMITTED PURSUANT TO THE REQUIREMENTS OF 10CFR: (CHECK ONE OR MORE BELOW) (11)															
POWER LEVEL %		0 9 0		20.402(b)				20.405(c)		xx		50.73(a)(2)(iv)				73.71(b)

TITLE: Engineered Safety System Actuation - service water pump start due to an invalid refuel floor high radiation signal.

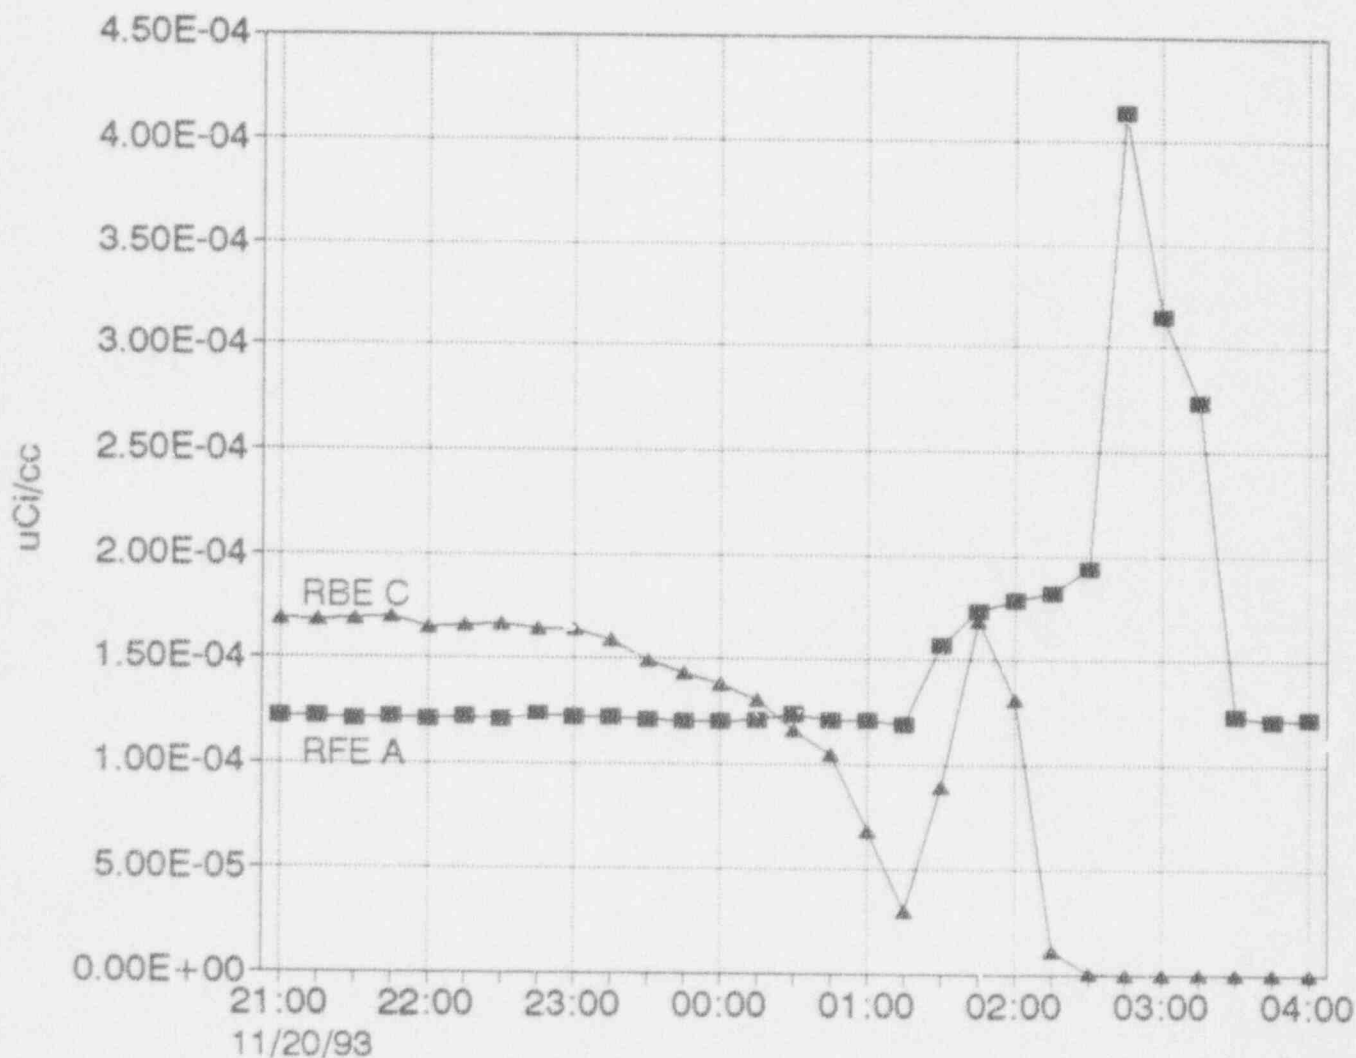
Although the two channels power supplies and circuits are physically separated, it is possible that the noise being generated by the "C" channel was being passed to the "A" channel RM80 through the common ground, and due to an unrelated failure on the "A" preamp card, a false high output was generated on the "A" RFE channel. The failure on the "A" RM80 preamp card would not be evident until such time as a noise induced increase in the reading was present. When the "C" RBE RM80 channel was removed from operation the "A" RFE channel returned to pre-event values. The "A" RBE and "C" RFE channels which share the same ground cable did not respond to the failure of the "C" RBE as their preamp devices were working properly.

A review of the remaining channel outputs, for the time period reviewed in this event, did not reveal any similar fluctuations or problems as seen on the "A" channel. The two preamp cards have been sent to the vendor for failure analysis.

The apparent root cause of the Isolation was due to failures of the A & C preamps for the "C" RBE and "A" RFE radiation monitoring channels and removal of the "C" RM23 which provided one of the required 2 out of 3 signals needed for actuation. The method of assessing the remaining channels performance prior to removing the "C" channel from service did not reveal the malfunction associated with the "A" RFE channel that the 15 minute trend readouts presented. The root cause of the preamp failures will be identified by vendor analysis of the cards.

1. The failed preamp cards in the "C" RBE and "A" RFE RMS channels have been replaced.
2. The failed preamp cards have been sent to the vendor for failure analysis. Based on the analysis additional corrective actions may be implemented.
3. This event will be reviewed with maintenance and system engineering controls personnel.
