BAW-10151A  
(Formerly BAW-1623)

CONTROL ROD GUIDE TUBE WEAR  
MEASUREMENT PROGRAM

Prepared for  
The B&W Mark B User's Group

SAFETY EVALUATION FOR BAW-1623, "CONTROL ROD GUIDE TUBE  
WEAR MEASUREMENT PROGRAM"

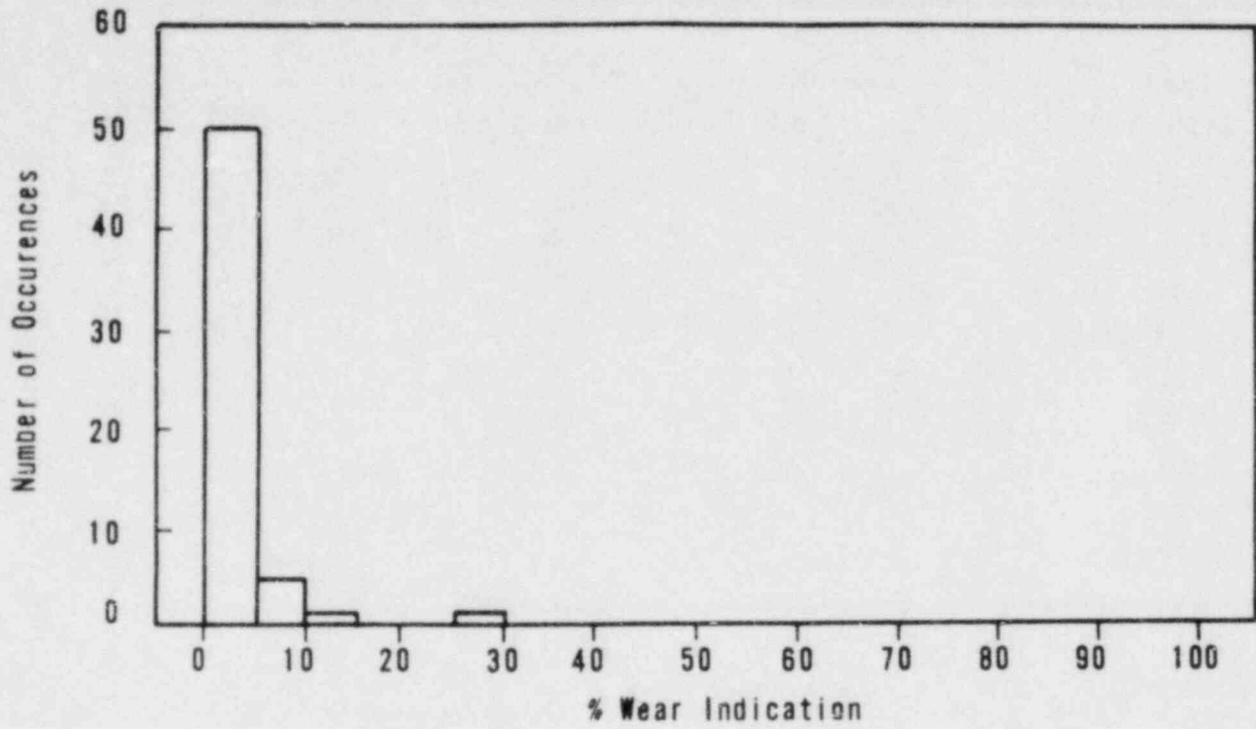
Figure 4-1. Oconee Wear Amplitude

The results from the Oconee examination (low flow rates) indicate less wear than Rancho Seco, with a maximum measured indication of 27% (in Oconee 3). The average wear for each Oconee fuel assembly was low, with a maximum of 6.7%. Table 4-2 shows the wear indication for each tube measured.

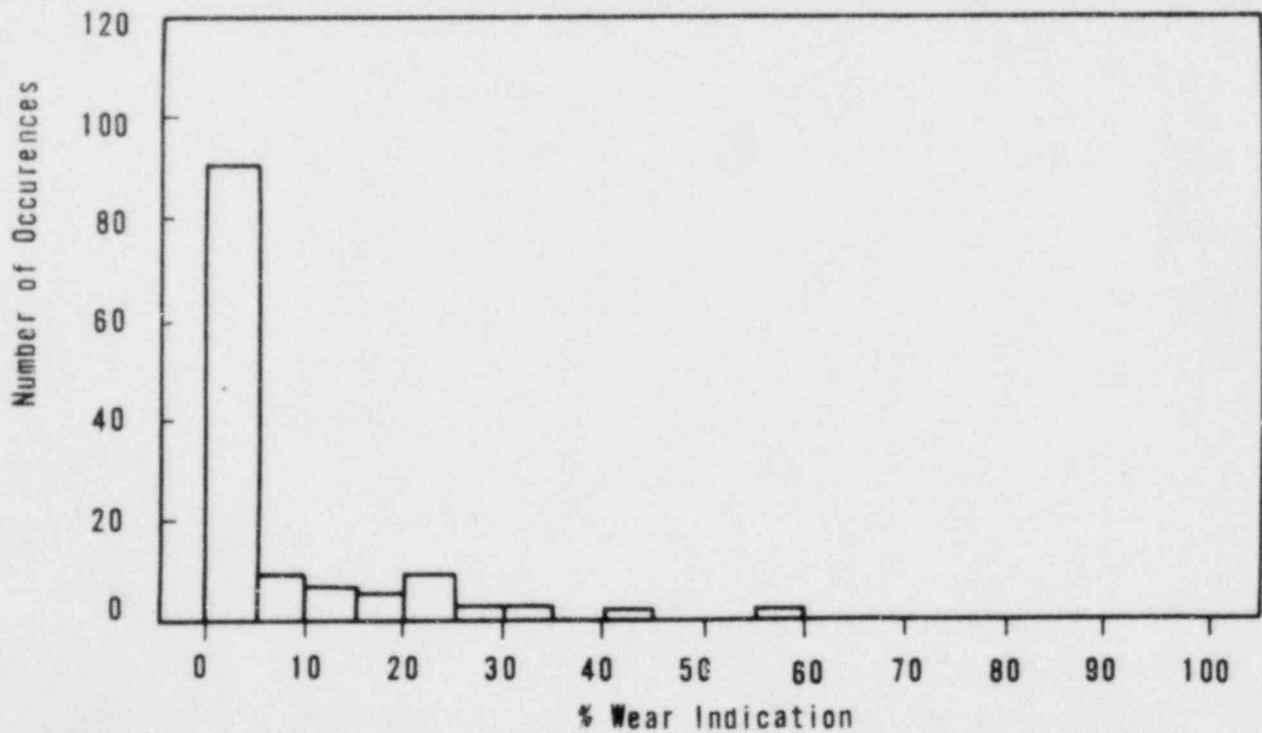
Figure 4-2. Rancho Seco Wear Amplitude

The results from the Rancho Seco examination (high flow rate) indicates that the largest measured wear was 57% (through-wall wear). In general, the wear was located approximately 9 inches down from the top of the guide tube, which corresponds to the location of the lower tip of the control rods of the safety banks in their park position. This location also corresponds to the control rod park position for control banks in some reactors. Four Rancho Seco fuel assemblies indicated wear ranging from 6.9 to 14.9% for one and one half cycles of operation. The other five assemblies examined indicated no wear. Table 4-1 shows the wear indication for each tube measured.

The results of both the Oconee and SMUD measurements show small average wear with the maximum average of 14.9% for one SMUD assembly with  $1\frac{1}{2}$  cycles of operation. The 14.9% was one-sided wear which is compared to an allowable wear of 100%. The distribution of wear indications is plotted in Figures 4-1 and 4-2.
