REPORTABLE OCCURRENCE 82-024

FORT ST. VRAIN NUCLEAR GENERATING STATION
PUBLIC SERVICE COMPANY OF COLORADO
16805 WELD COUNTY ROAD 19 1/2
PLATTEVILLE, COLORADO 80651-9298

REPORT NO. 50-267/82-024/03-X-2

Corrected Revised Final

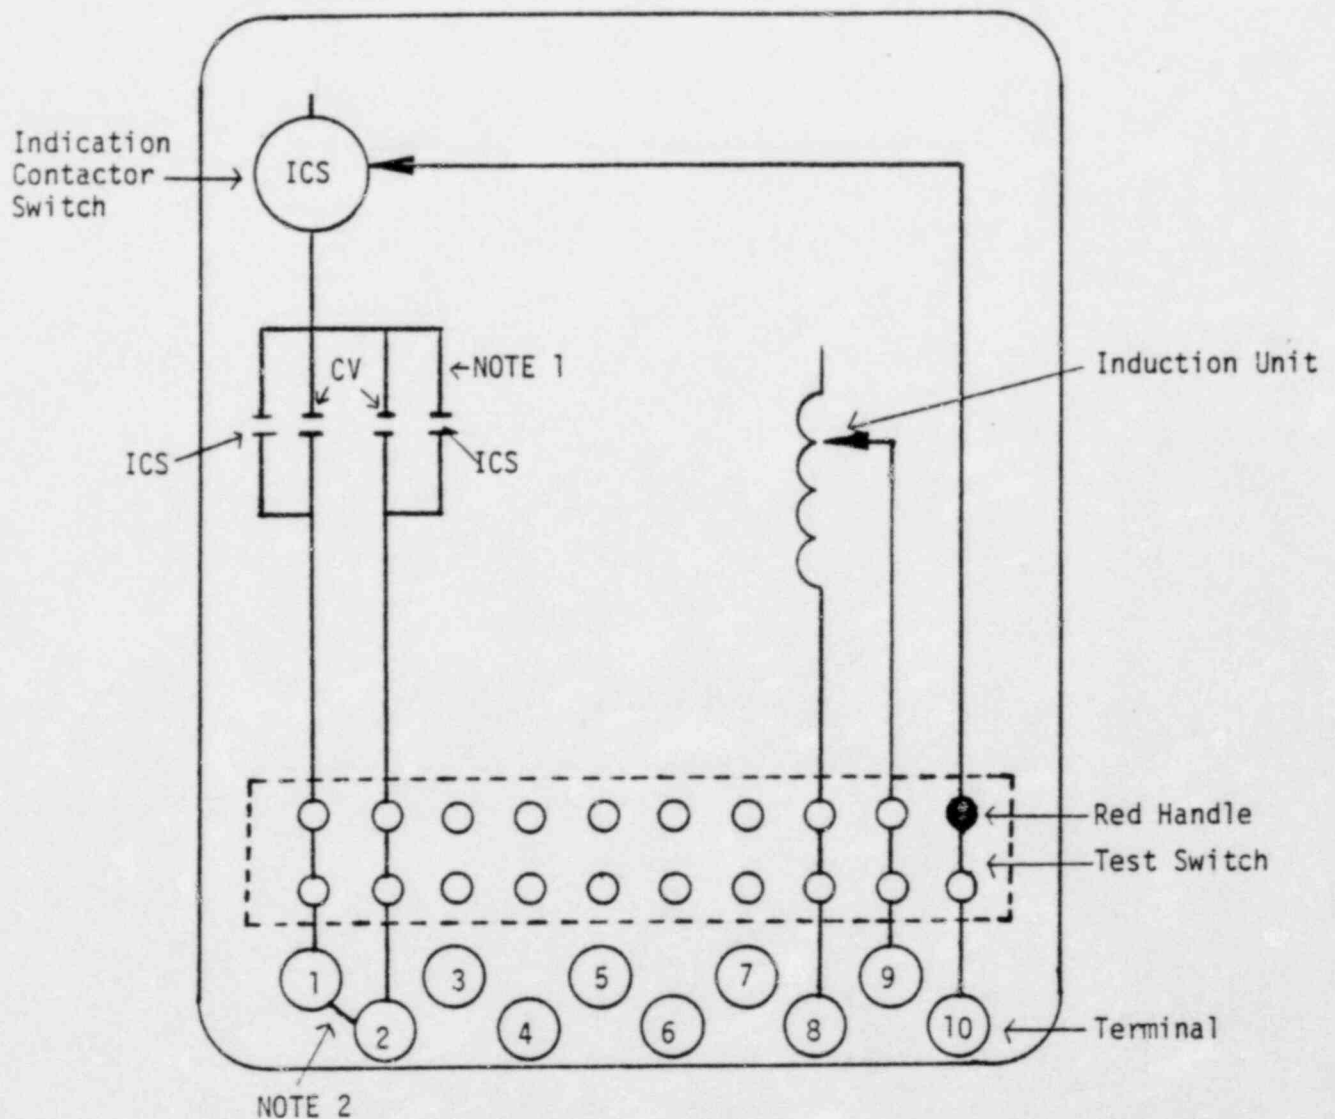
FIGURE 1: Internal Schematic of the Double Trip
Type CV Under or Over Voltage Relay

Upon investigation of this event, it was found that the undervoltage relay which tripped contains two parallel contacts. However, the relay calibration procedure stated calibration of only one contact. It was noted that Fort St. Vrain is one of few locations within the Public Service Company of Colorado's distribution system which contains the dual parallel contacts. The normal Westinghouse type CV-2 voltage relay used by Public Service Company contains only one contact with the capability of adding a second contact (see Figure 1).

According to the records, upon the last calibration check of this relay, it was found to trip at 44 volts (63.8% of rated voltage). The relay was then calibrated to 55 volts (79.7% of rated voltage) by the procedure. The procedure, however, did not include calibration of the second set of contacts which are affected by the setting of the primary contacts. After the trip on June 5, 1982, the relay was checked, and the second set of contacts were found to trip at 63 volts (69 volts is 100%). Plant conditions at the time of this occurrence were sufficient to lower the operating voltage of the electrical system to the premature undervoltage trip setting on the second set of contacts.

NOTE 2: Most relays used by PSCo do not have the contacts associated with Terminal 2.
Fort St. Vrain does have parallel contacts as shown.

After the proper procedure for calibrating both sets of contacts was written via a Procedure Deviation Report, the relay was recalibrated and adjusted to the proper setting of 55 volts.

The calibration procedure which was found to be inadequate has been rewritten and verified against the equipment used at this plant.

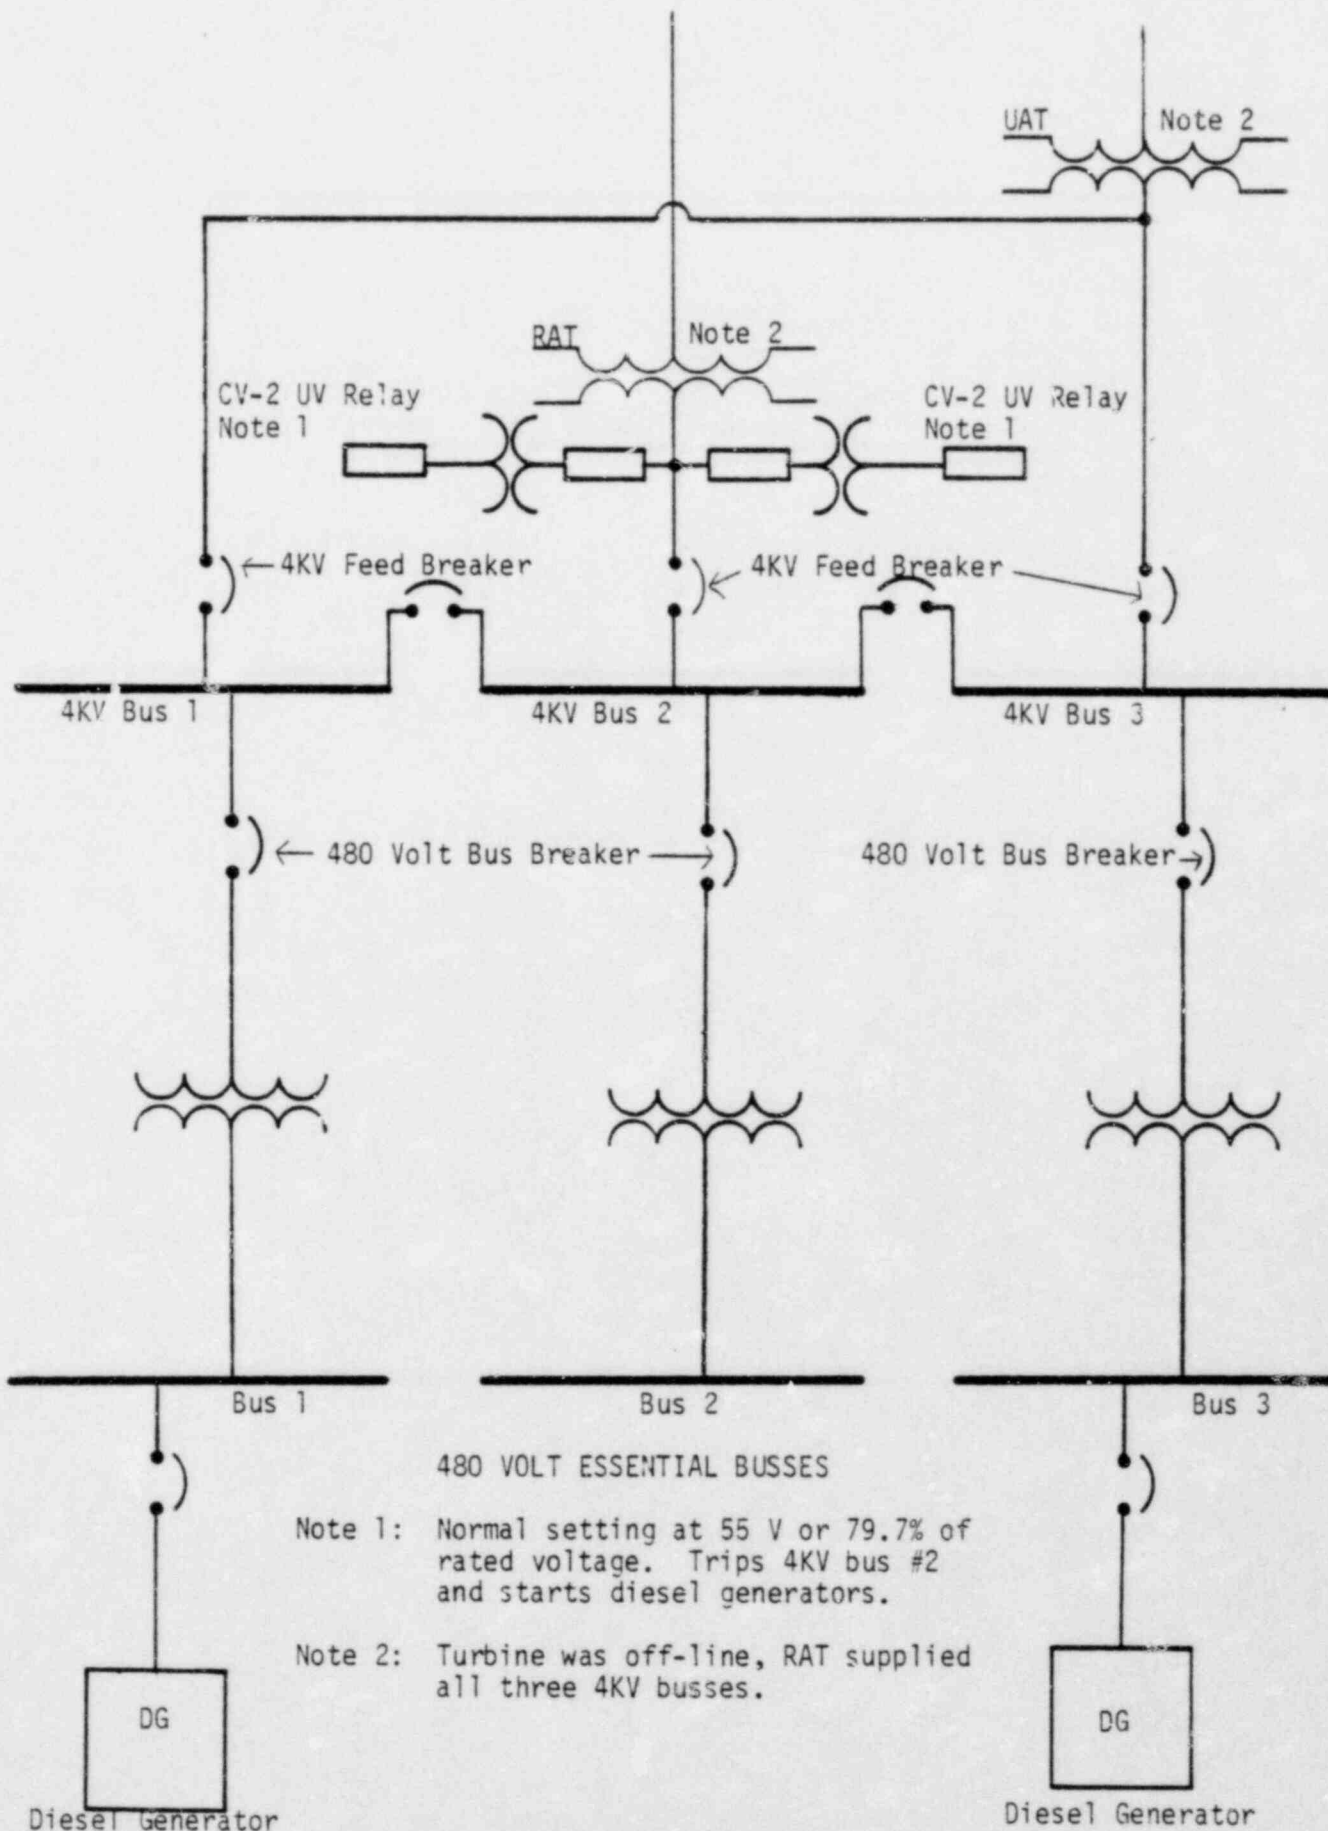
FIGURE 2: Basic Schematic of 480 Volt
Electrical Supply

On June 5, 1982, at 1550 hours, while recovering from a single loop shutdown (loop shutdown had occurred on June 4, 1982, from a spurious ultrasonic steam rupture trip signal), and reactor power at approximately 13%, one of two undervoltage relays which monitor the 4,000 volt side of the reserve auxiliary transformer (RAT) tripped. The tripping of this relay (Westinghouse type CV-2 undervoltage relay) caused automatic shedding of all three 480 volt essential busses. All three essential busses were lost due to the turbine being off-line and the RAT supplying the busses.

essential 4,000 volt equipment (1B boiler feedwater pump, 1A and 1B condensate pumps, 1A and 1B circulating water pumps) was not lost and that equipment remained operating/operable (see Figure 2).
