SACRAMENTO MUNICIPAL UTILITY DISTRICT □ 6201 S Street, Box 15830, Sacramento, California 95813; (916) 452-3211

August 3, 1982

DOCKET NO. 50-312
LICENSE NO. DPR-54
LICENSEE EVENT REPORT 92-17

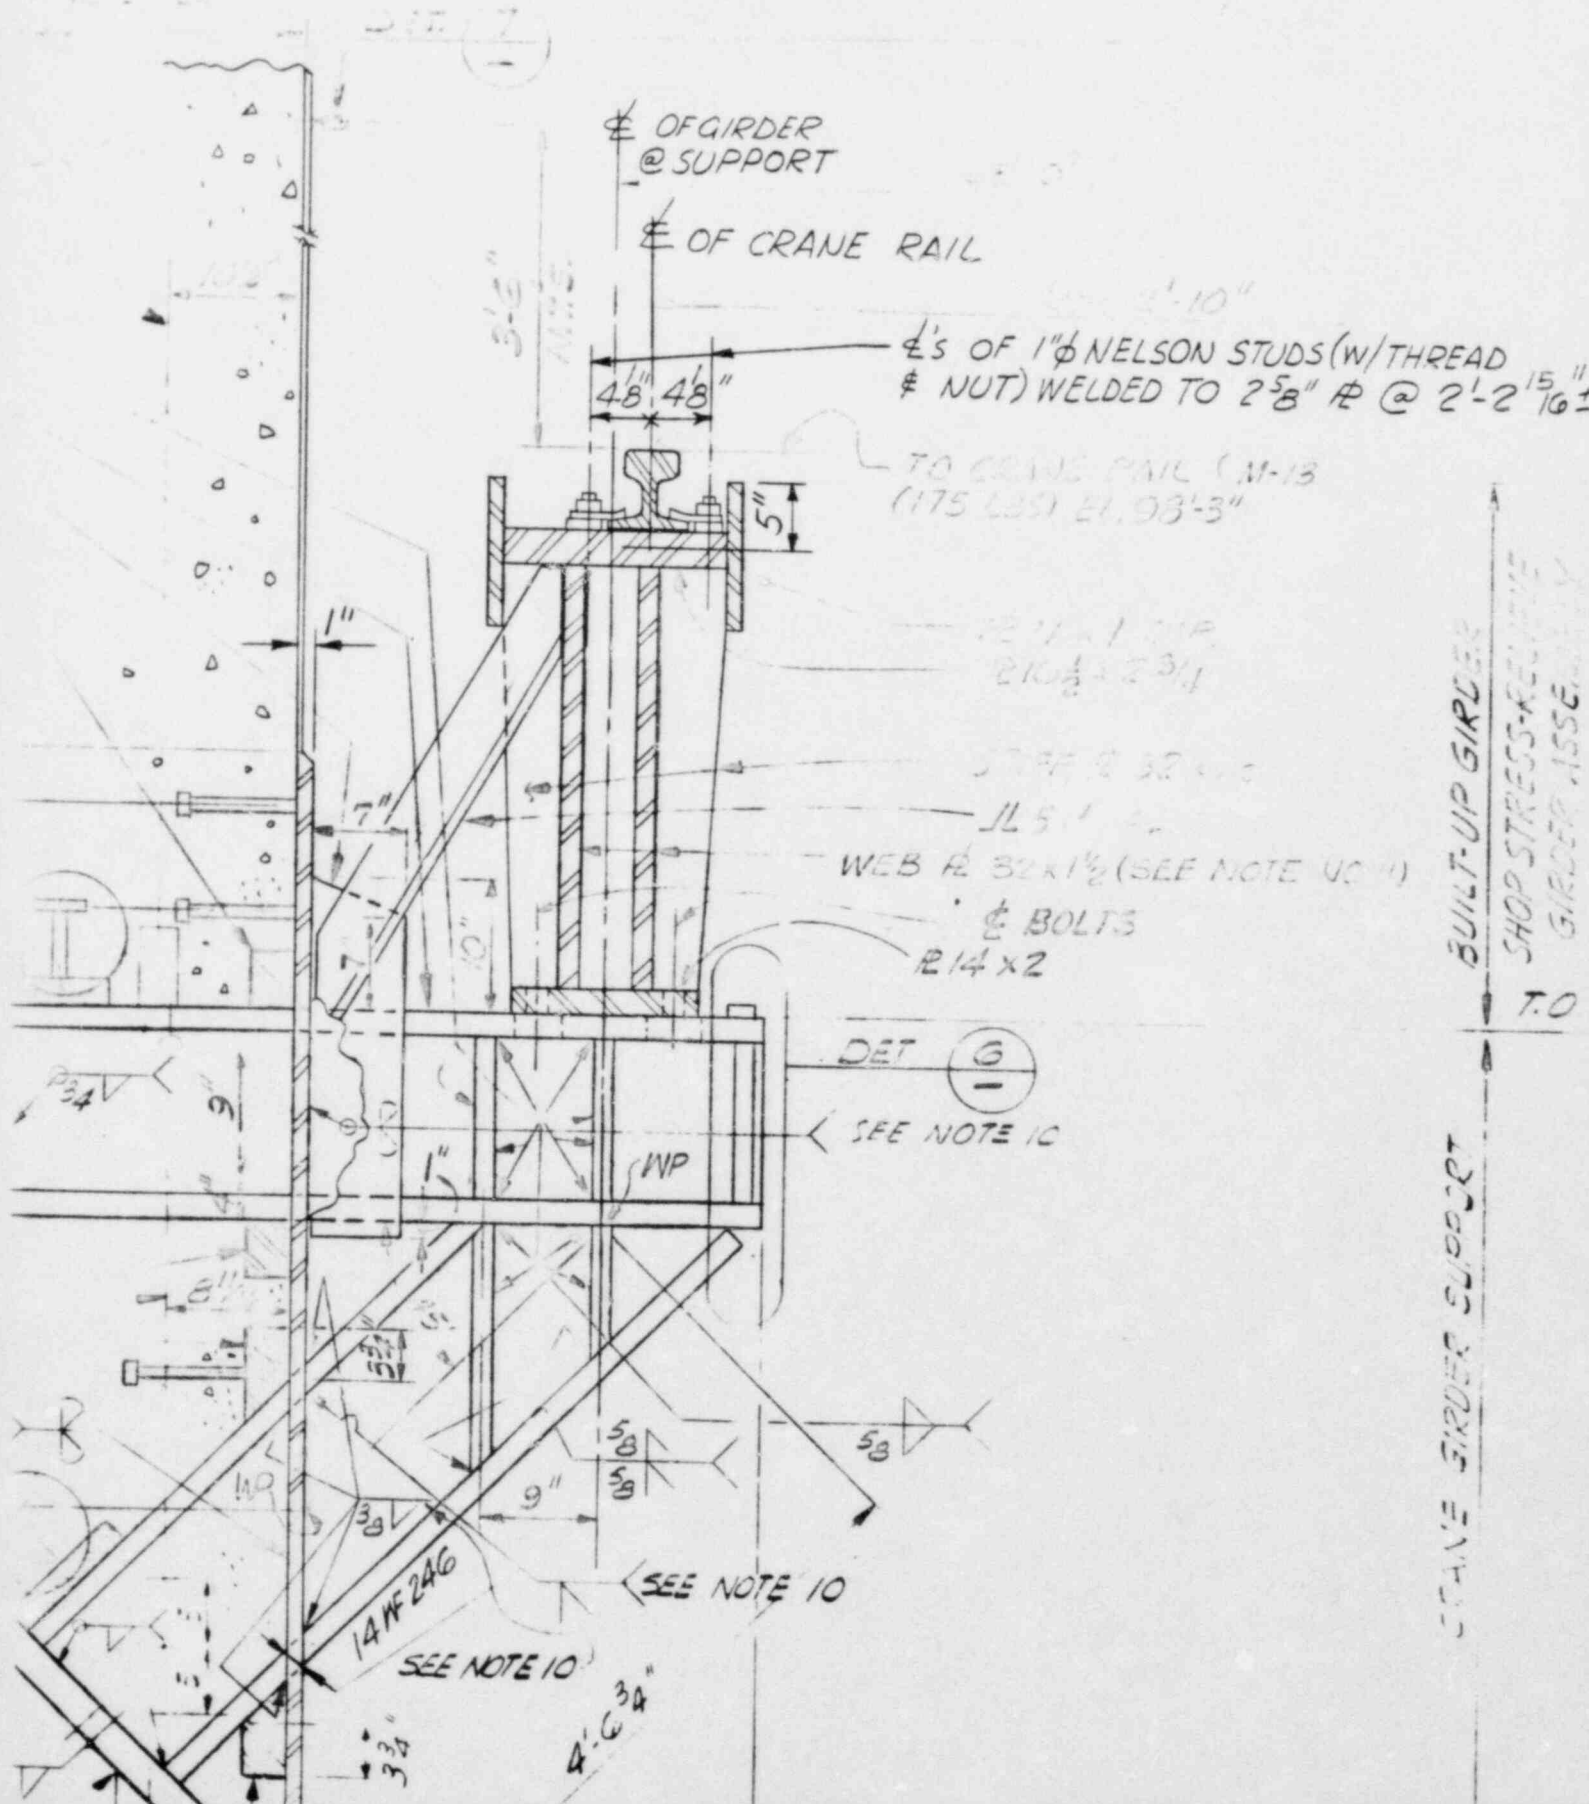
POLAR CRANE RAIL CONFIGURATION

On July 15, 1982, a visual inspection of the polar crane rail at Rancho Seco Nuclear Generating Station discovered 4 failed bolts on the rail hold-down clips. Inspection of all clip bolts, using a hammer impact test initially and a torque test as the ultimate evaluation technique, resulted in failure of 11 additional bolts. The bolts were originally installed using the Nelson stud weld process. The failures appeared to be due to high cycle fatigue.

Attached is a sketch of the cross section of the rail and its supporting girders. As can be seen from this sketch, the rail is located in such a way that it cannot fall, nor due to the length of the crane bridge itself, could the crane fall should the rail shift. For this reason, there is no safety impact on the plant. The District is reporting this only as an event of potential public interest. The NRC Site Resident Inspector was notified of this condition on July 19, 1982.

The cause of the failures appears to be a complex process involving several factors. First, the rail is a solid ring supported by the structural steel girders inside the containment. Due to the temperature variations in the containment, provision had to be made for thermal expansion of the rail. Thus, the hold-down clips were designed to allow lateral movement of the rail. Additionally, post-tensioning of the Reactor Building would have resulted in a lateral shift of the rail.

In reviewing the bolt failure data, a pattern can be extrapolated. It appears that the majority of the bolts that failed were located

on the outside rail clips and that the highest frequency of failure was in a sector of crane travel that coincided to an area above and to either side of the hatch. This would be the area which would see the most frequent crane usage, hence it would be the area of the rail that would experience the largest load cycles.

The District is planning to replace the failed bolts with new bolts using full penetration welds. There is evidence that this will correct the problem because when similar failures were observed in 1974, they were replaced using full penetration welds. There has been no evidence of failure of those replacements, to date.
