SECY-82-186

POLICY ISSUE
(Information)

For: The Commissioners
From: William J. Dircks
Executive Director for Operations
Subject: STATUS OF MAKE-UP NOZZLE CRACKING IN BABCOCK & WILCOX
(B&W) PLANTS

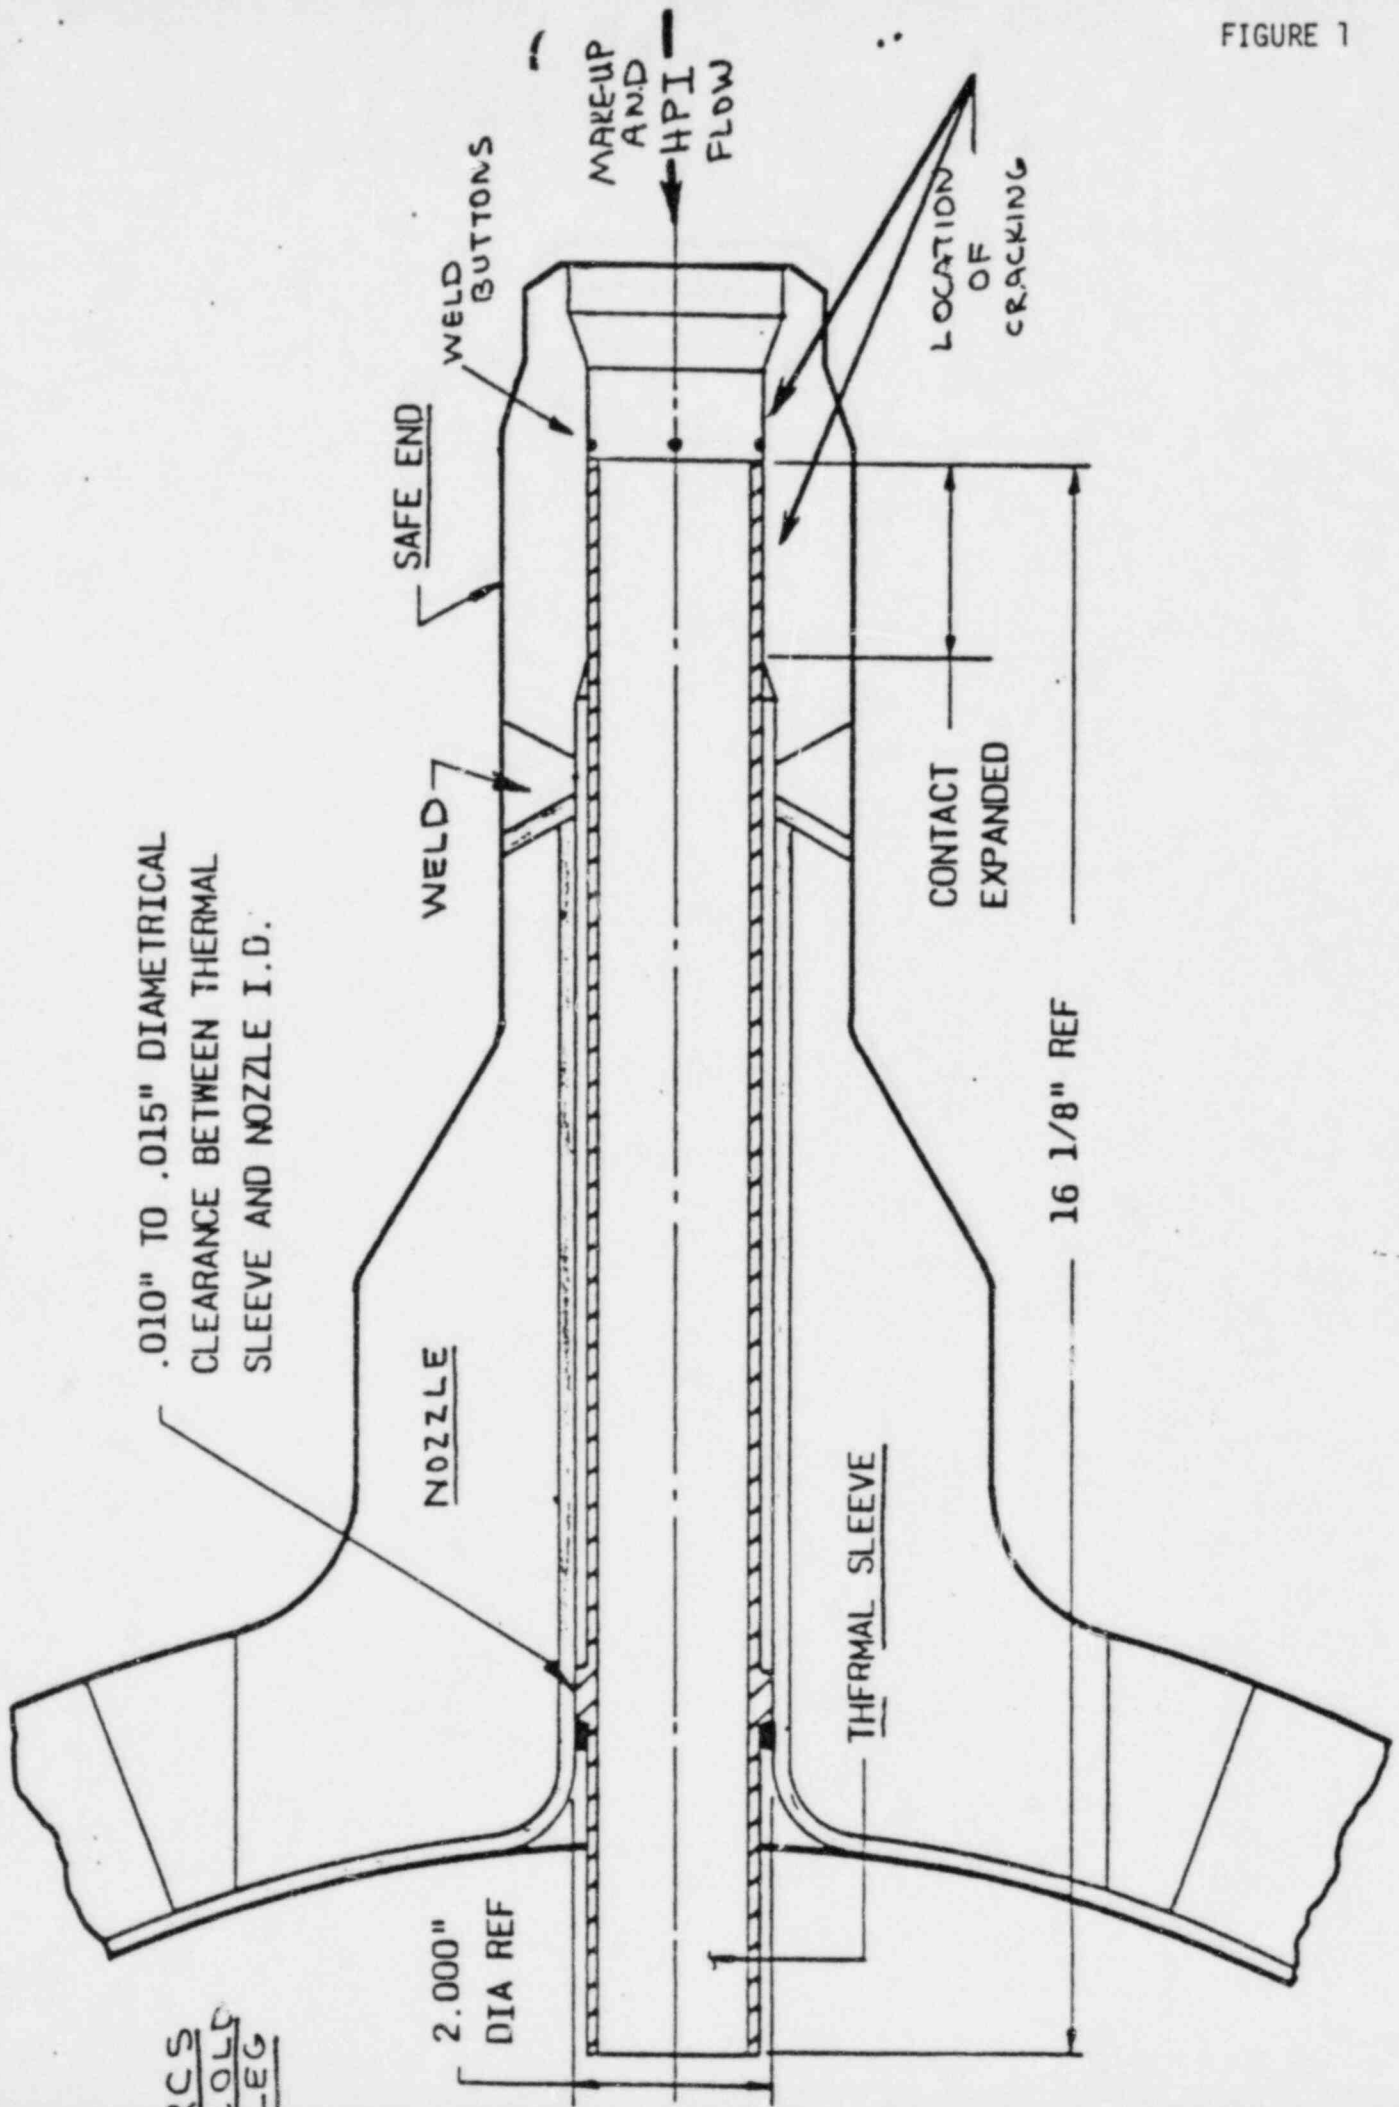
FIGURE 1

For all B&W plants, except Oconee, the normal make-up nozzle
is one of four nozzles to the cold leg of the reactor coolant
system that are used in the event HPI is required. At Oconee,
two of the four lines are used for normal make-up. The make-up
line is a "double-duty" line in that it is used for normal
primary coolant make-up in addition to its HPI function.
Thermal sleeves are installed within all of the HPI/make-up
nozzles to protect the nozzles from the effects of cool water
from the make-up tank or borated water storage tank thermally
shocking the nozzles that are in contact with hot reactor
primary coolant water. A typical thermal sleeve design for
B&W plants is shown in Figure 1.

Although the affected licensees haven't determined the cause of the cracking, from the investigation findings to date, it appears that the cracking problem is related to the condition of the thermal sleeve. In each instance where nozzle cracks have been detected, the associated thermal sleeve has been loose or, for Rancho Seco, missing and has yet to be located elsewhere in the primary system. The sleeve repair being employed calls for hard rolling of the HPI/make-up line end of the sleeve in lieu of the contact roll which had been employed. All of the cracked nozzles in the safe end areas have been or will be replaced before restart of the plants involved. The through-wall crack discovered at the check valve/make-up nozzle interface at CR-3 which initiated the subsequent inspections was limited to CR-3.
