MEMPHIS STATE UNIVERSITY  
AGN-201 NUCLEAR REACTOR FACILITY  
LICENSE R-127, DOCKET NO. 50-538

FOLLOW-UP REPORT TO REPORTABLE OCCURRENCE NO. 82-1

Date of Report: August 12, 1982  
Date of Occurrence: August 11, 1982  
Initial NRC Notification: August 11, 1982

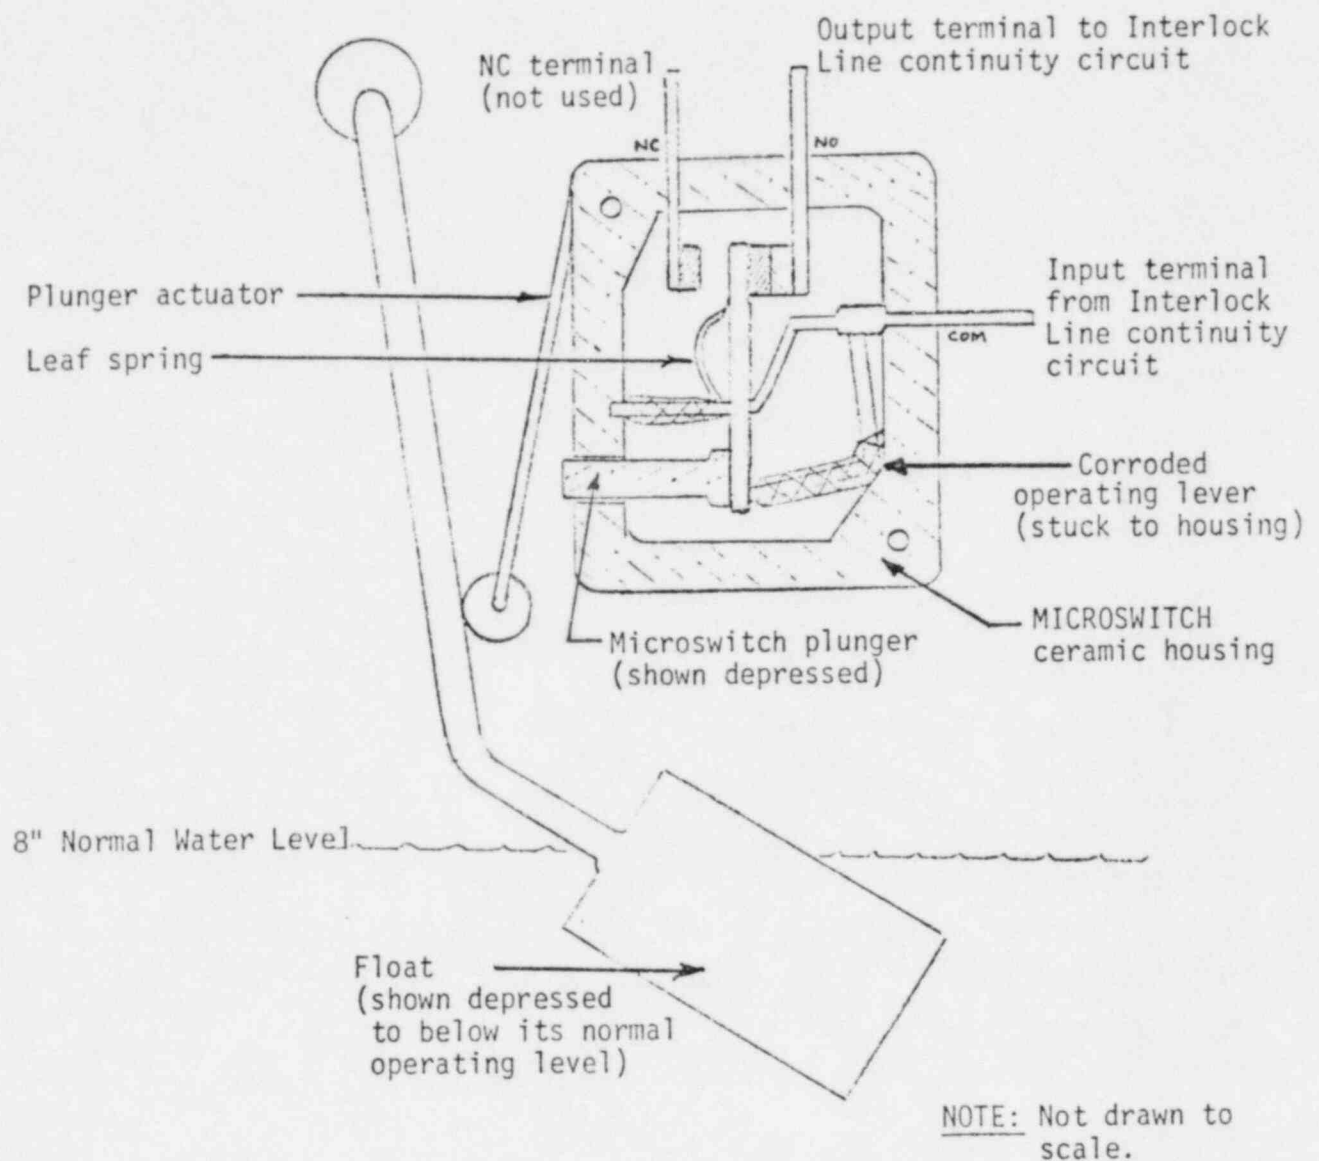
Upon depressing the float to its lowest level, simulating a water level of approximately 9.5 inches below the tank top, the operator did not hear an audible "click" of the associated microswitch which is physically located about 2½ inches above the water line nor was the Interlock line continuity circuit interrupted as observed by the Senior Operator stationed at the control console.

Gradual buildup of corrosion products in the internal operating mechanism of the microswitch due to its location in the humid atmosphere of the shield tank resulted in the internal switch operating lever being stuck to the ceramic switch housing (Figure 1). Spring pressure, which normally opens the active switch contacts when the float operating arm permits movement of the microswitch plunger, was insufficient to overcome the corrosion effects; thus, the switch contacts remained closed and prevented interruption of the Interlock Line.

FIGURE 1. Shield Tank Float Switch Assembly (Microswitch shown in failed position)

The microswitch was replaced with a new switch of the same type on August 11, 1982.

The microswitch casing is of riveted construction which precludes periodic disassembly and cleaning of switch internals. The availability of a model more suitable to a humid environment or a model constructed such that periodic cleaning of switch internals is possible will be investigated.
