WCAP-13603

Addendum 1

## RV Closure Head Penetration Alloy 600 PWSCC (Phase 2)

A Westinghouse Owners Group Program Report

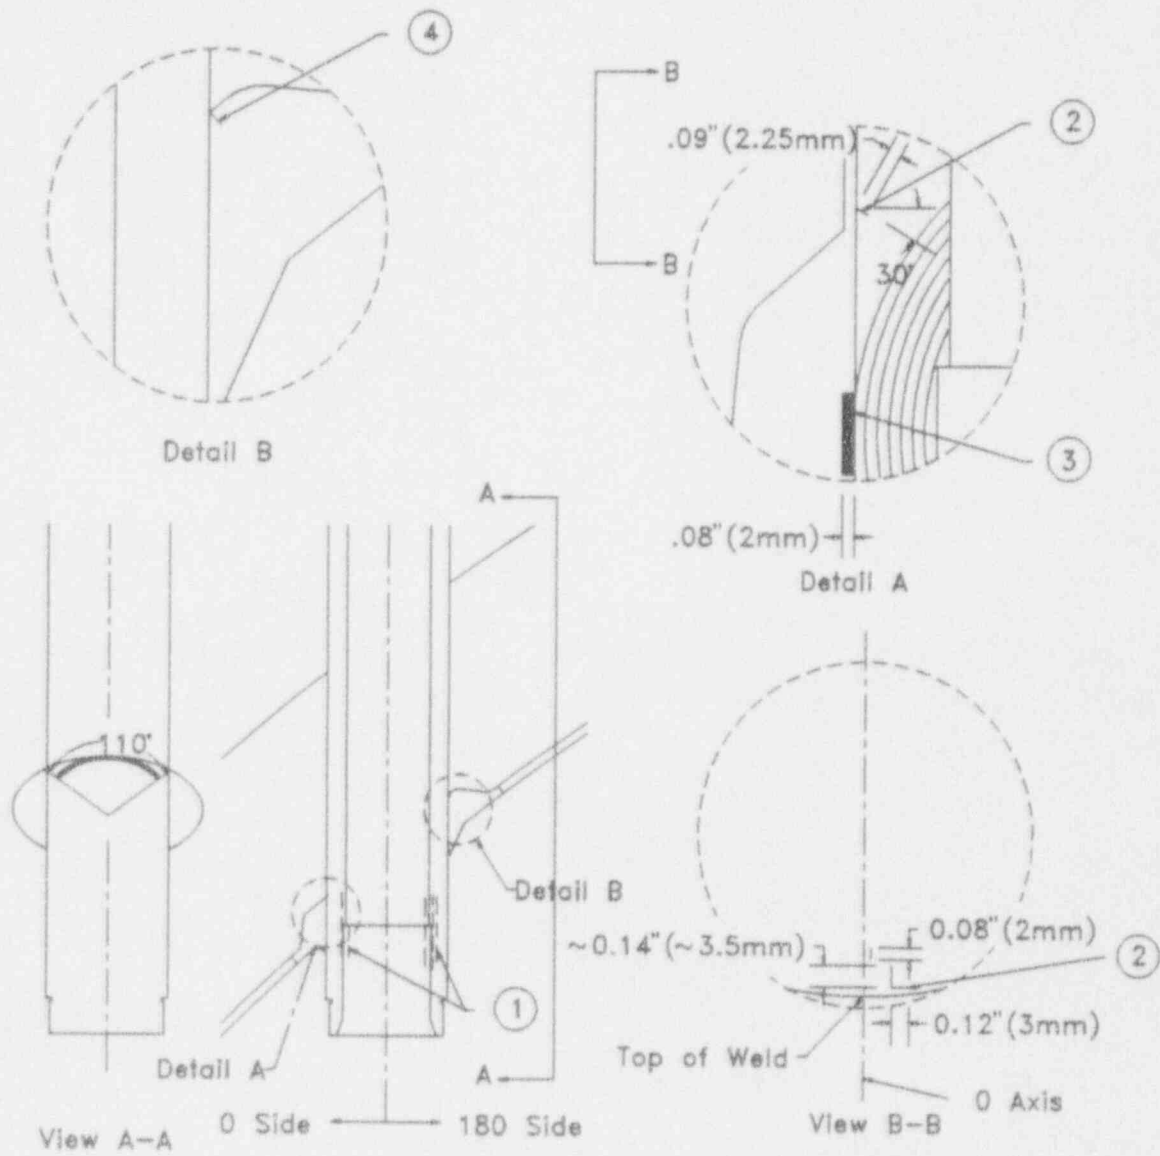
Figure 1. Geometry of Flaws Observed During Destructive Examination of Bugey Unit 3 Penetration 54

Since that time, EDF has reported that destructive examination of the only head penetration known to have leaked revealed two circumferential orientated cracks, as shown in Figure 1. Both cracks were located at the outside surface of the penetration, one in the weld and one in the Alloy 600 base metal just above the weld. The crack in the weld is fabrication related while the crack in the penetration tube is primary water stress corrosion cracking. The presence of these cracks has raised the issue of their safety significance, since a circumferential flaw propagating entirely around the circumference could lead to severance of the penetration.

The head penetration which had originally leaked was destructively examined by Electricité de France, and three additional flaws were found, as shown in Figure 1. These flaws were in addition to the through-wall axial flaws discovered by inspection in that same penetration.

The first of the three flaws shown in Figure 1 is the most important, because it has been verified to be the result of primary water stress corrosion cracking, and is oriented circumferentially. The second flaw is oriented axially, and therefore already treated by the axial flaw propagation studies reported earlier. The third flaw is also circumferential in nature, and is reported to be a "hot crack" resulting from the original welding process.

Therefore the crack number 1 in Figure 1 will be the subject of primary interest here. The flaw is oriented circumferentially, at an angle of about 30 degrees to the horizontal plane, as shown in the cutaway view in Figure 1. When viewed from the outside of the penetration, the flaw would appear as a horizontal line.

The flaw is located near the zero degree, or lower hillside location in the penetration, at the outside surface just above the weld. The flaw was reported to be 3 mm long and 2.25 mm deep.

The angular orientation of the flaw is such that it is propagating in a direction downward toward the centerline of the vessel. The plane of the flaw therefore includes only a very small portion of the circumference of the penetration which is above the weld. Therefore, even if the flaw were to extend around in this plane, the penetration would still be captured by the existing penetration to head weld. The evaluation discussed here has examined a number of possible paths of propagation, including continued propagation along the original plane.

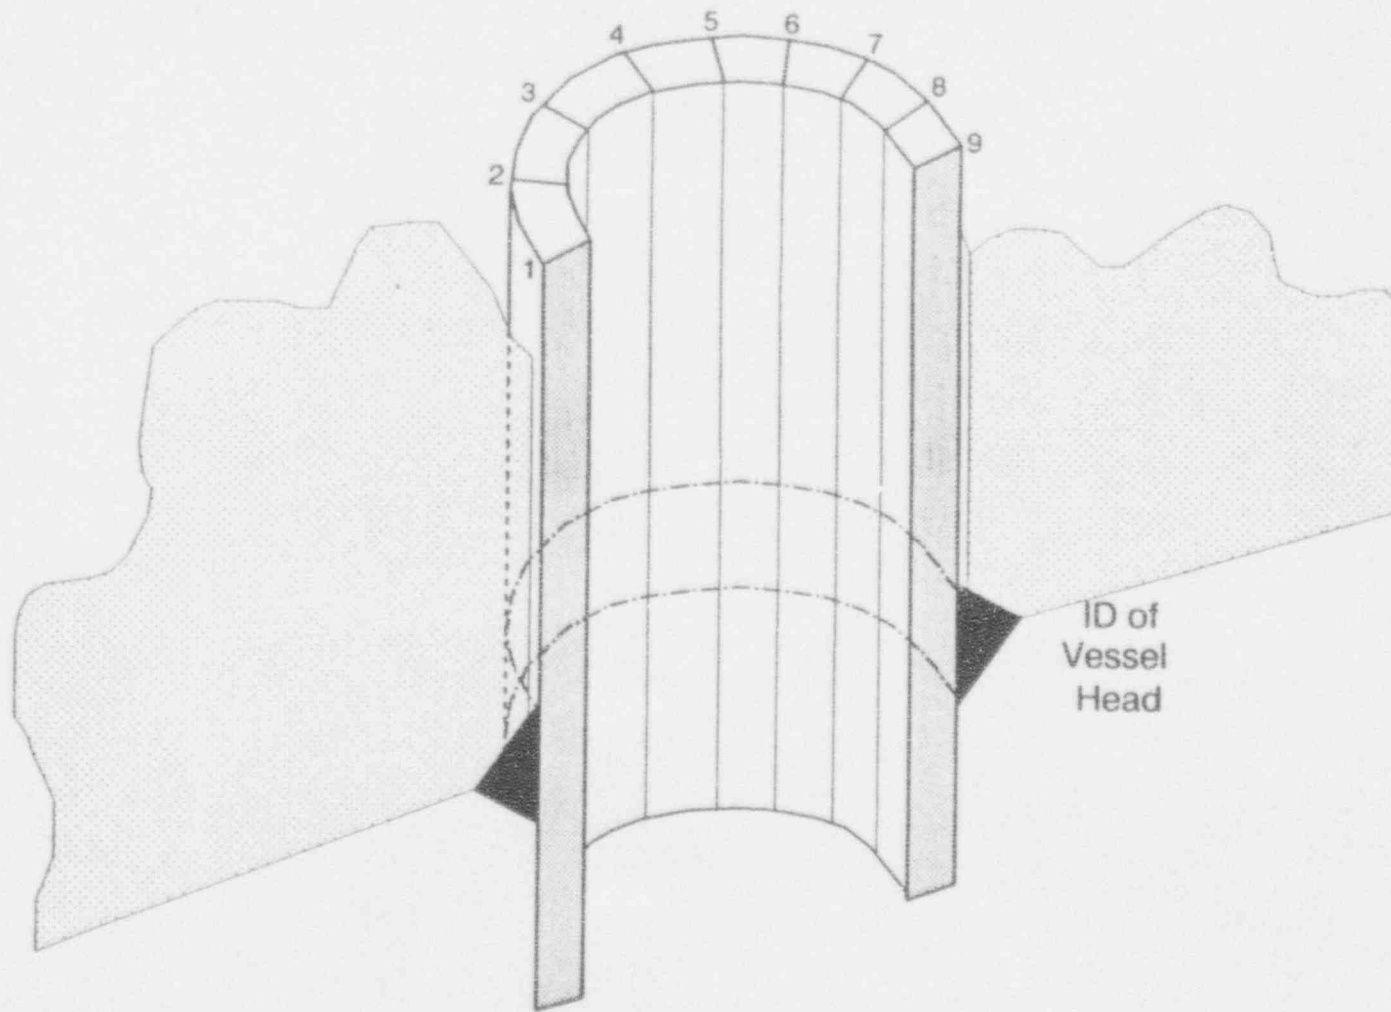
Figure 2. Schematic Showing the Stress Cuts Chosen to Display Both Axial and Hoop Stresses in the Penetration Near the Weld Region

Nine different locations around the circumference were considered, as shown schematically in Figure 2. Both the axial and hoop stresses are shown in each of these cuts in Figures 3 through 6. Note that the axial stress shows a peak value at the lower hillside location (cut 1), just above the weld, which is precisely where the crack was found in the Bugey Unit 3 penetration, as shown in Figure 1.
