U.S. NUCLEAR REGULATORY COMMISSION

Report No. 040-08948/93001(DRSS)

Facility: Shieldalloy Metallurgical Corporation
Route 209 South
Cambridge, OH 43725

Inspection Conducted: October 6, 1993 through January 13, 1994

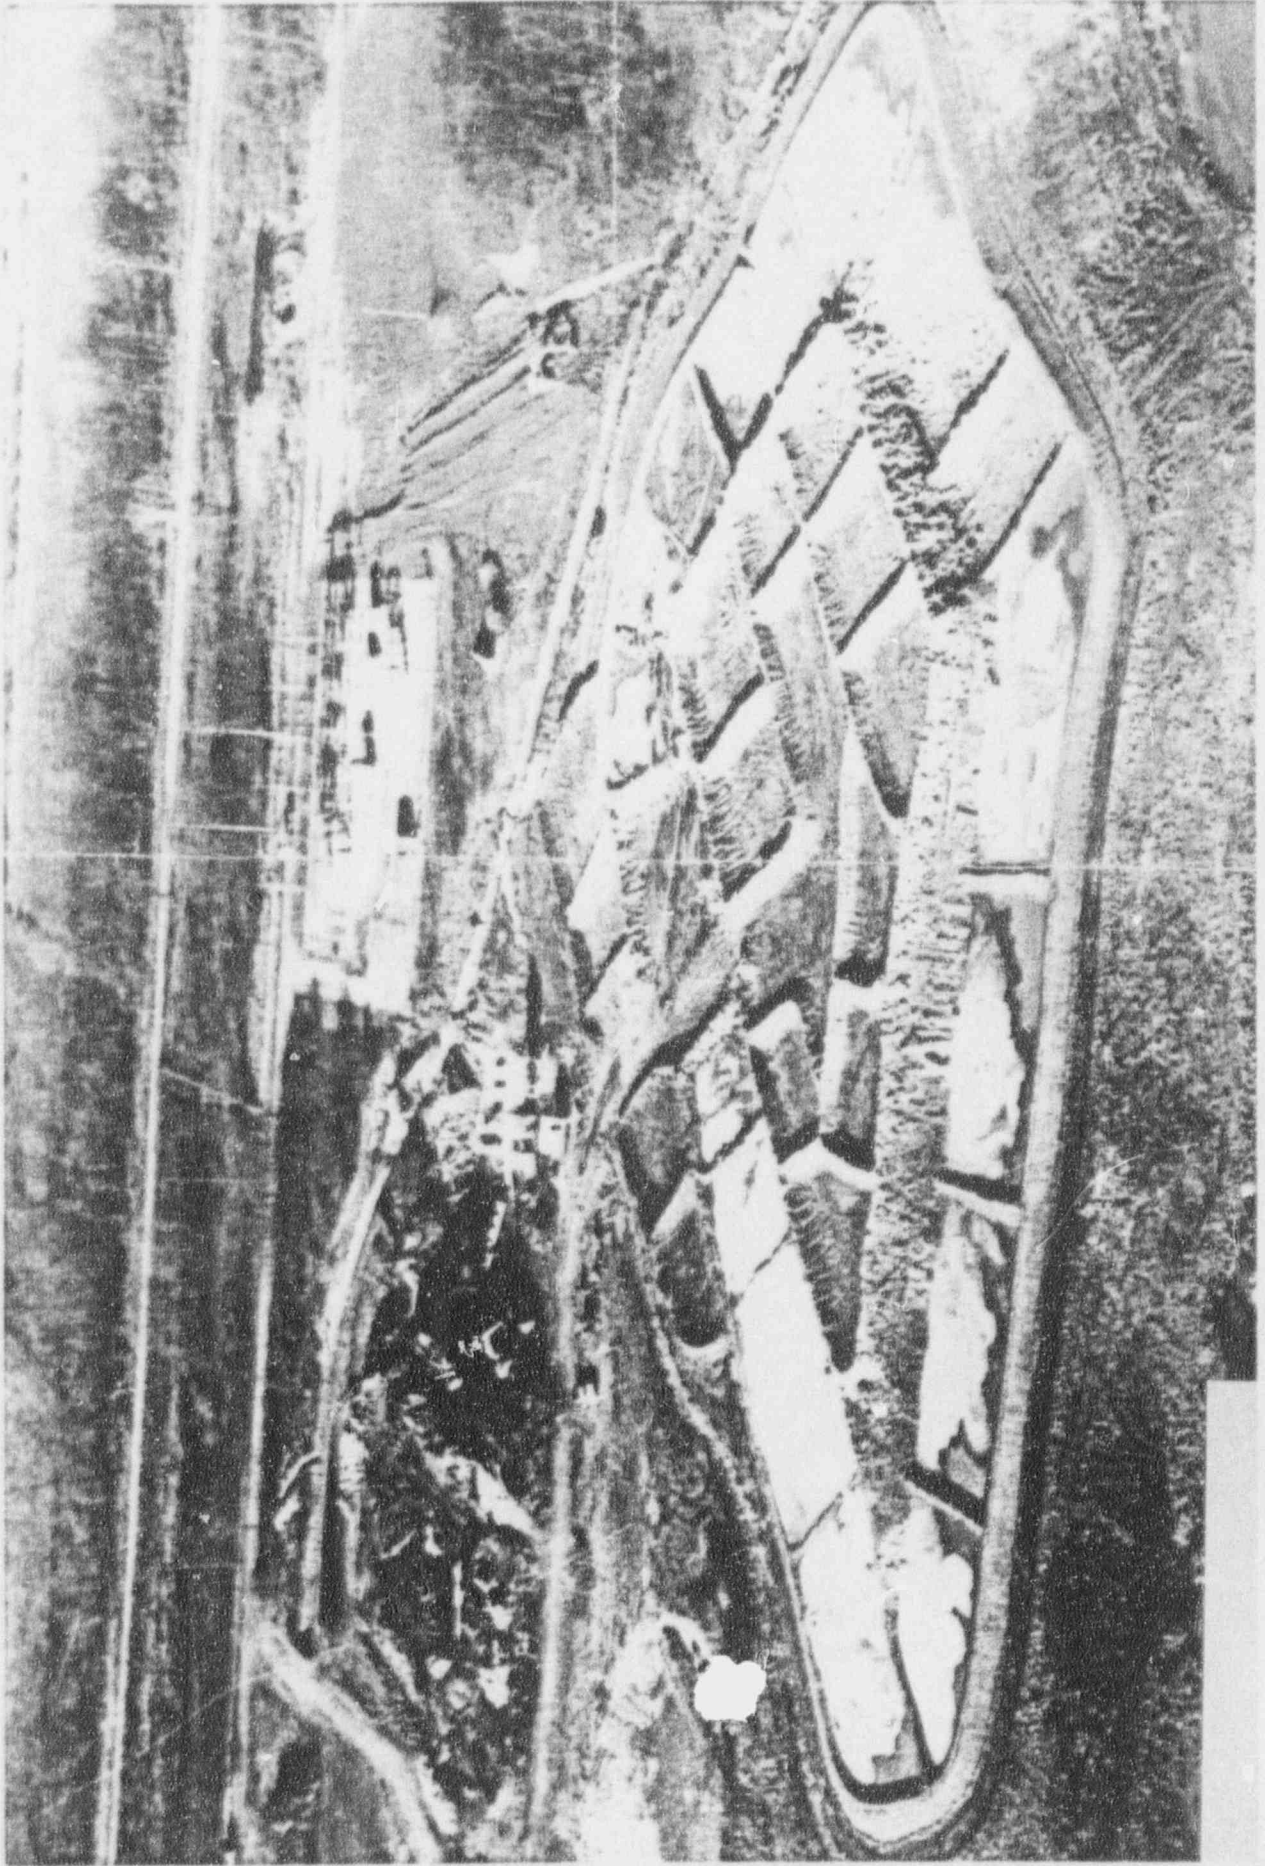
This pile originally consisted of approximately 3.0×10^5 tons (3.0×10^{08} kgs) of slag and soil covering 7.6 acres with an average concentration of thorium-232 (Th-232), uranium-238 (U-238) and radium-226 (Ra-226) of 1.4 picocuries per gram (pCi/g) {52.0 millibecquerels per gram (mBq/g)}, 3 pCi/g {111 mBq/g}, and 2.4 pCi/g {89.0 mBq/g}, respectively. Following decontamination of the manufacturing facilities and adjoining areas, an additional 1.4×10^5 tons (1.4×10^{08} kgs) of higher concentration slag was added to the West Pile. The additional material had an average concentration of Th-232, U-238, and Ra-226 of 42 pCi/g { 1.6×10^3 mBq/g}, 54 pCi/g { 2.0×10^3 mBq/g}, and 42 pCi/g { 1.6×10^3 mBq/g}, respectively. The top of the pile, according to SMC employees, is composed of at least 6-8 feet of cover material consisting of Chemfix (a clay-like material), a geotextile cover material, and approximately 6-8 inches of sand. This covers the top of the slag pile only. The shoulders of the piles are not covered and the slag is exposed. The licensee indicated during the December 13, 1993 exit meeting that it had planned to put a similar cover over the shoulder and then cover the entire pile with another 2 feet of soil and seeding. However, the licensee delayed this phase in 1991 when it failed to obtain final NRC approval for the containment request. Attachment B is a picture of the construction of the Chemfix cover.

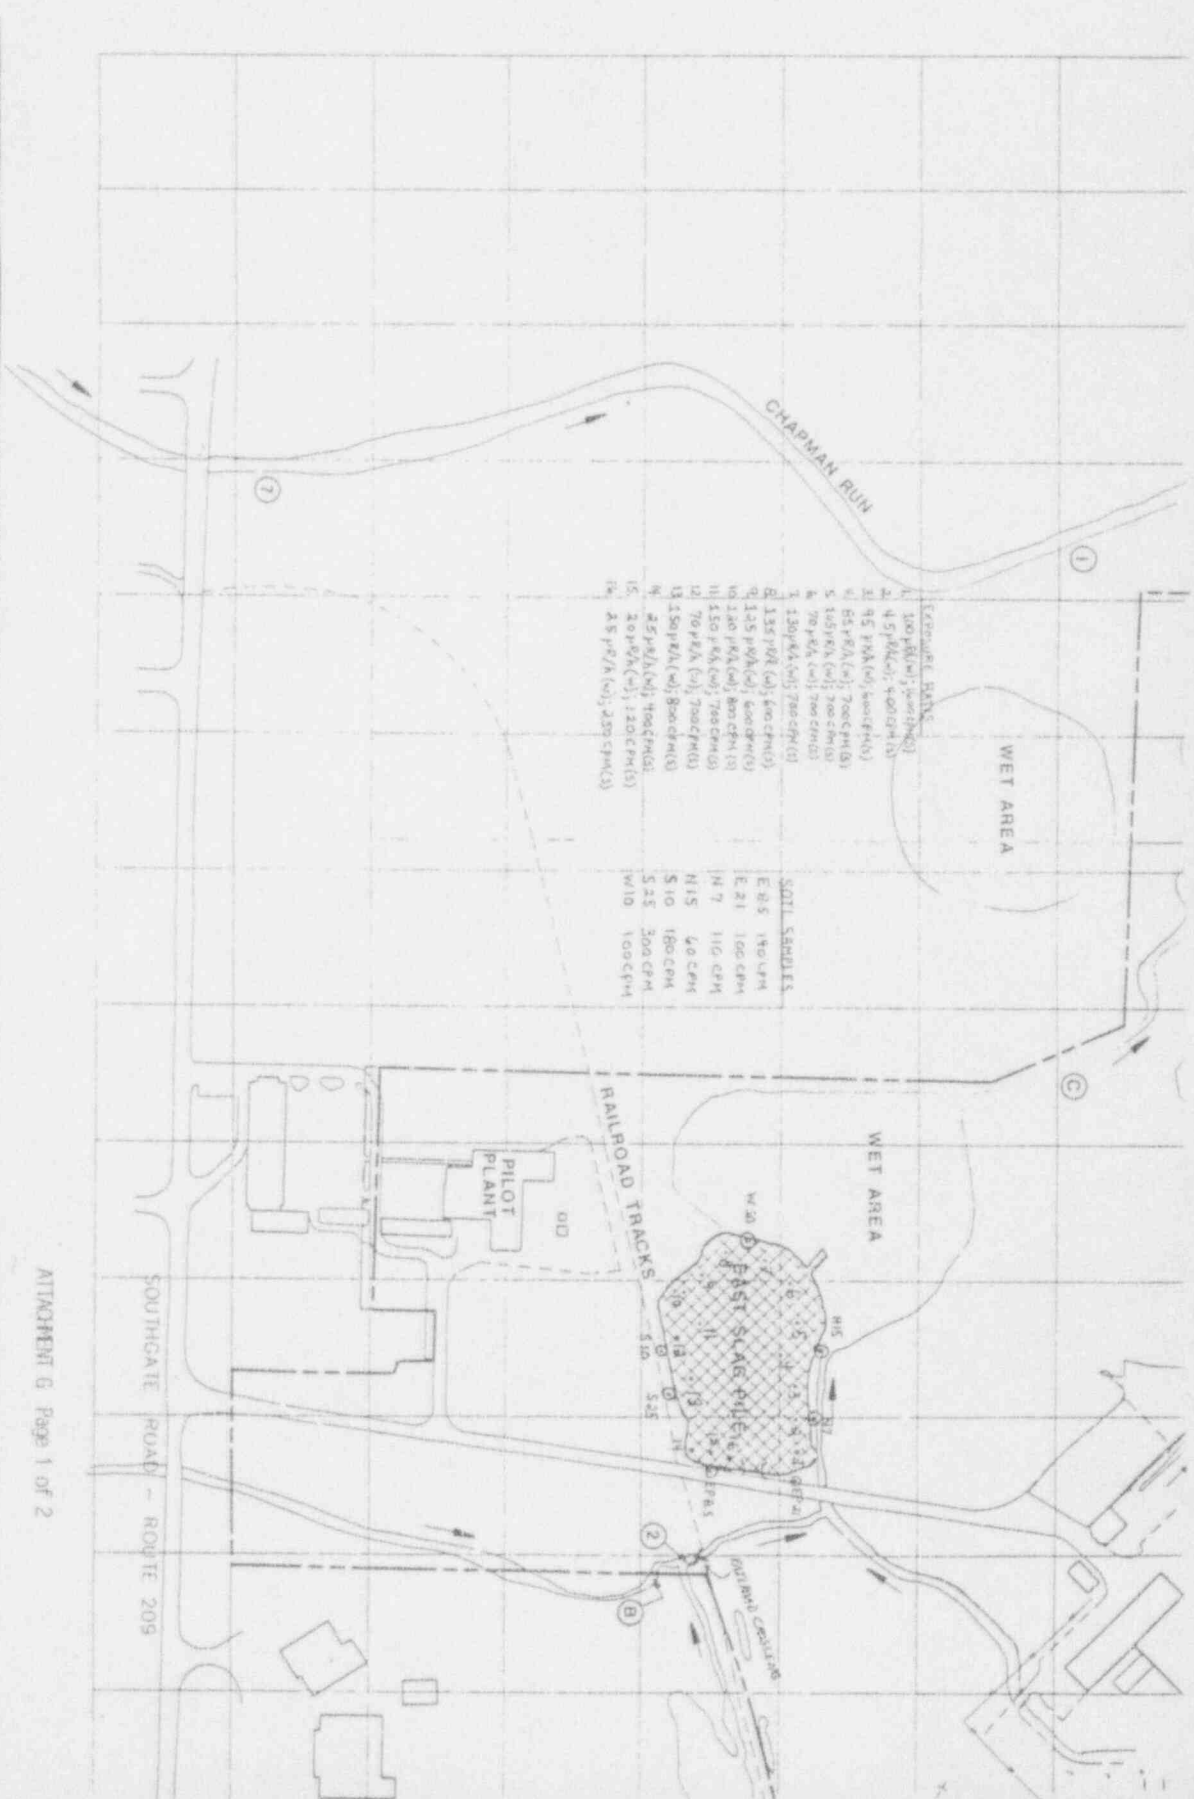
ATTACHMENT G Page 1 of 2

The following radiation measurements on the East Slag Pile are keyed to numbered locations on NRC Inspector's site map, Attachment G:

- (1) 1,600 counts per minute (cpm) (surface), 100 microreontgen per hour (μ R/h) (waist);
- (2) 400 cpm (surface), 45 μ R/h (waist);
- (3) 600 cpm (surface), 95 μ R/h (waist);
- (4) 700 cpm (surface), 85 μ R/h (waist);
- (5) 700 cpm (surface), 105 μ R/h (waist);
- (6) 700 cpm (surface), 70 μ R/h; (waist)
- (7) 700 cpm (surface), 130 μ R/h (waist);
- (8) 600 cpm (surface), 135 μ R/h (waist);
- (9) 600 cpm (surface), 125 μ R/h (waist);
- (10) 800 cpm (surface), 120 μ R/h (waist);
- (11) 700 cpm (waist), 150 μ R/h (waist);
- (12) 700 cpm (surface), 70 μ R/h (waist);
- (13) 800 cpm (surface), 150 μ R/h (waist);
- (14) 400 cpm (surface), 25 μ R/h (waist);
- (15) 120 cpm (surface), 20 μ R/h (waist);
- (16) 250 cpm (surface), 25 μ R/h (waist).
