HADDAM NECK PLANT

Reference: Facility Operating License No. DPR-61
Docket No. 50-213
Reportable Occurrence LER 50-213/94-001-00

LICENSEE EVENT REPORT (LER)

TITLE (4)
Containment Air Recirculation Fans Failed Flow Test

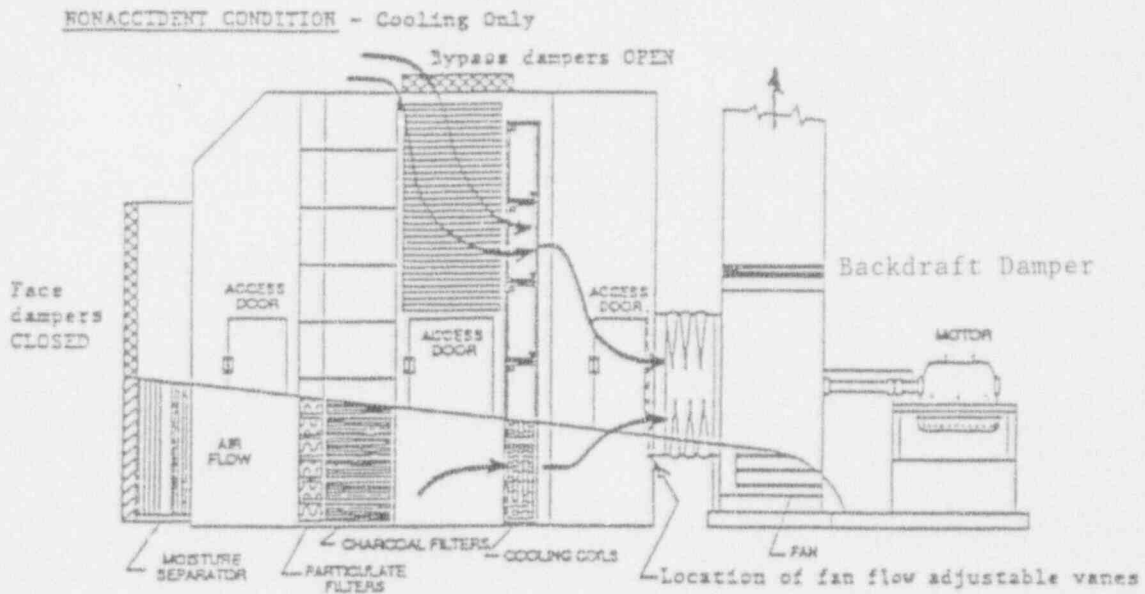
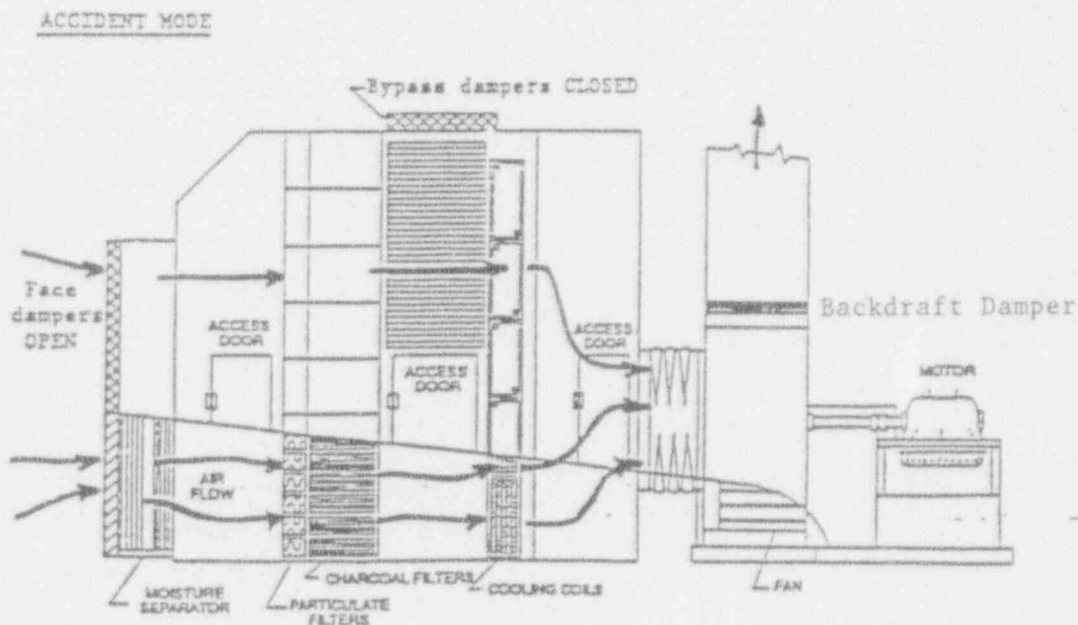
FIGURE 1

Four containment air recirculation (CAR) fans (EIS Code: BK) take suction near the outer periphery of the containment building middle level and discharge to a common duct which branches to distribution outlets within containment. During normal operation (see Figure 1) air enters the units through "bypass" dampers to cooling coils and then to the fan. These dampers are so named because they bypass the accident mitigation section of the unit (chevron moisture separators, high efficiency particulate air (HEPA) filters, and charcoal adsorbent trays.) Under normal conditions the inlet to the accident section is blocked by the "face" dampers. Upon receipt of a safety injection/containment isolation signal, the "face" dampers open and the "bypass" dampers close and air flows through the accident section of the CAR fan unit to the cooling coils to the fan. Technical Specification 3.6.2 requires at least four CAR fans operable in Modes 1 through 4. Technical Specification 4.6.2 requires that each CAR unit be capable of operating with a flow rate of 52,500 +/- 2,500 cfm.
