U.S. NUCLEAR REGULATORY COMMISSION
REGION I

Docket Nos.: 50-245 50-336 50-423
Report Nos.: 93-27 93-20 93-23
License Nos.: DPR-21 DPR-65 NPF-49

Facility: Millstone Nuclear Power Station, Units 1, 2, and 3

EXECUTIVE SUMMARY
Millstone Nuclear Power Station
Combined Inspection 245/93-27; 336/93-20; 423/93-23

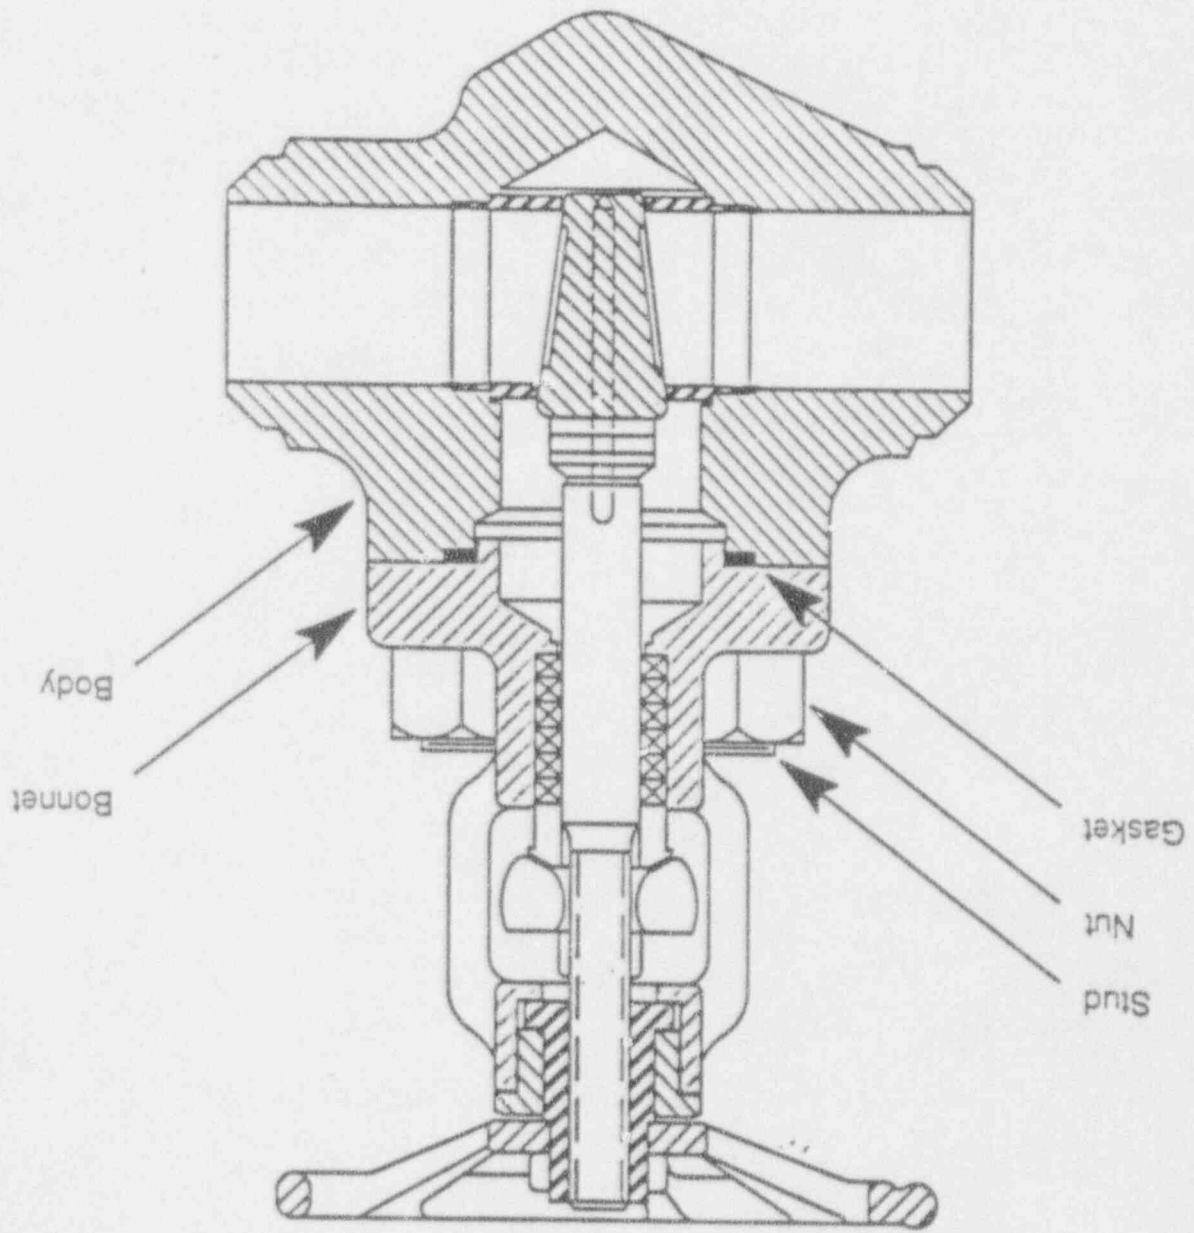
Figure 7.1: Valve 2-CH-442

- 5/24/93 Minor body-to-bonnet gasket leak identified on valve 2-CH-442 (2", 1500 lb., bolted bonnet gate valve, reactor coolant system to letdown (manual isolation))
- 6/4/93 AWO M2-93-07225 released to perform repair; first injections performed
- 6/9/93 NUSCO assessment increased maximum allowable pressure; memo on restricted drilling areas provided
- 6/10/93 AWO M2-93-07864 released to install additional fittings and to perform sealant injection
- NUSCO evaluated acceptability of drilling locations since vendor did not comply with supplied drawing
- 6/12/93 Attempted to install body clamp--did not fit; liquid sealant injected

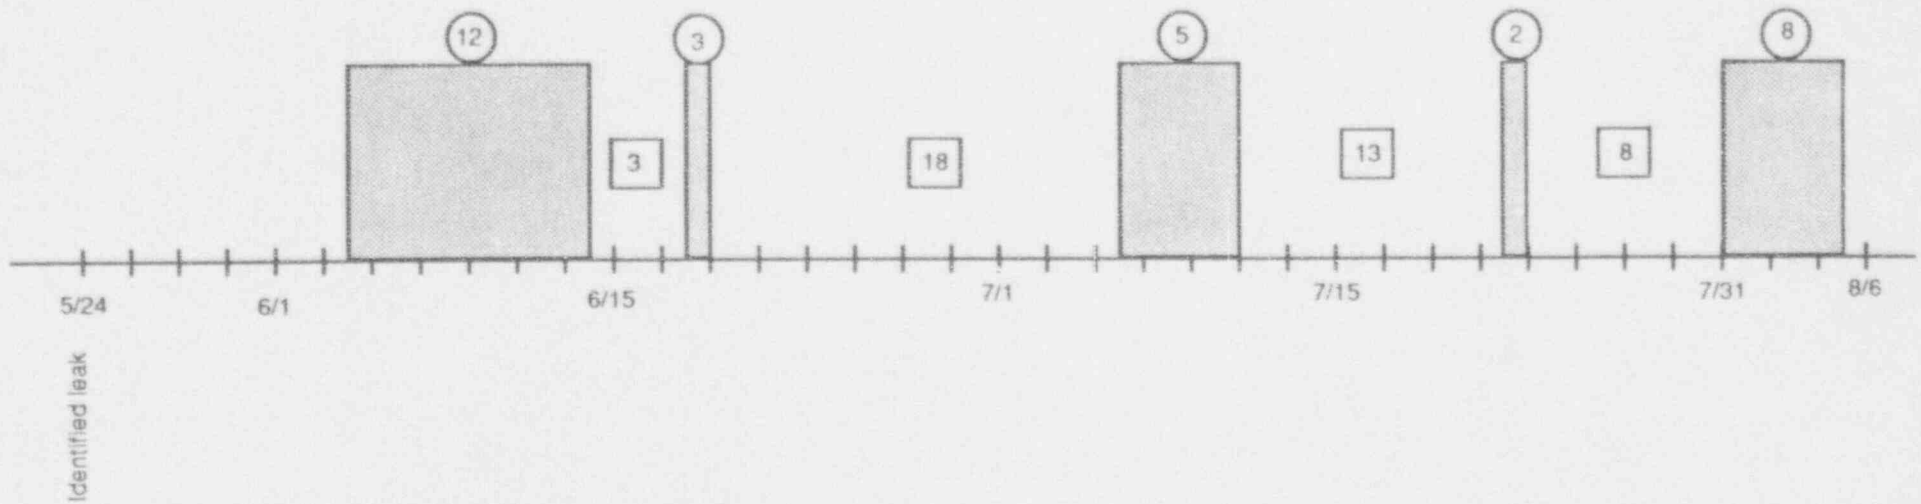
2-CH-442 Leakage Histogram

Shaded areas represent days of 2-CH-442 injection
