Report No. 50-293/82-20

Facility Name: Pilgrim Nuclear Power Station

Inspection on June 11-13, 1982 (Inspection Report No. 50-293/82-20)

Areas Inspected: Special, announced inspection of initial licensee actions after spent resin was found on roof-tops and pavement within the protected area of the Pilgrim Station on June 11, 1982. Areas inspected included: initial contamination identification, contamination surveys, posting and barricading, resin removal, resin source determination, notifications and initial and long term planned corrective actions. Upon arrival at the site at 10:30 p.m. on June 11, 1982, the inspectors toured the site to review the extent and control of the resin contamination. The inspection involved 33 inspector-hours onsite by three region-based inspectors.

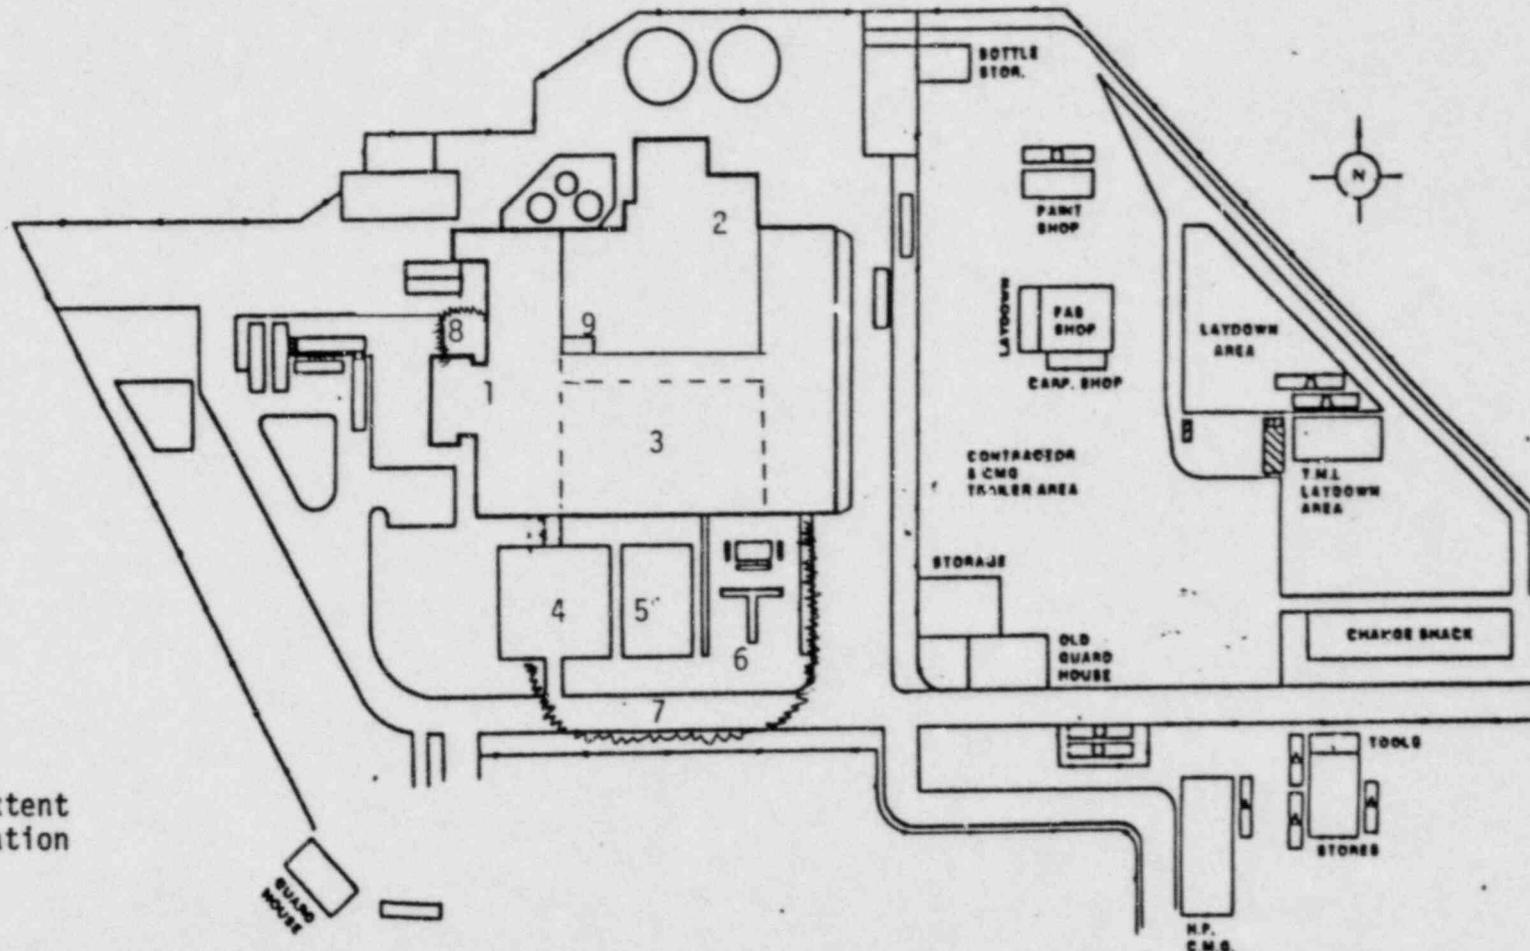
FIGURE 1

During a tour of the Retube Building Roof (see Figure 1) at about 1:00 p.m. on June 11, 1982, a Radiation Protection Technician saw resin in the building's rain gutters. Subsequent contamination surveys of small piles of the resin (about several grams) indicated activity levels of 100-200,000 disintegrations per minute (DPM).

The licensee identified resin contamination on the Reactor, Turbine, Administration, and Augmented Off-Gas Buildings. Resin was also identified on two areas of pavement (see Figure 1).

- *1. Administration Building Roof - pockets, 100K - 200K dpm
- 2. Reactor Building Roof - clean
- 3. Turbine Building Roof - pockets, 100K dpm
- 4. ACG Building - pockets, 200K dpm
- 5. Retube Building - pockets, 200K dpm
- 6. Main Transformer Area - 1K - 25K dpm (small areas)

- 7. Pavement - along curb, 20K - 80K dpm
- 8. Pavement - along curb, 100K - 200K dpm
- 9. Plant Vent - Point of Release

The review of this area indicated the licensee initiated vacuuming of the resin from the contaminated areas and from the Reactor Building Contaminated Ventilation Exhaust System in an expeditious manner.

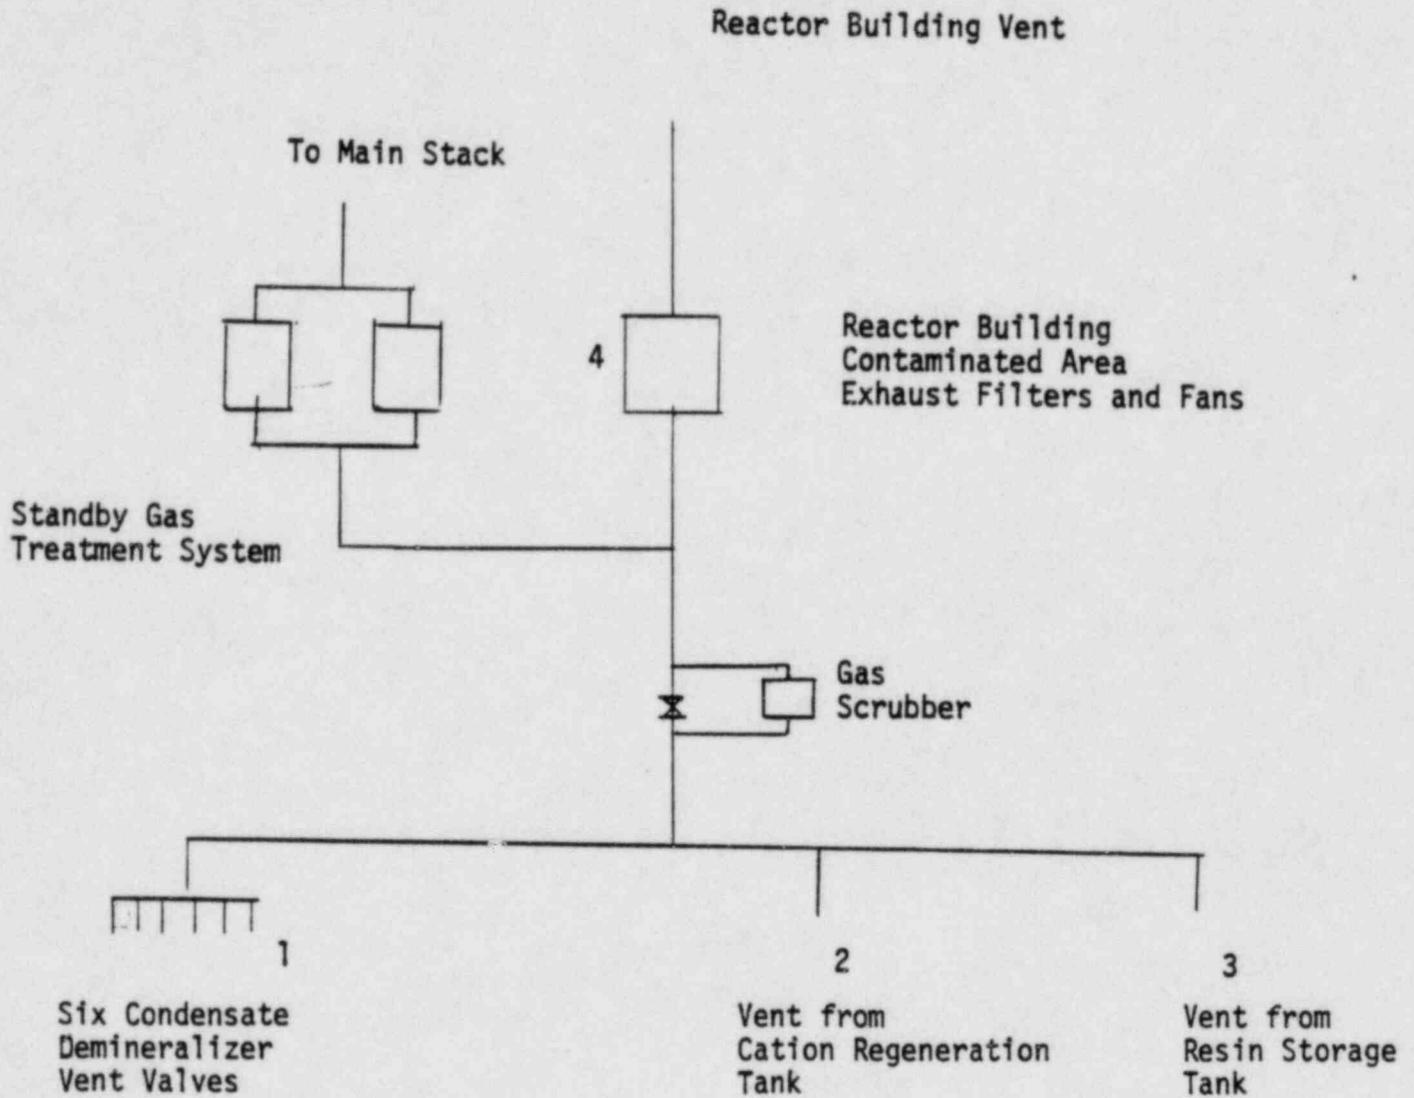
FIGURE 2
SPENT RESIN CONTAMINATION/RELEASE
PATHWAY

The licensee's initial findings indicated the resin was entering the ventilation system during resin cleaning operations. The licensee subsequently suspended all operations which could result in further resin releases to ventilation system duct work. Figure 2 provides the apparent resin contamination/release pathway.

Licensee representatives stated that in September 1981, the Reactor Building Contaminated Area Exhaust Filters were found to be bypassing, apparently due to improper filter fit and degradation and were subsequently replaced. The licensee representatives stated that the contamination most likely exited the plant vent via the by-pass prior to the repair of the filters.

1. Possible source prior to repair.
2. Apparent source during backwashing.
3. Possible source during resin transfer
4. Filters found to be by-passing about September 1981.

- Discontinue back flushing, regenerating or ultrasonically cleaning condensate demineralizer spent resins until the source of the resin contamination of ventilation systems is identified and corrective actions taken for its cause. In the event long term plant design changes are needed to correct the cause of the resin release to the ventilation system, resin cleaning operations may be performed provided that: a) appropriate procedure revisions and other administrative controls are established to prevent further resin releases to the ventilation system; b) a test of the adequacy of the procedure revisions and other administrative controls is performed using clean resin and; c) the integrity of the Contaminated Exhaust Ventilation filters has been verified by DOP testing.
