PRAIRIE ISLAND NUCLEAR GENERATING PLANT
Docket Nos. 50-282 License Nos. DPR-42
50-306 DPR-60

Response to Notice of Violation
NRC Inspection Report No. 306/93021(DRP)
Control of Outage Activities

RESPONSE TO INSPECTION REPORT

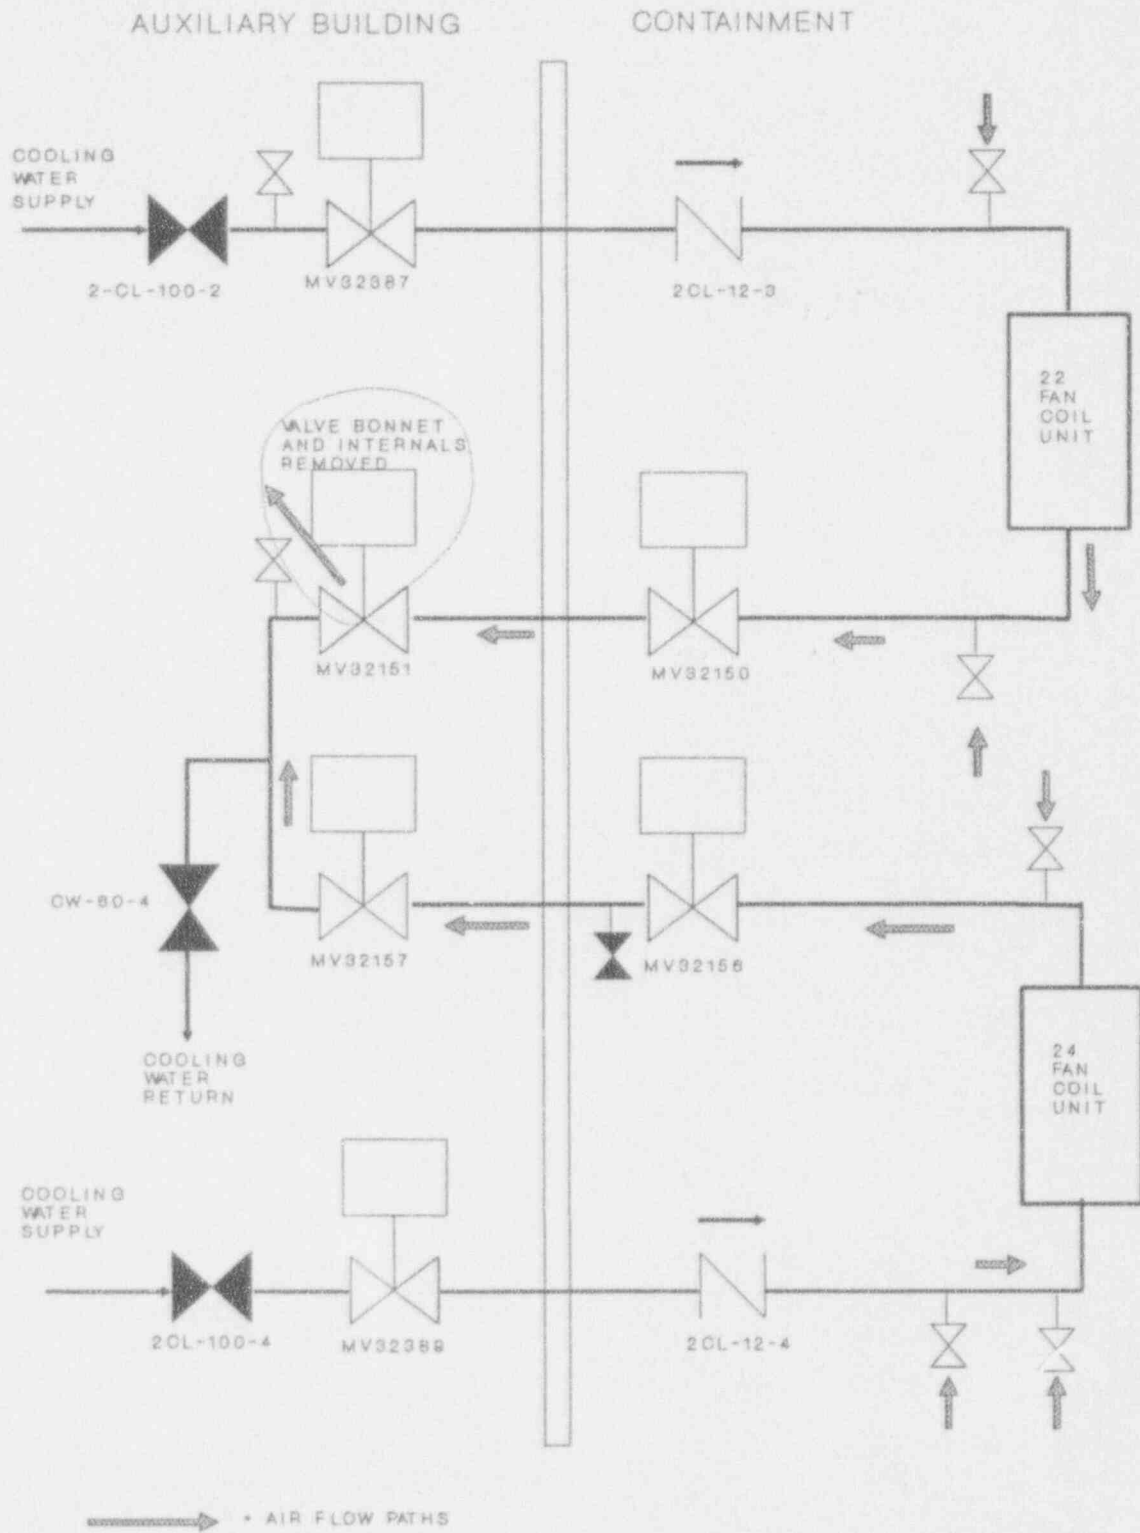
FIGURE 1
SIMPLIFIED FLOW DIAGRAM

On November 17, 1993, Unit 2 was in cold shutdown for refueling. The Unit 2 core had been unloaded, and maintenance and testing activities were in progress. Work had begun on isolation and repair of MV-32151, No. 22 Fan-Coil Unit Cooling Water Outlet. See Figure 1. The work request required No. 22 and No. 24 Fan-Coil Units (FCU) to be isolated and drained. Cooling water to both FCU's was isolated by closing manual valves 2CL-100-2, 2CL-100-4 and CW-60-4. Motor valves MV-32387, MV-32151, MV-32150, MV-32157, MV-32156 and MV-32389 were opened. Cooling water supply and return line vents and drains were then opened to allow draining of the isolated header.

At 0940 on November 24, 1993, with core reloading still in progress, a Quality Control inspector noted that air was coming from the open valve body of MV-32151. The inspector called the control room to report his observation. Investigation showed that MV-32150 was open and allowing air to flow from containment to the Auxiliary Building. MV-32150 was immediately closed manually. MV-32156 was then checked and also found open; it too was immediately closed manually, and "Refueling Integrity" was established. MV-32387 was also checked and found open and was manually closed.

Contrary to the above, on November 23, 1993, core alterations commenced when a direct path from the containment atmosphere to the outside (in this case the Auxiliary Building) existed through penetration No. 38B because valve MV-32150 was open.

Contrary to the above, on November 17, 1993, an operator installed safety tags on motor-operated valves MV-32387, MV- 32150, and MV-32156, when they were containment boundary components, per work request U2156-ZC-Q, without placing the valves in the required position.

Upon discovery that MV-32150 was open, it was closed manually. MV-32156 was then checked and also found open; it too was closed manually, placing the unit in compliance with Technical Specification 3.8.A.1. MV-32387 was also checked and found open and manually closed.
