KAH-032-94
February 11, 1994

SUBJECT: Notification of Potential Defect in Assembly of Group Rod Indicator Display (GRID), Step-Counter

Enclosure (1)
KAH-032-94

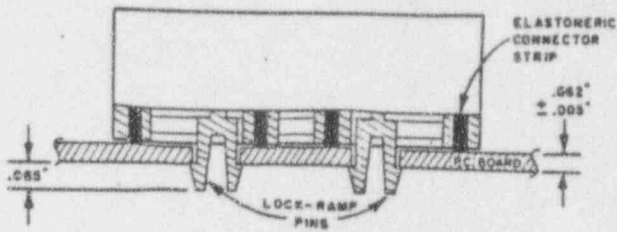
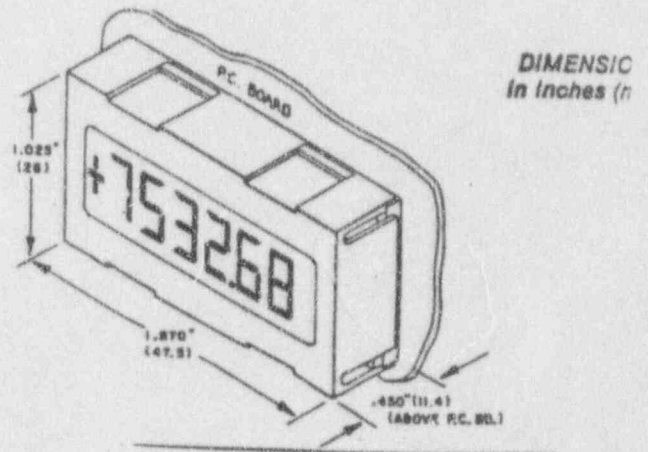
MOUNTING & DIMENSIONS

Snap in mounting on the P.C. Board is facilitated by two, split, lock-ramp pins which engage mounting holes drilled in the P.C. Board. The silicone rubber elastomeric connectors compress to accommodate P.C. Board thickness variation of $\pm .005$ ".
